Laboratory fire experiments with a 1/3 train carriage mockup

Alexander Claesson, Anders Lönnemark, Haukur Ingason,
Johan Lindström, Ying Zhen Li and Mia Kumm

SP Report 2012:06
ISBN 978-91-87017-23-0
ISSN 0284-5172
Borås 2012

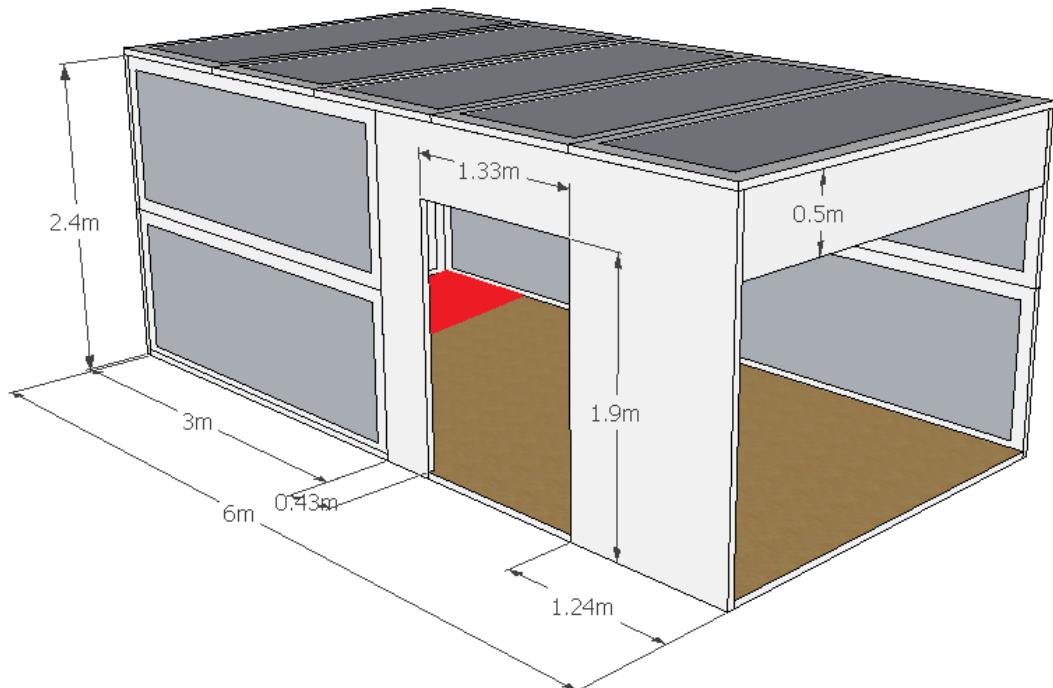
The dimensions of the mock-up were 6 m×3 m×2.4 m (L×W×H) with two openings, see Figure 1. The open end of the model had a 0.5 m high edge to create a smoke layer in the carriage. The inner linings, walls and ceiling, were covered with non-combustible boards (Promatect H). The floor was covered by 12 mm plywood boards. In the corner where the fire was started, i.e. the corner marked red in Figure 1, the non-combustible boards were covered with combustible 1 mm HPL (high pressure laminate, density of 1400 kg/m³) boards.

Figure 1 1/3 train carriage mock up. The width of train carriage was 3 m.

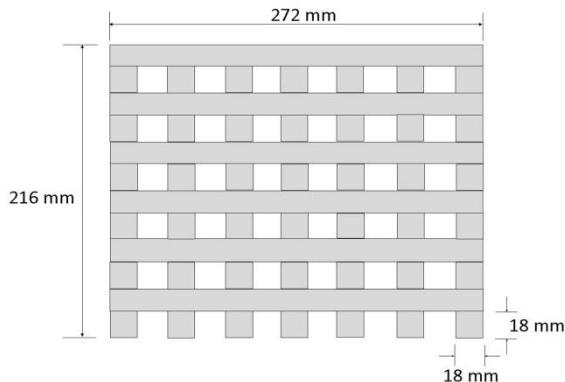
Figure 2 Geometry of the wood cribs used as ignition source.

The wood cribs were made of wood sticks, each 272 mm long and with a cross section of 18 mm. In total there were 12 layers of sticks, with 7 sticks in each layer. To ignite the wood crib, stick 3 and 5 in the bottom layer were made of fiber-board and soaked in heptane. The estimated heat release was 150 kW per wood crib. In Appendix D, photos from each test are shown, and where the location of the ignition source can be observed.

In tests 1 to 4 the ignition source consisted of wood cribs, see Figure 2, and in test 5 and 6 the ignition source consisted of 1 liter of petrol, see Figure 3.

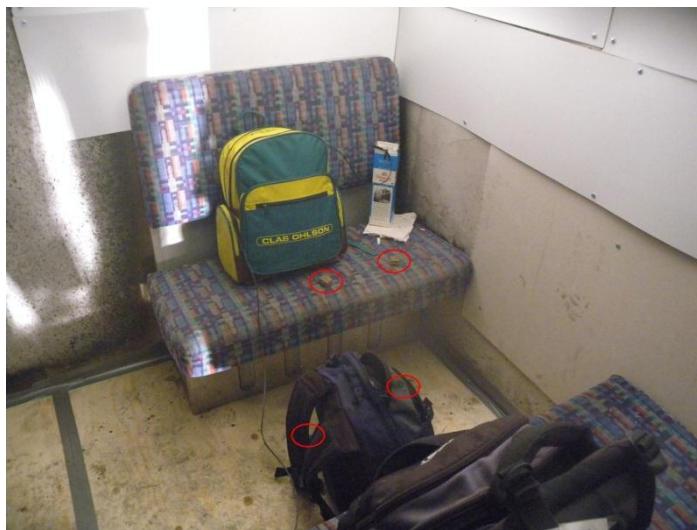
When petrol was used as the ignition source, a milk container was filled with 1 liter of petrol. Four small flames were lit, two on the floor and two on the seat, see the four red circles in Figure 3. The petrol was lit by pulling a string attached to the milk container and spilling the petrol over the flames.

Figure 3 Picture from test 5 showing the experimental set-up with milk container filled with petrol. Positions of flames are marked with a red circle, the lower two were placed on the floor in front of the backpack.

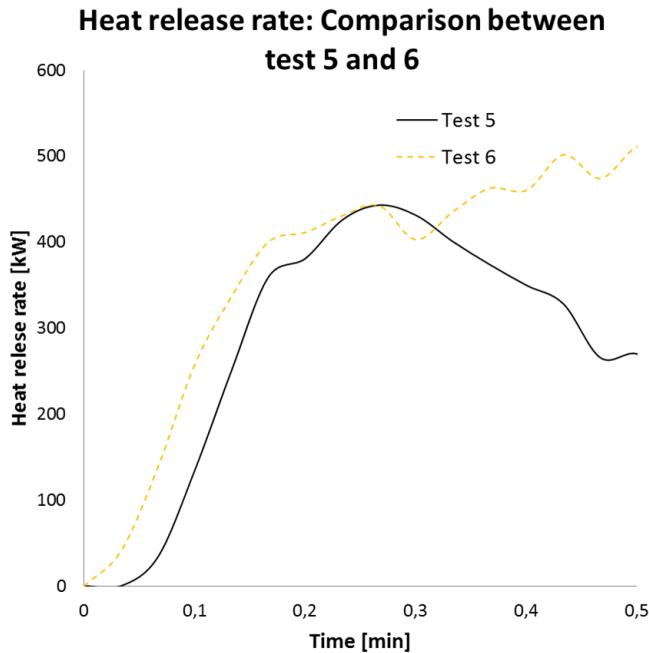
The maximum heat release rate of the petrol was estimated from the initial heat release rate in test 5 and 6, see Figure 4. During the first 15 s the heat release rate increases at approximately the same rate in both test 5 and 6. Since there was very little time for flame spread, this increase in heat release is most certainly due to the burning petrol. In both test 5 and 6 the heat release rate levels off at about 440 kW, see Figure 4, and after that there is a small decrease in HRR before the flames spread rapidly in test 6 and more slowly in

test 5. See Chapter 4 for more detailed information about the continuous development. The conclusion is that the maximum effect of the petrol used for ignition is 440 kW.

Figure 4 The measured heat release rate from test 5 and 6 between 0 and 0.5 min to see max HRR of petrol.

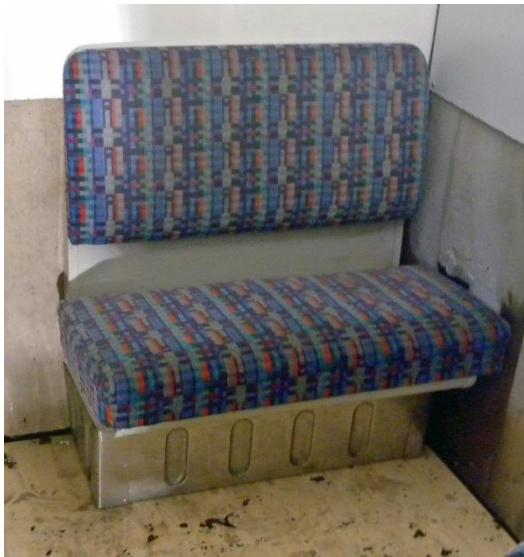
Passenger seats: Seats were taken from an X1 train and installed in the train carriage mockup. The seats consisted of, from the top: fabric 3 mm, foam (seat 60 mm and backrest 12-25 mm, respectively), cork wood 9 mm and painted wooden board 4 mm [5]. Cone calorimeter data for the seat material are given in Table 1.

Figure 6 Photo of seats in the train carriage mockup.

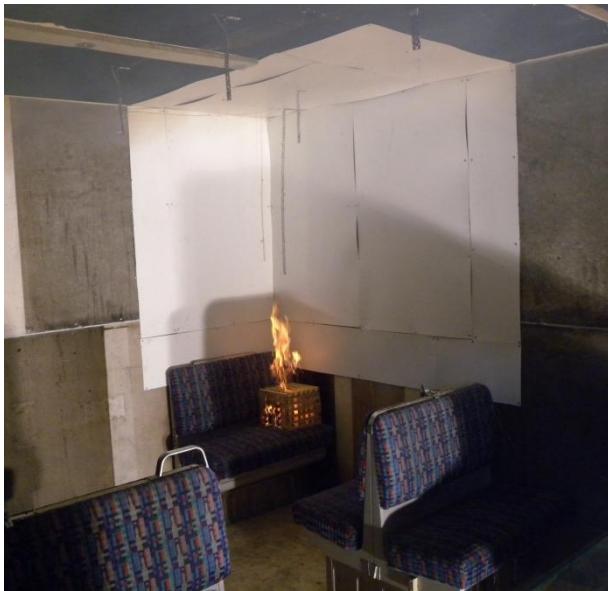
Walls and ceiling: The walls and ceiling was constructed of non-combustible boards (12 mm thick Promatect H). The walls and ceiling near and above the ignition source were covered by combustible high pressure laminate (HPL) boards, see Figure 7. Cone calorimeter data for the HPL are given in Table 2

Figure 7 A photo of the HPL boards on the wall and ceiling above the ignition source.

All tests were carried out with combustible HPL boards on the walls and ceiling above the ignition source, see figure 7. The rest of the walls and ceiling was constructed in non-combustible boards. The vertical flame-spread on the HPL boards was relatively similar in the different tests with wood cribs as the ignition source. In these tests the flames spread in the corner up to the ceiling. In the case of a liquid ignition source (petrol), the vertical flame spread differed between test 5 and 6. In test 5 it was very weak, see pictures from test 5 in Appendix D – Photos from tests, and in test 6 it was extremely strong. A possible explanation is that this is related to the disposition of the bags that was placed in the vicinity of the ignition source, see Figure 20.

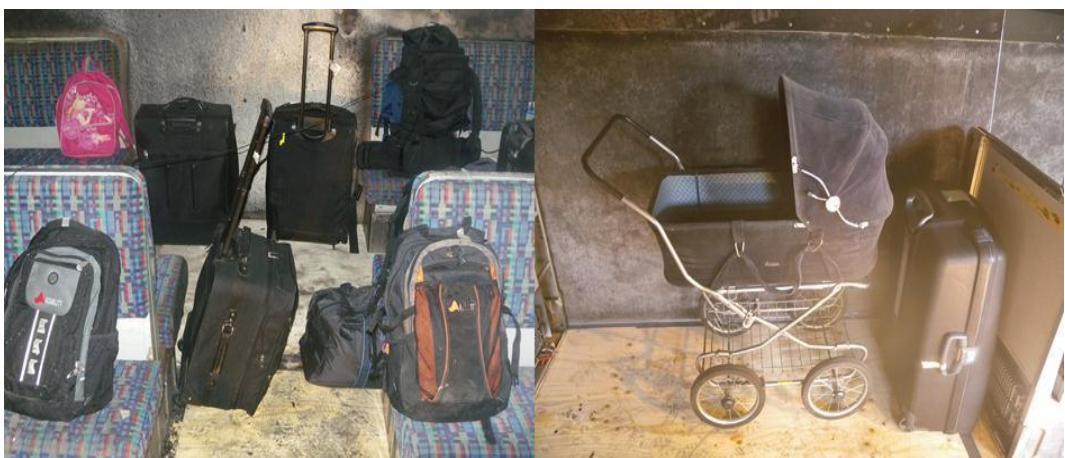
Luggage: Bags with different size and weight were used as fire load in test 4, 5 and 6. The bags were filled with clothes (textile) and paper (cellulosic), see Appendix B. During the tests, the bags were placed in different positions in the train carriage, both on the floor and on seats. In test 5 and 6 a baby carriage was placed close to the opening, see Figure 8.

Figure 8 A picture of bags in test 6 (left) and the baby carriage used in both test 5 and 6 (right).

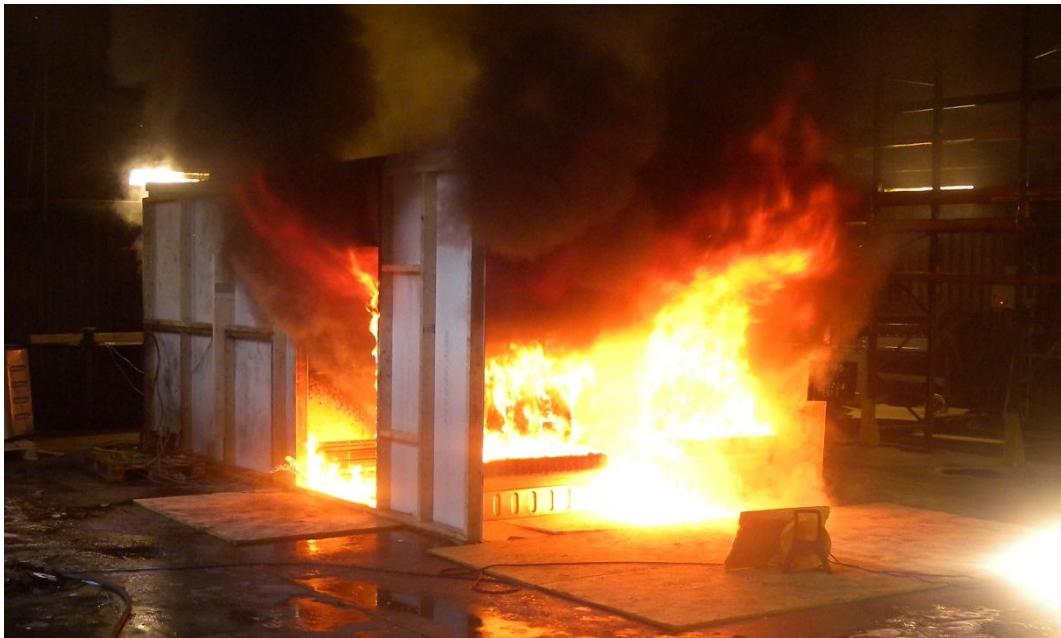
In Figure 10 a picture of a fully developed fire in test 6 is presented. The picture is taken shortly after flashover occurred.

Figure 10 A photo of the fully developed fire in test 6.

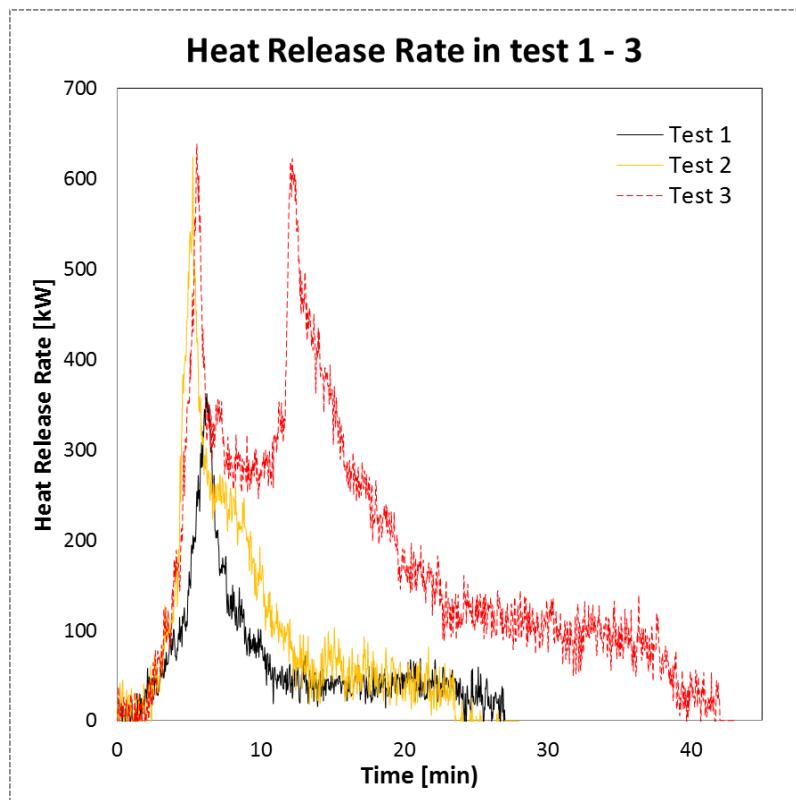
Figure 11 Heat release rate in test 1 – 3

When a flashover is established we know that 2.1 MW is required. If analyzing the figures 11 – 12, we observe that if the heat release rate becomes higher than 700 – 900 kW, a fire development that grows to a flashover is obtained. This is the minimum heat release rate required in order to continue the fire growth. This number shall not be compared directly with 2.1 MW, which is the calculated value when a flashover is established.

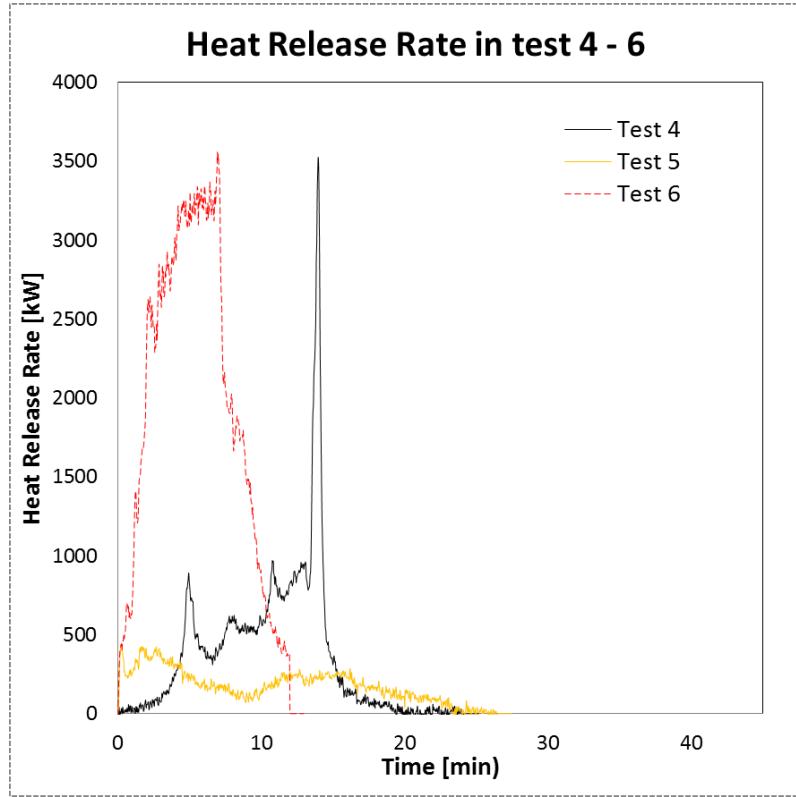
Figure 12 Heat release rate in test 4 – 6. The fire was manually extinguished after 14 min in test 4 and in test 6 it was manually extinguished after approx. 7 min.

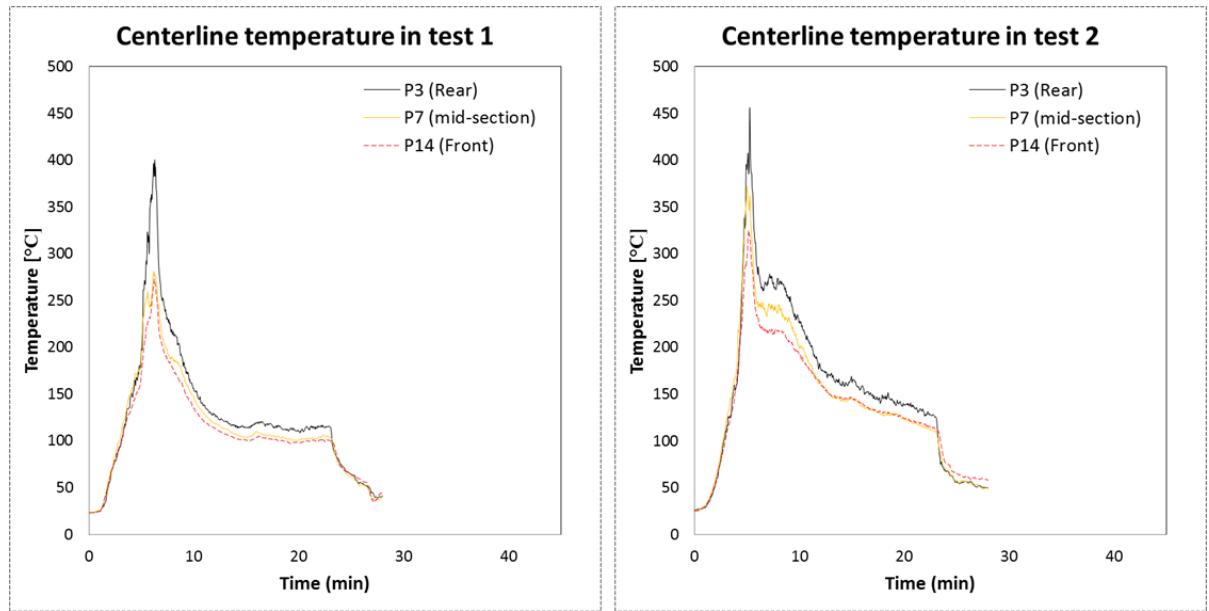
Figure 13 Center line temperatures in test 1 and 2.

In Figure 13 to Figure 15 center line gas temperatures from each test is presented. In the figures below measure point P5, P9 and P11 are excluded to make the diagrams easier to interpret.

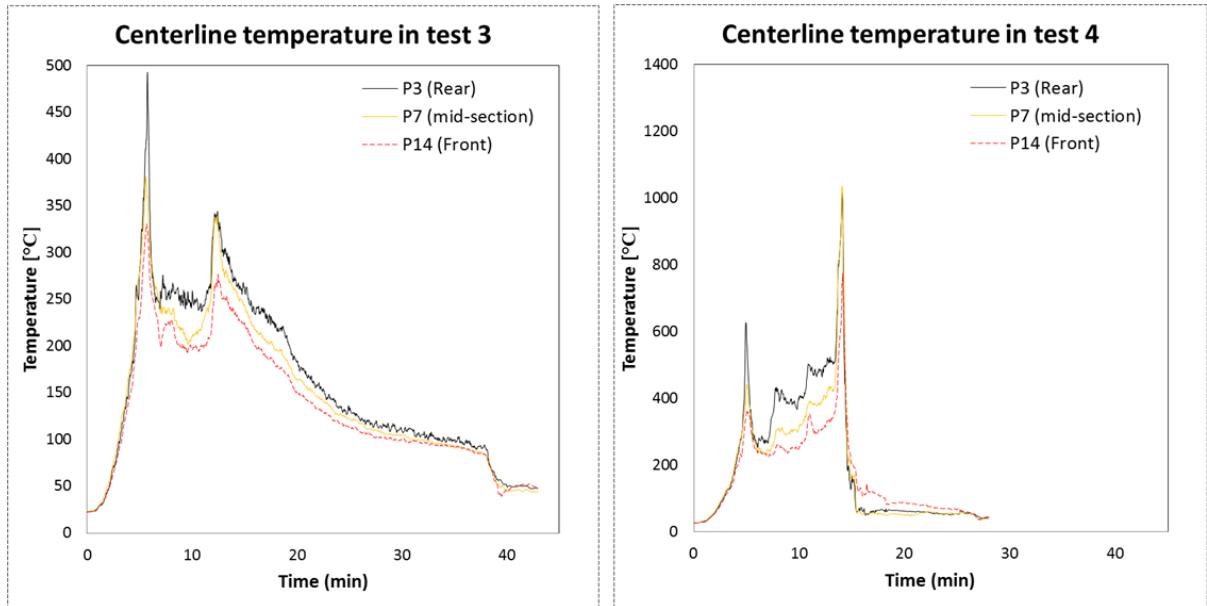
Figure 14 Center line temperatures in test 3 and 4.

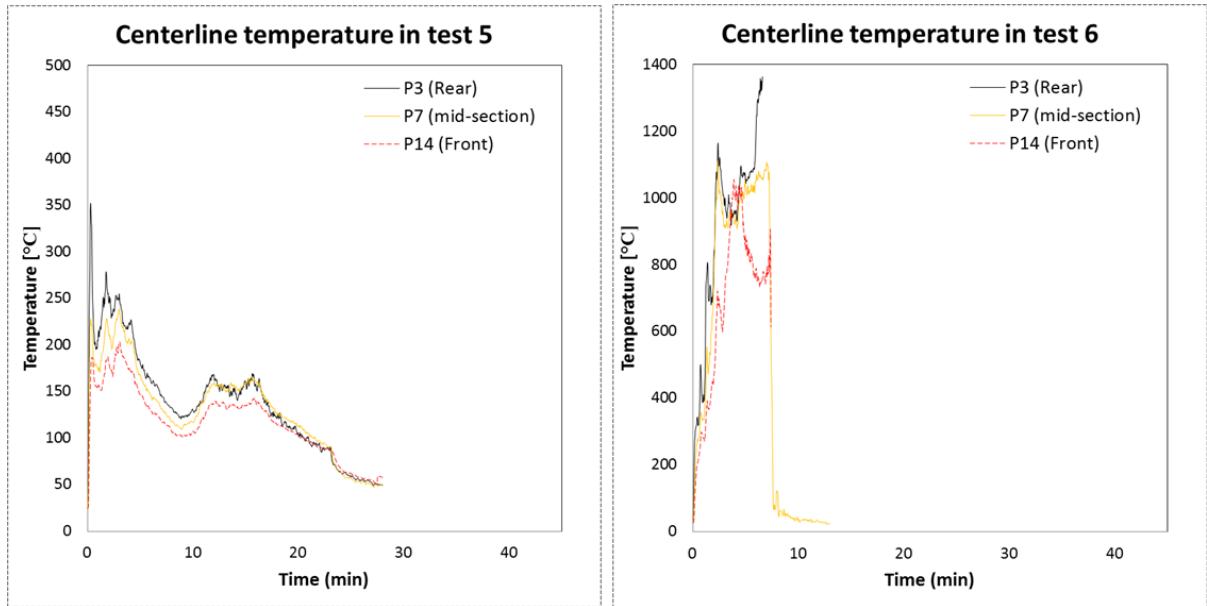
Figure 15 Center line temperatures in test 5 and 6.

In test 6 several of the thermocouples reported void data between 5 and 10 min, this could be because the fire broke through the ceiling after about 7 min and destroyed the thermocouple suspension and/or the thermocouples themselves. Another possibility is that the void data is a result of the fire extinguishment that started after about 7-8 min. In any case it does not affect the conclusions or the findings presented here.

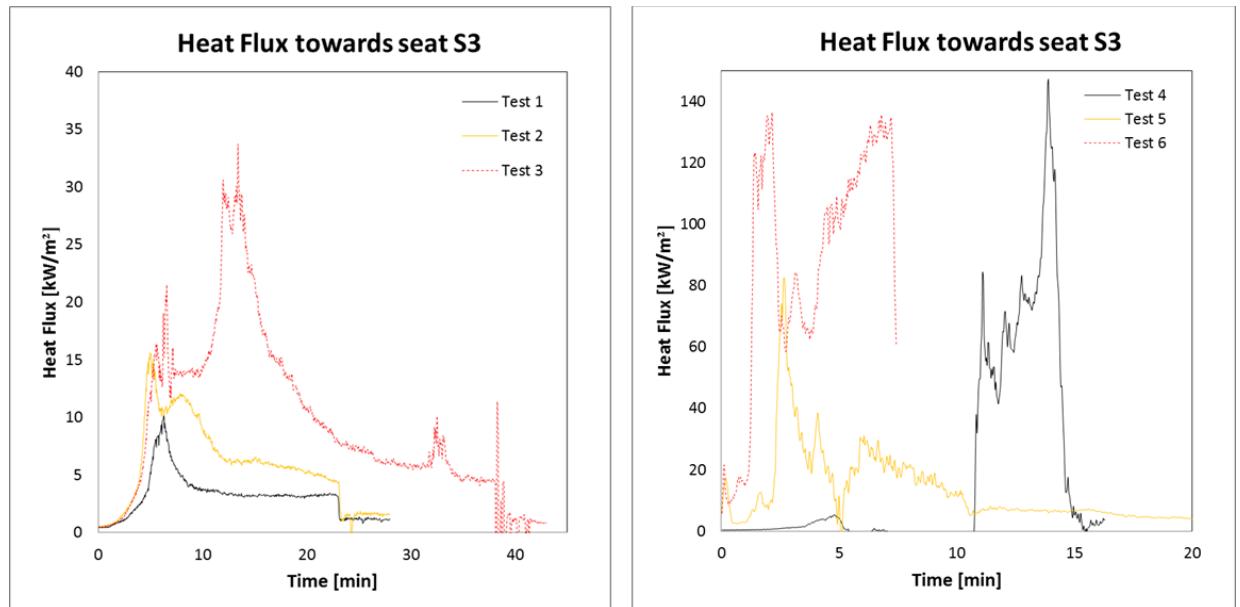
Figure 16 Heat Flux towards seat S3 (measurement point P4). Test 1-3 to the left and test 4-6 to the right.

The information in figures 17 to 19 can be used to interpret the risk for fire spread between the seats. In tests 3, 4, 5 and 6, the incident radiation at seat S3 (measurement point P4), all exceed the value of 20 kW/m^2 , at some stage of the fire development. Comparing this information with which tests the fire spread to the opposite seat of the ignition seat, a good correlation was found, see test protocols in Appendix B. This is also confirmed by the values given in Table 7. In conclusion, in order to obtain a flashover, the fire has to spread further than the seat S3. A more accurate analysis of the fire spread is given in the following subsections.

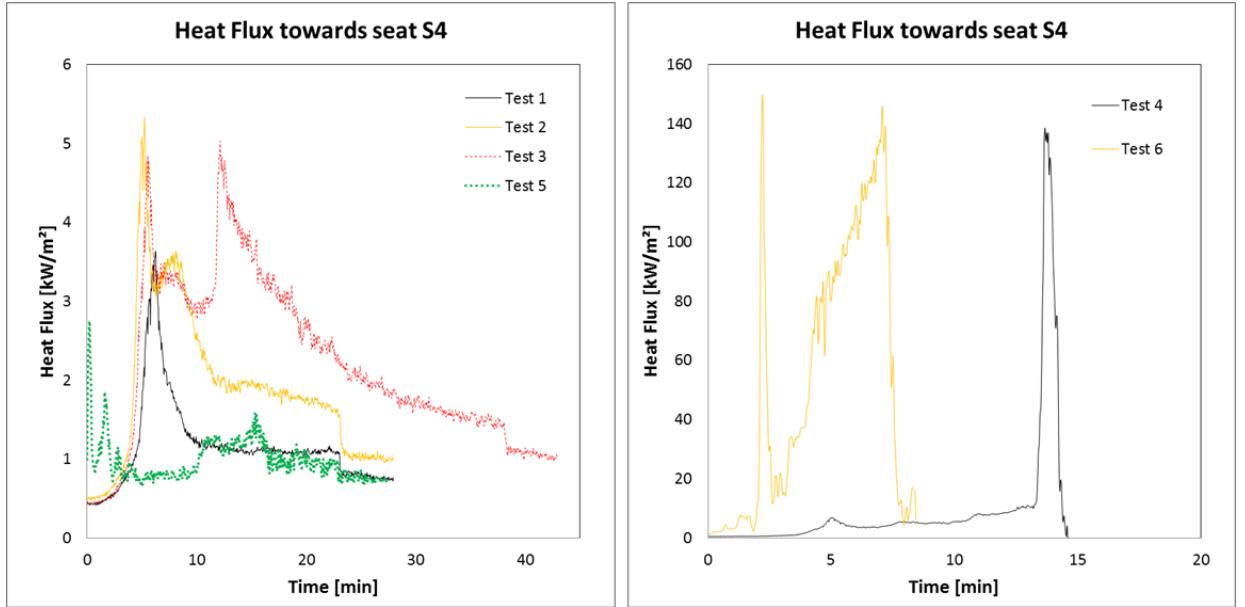
Figure 17 Heat Flux towards seat S4 (measurement point P6). Test 1-3 and 5 to the left and test 4 and 6 to the right.

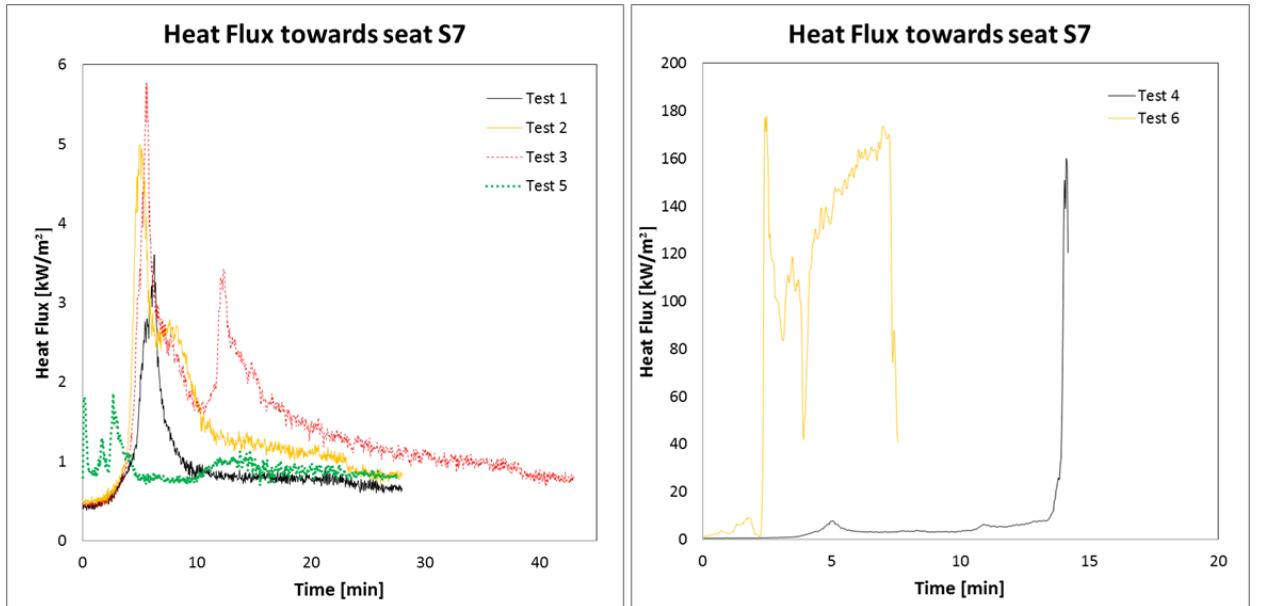
Figure 18 Heat Flux towards seat S7 (measurement point P8). Test 1-3 and 5 to the left and test 4 and 6 to the right.

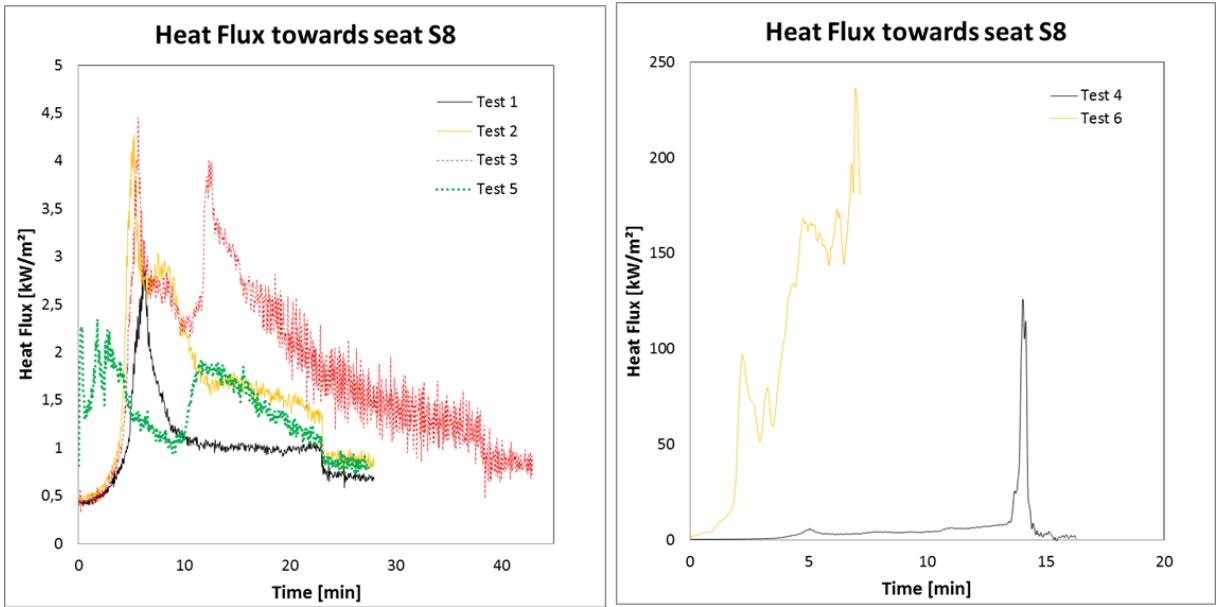
Figure 19 Heat Flux towards seat S8 (measurement point P10). Test 1-3 and 5 to the left and test 4 and 6 to the right.

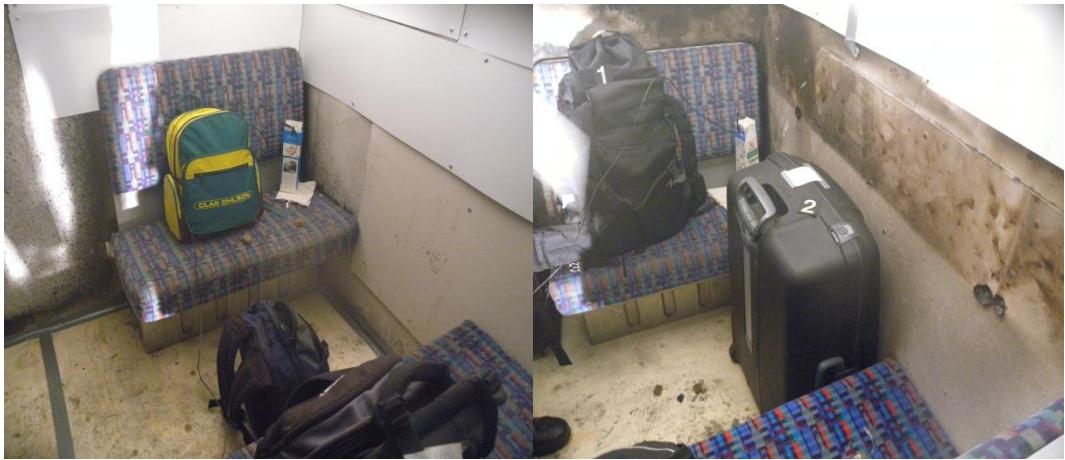
Figure 20 Disposition of bags in the vicinity to the ignition source in test 5 (left) and test 6 (right).

In test 5 bags were placed away from the wall making it more difficult for the flames to spread to the HPL boards and in test 6 the bags were larger and placed closer to the wall.

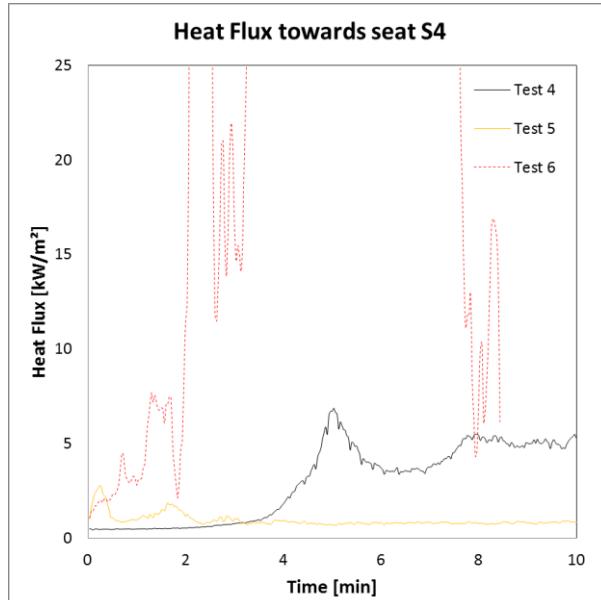
Figure 21 Heat flux towards seat S4 in test 4-6. Note that the heat flux axis has been limited to 25 kW/m^2 to be able to see the difference between the tests. The time of increased radiation in test 4 correspond to the time when the flames started to spread to the HPL boards.

The weak vertical flame spread in test 5 probably influenced the horizontal flame spread and could have been one of the reasons why the fire never reached flashover. In the tests with a strong vertical flame spread the radiation towards the fuels (luggage and seats) ahead of the flame-front was higher. This higher level of radiation probably served to pre-heat fuel which fostered horizontal flame spread. This could be the reason why flashover was observed in test 4 and not test 5 even though the fire load was significantly higher in test 5. The difference in radiation can be seen in Figure 21 below, where the heat flux towards seat S4 is plotted.

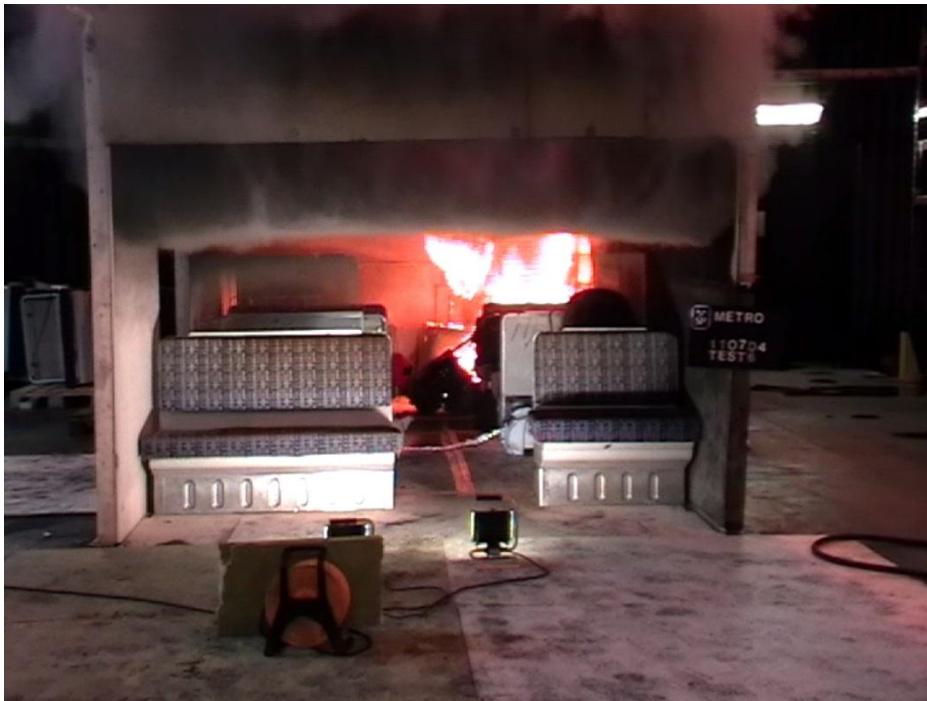
Figure 22 Test 6 shortly before a big piece of the burning HPL boards fell (time 1:21)

The vertical flame spread might also have accelerated the horizontal flame spread by making burning HPL boards fall from walls and ceiling and on to seats and floor. The falling HPL boards were observed in test 4 and 6. An example of this can be seen in Figure 22 and Figure 23. The figures show snapshots from test 6 shortly before and after a big piece of the ceiling HPL board fell. In Figure 23 it is possible to see burning pieces of HPL boards on seat S4.

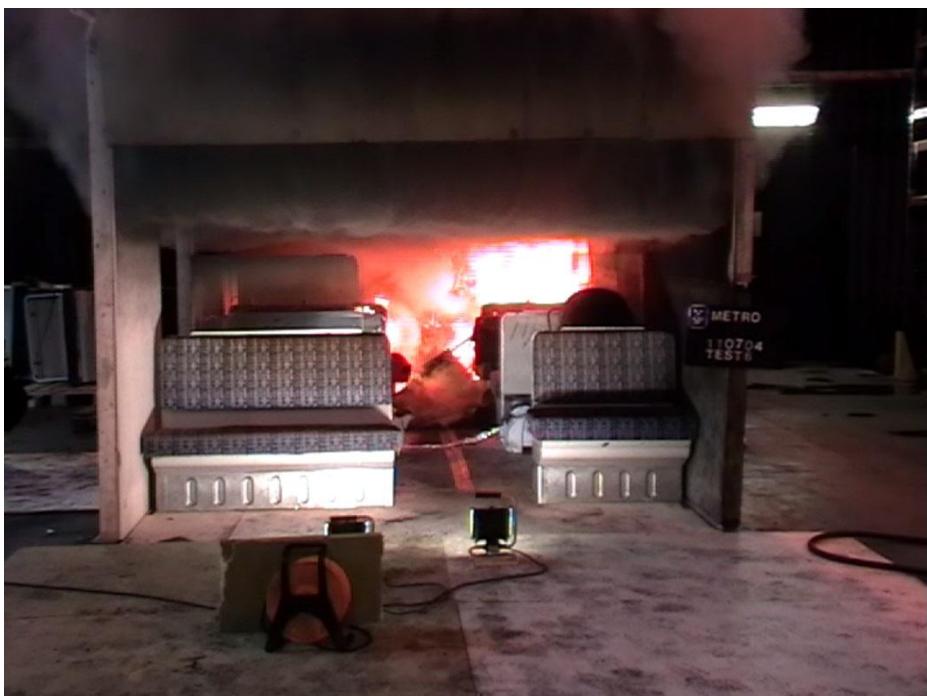
Figure 23 Test 6 shortly after a big part of the burning HPL boards fell (time 1:25). The HPL board fell at 1:23. The fallen HPL board can be seen in the middle of the carriage between seat S3 and S4.

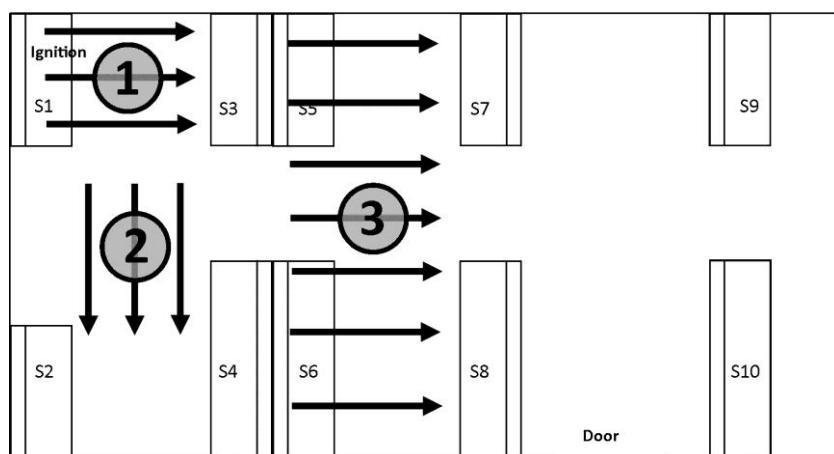
Figure 24 Schematic picture of flame spread in the train carriage in three steps.

Step 3: After seat S4 ignited the flames started to spread over the full width of the train carriage towards the opening.

This is, of course, a very simplified model of the fire spread, but these were the trends. The tests that did not lead to a flashover followed the same pattern but the decay started during step 1 or 2 depending on the varied variables. For more details about flame spread in the different tests see Appendix C – Flame spread.

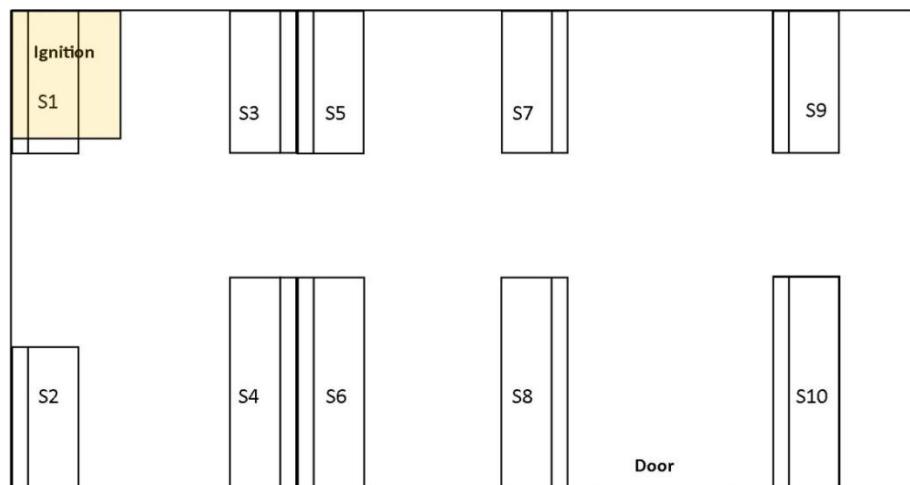
Figure 27. Total flame spread in test 1.

The time dependent flame spread is visualized with red lines in a snapshot of the train carriage and the transparent yellow rectangular represent the total area that was burnt during the test. Each red line is connected to both the vertical and horizontal time axel creating a rectangular within the train carriage. The rectangle represent the flame spread at a certain time and the vertical and horizontal spread time can be read from each time axel. Figures without a time axel means that there has been very limited or no flame spread from the vicinity of the ignition source during the entire test. If the time on the time axels are shorter than the test time, this means that the flames never spread further during the test.

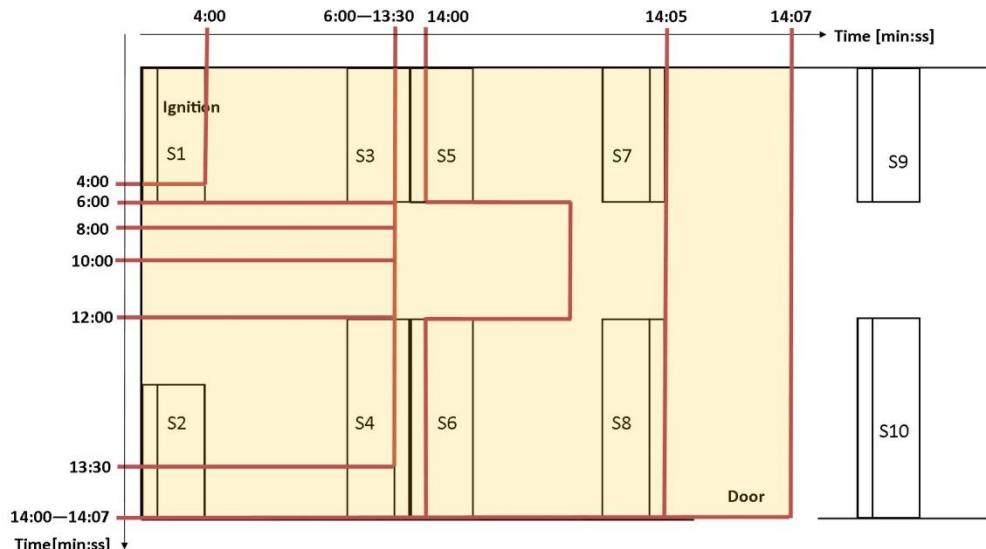
Figure 30. Time dependent flame spread in test 4.

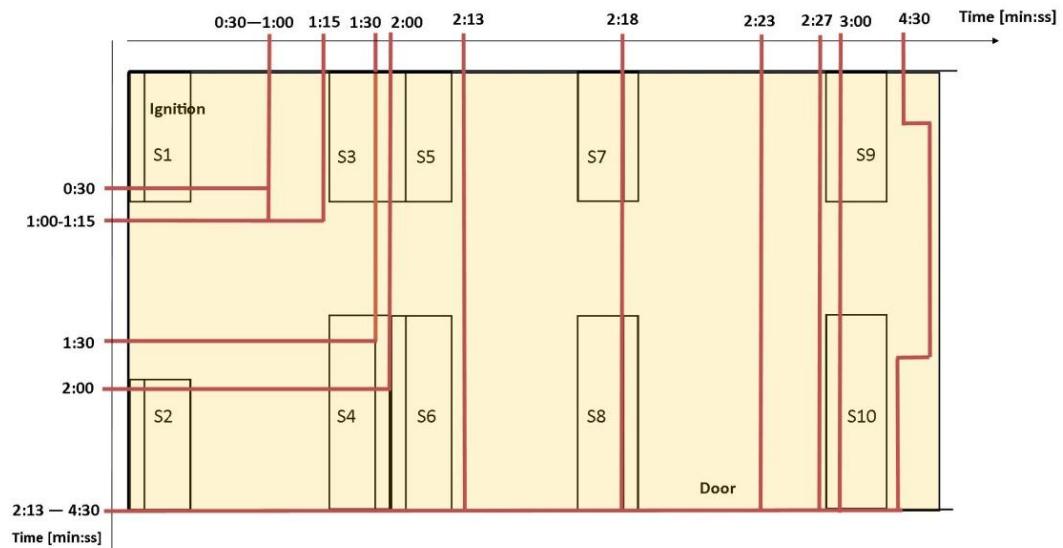
Figure 32. Time dependent flame spread in test 6.
