Full-scale fire tests with a commuter train in a tunnel

Anders Lönnermark, Alexander Claesson, Johan Lindström, Ying Zhen Li, Mia Kumm, Haukur Ingason

SP Technical Research Institute of Sweden

SP Report 2012:05
ISBN 978-91-87017-22-3
ISSN 0284-5172
Borås

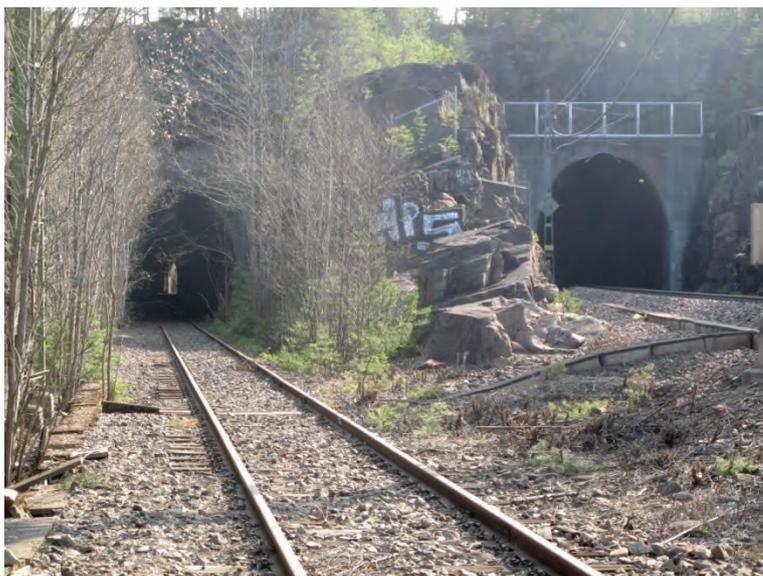
Figure 2.2 The old (left) and the new (right) Brunenberg tunnel. The picture was taken towards the western entrance.

The full scale tests were performed in the old Brunenberg tunnel, located between Kil and Arvika in western Sweden (see Figure 2.1). This abandoned, 276 m long tunnel lies on a siding about 1 km long. It was taken out of service when a new tunnel was constructed to reduce the sharpness of a bend in the route (see Figure 2.2).

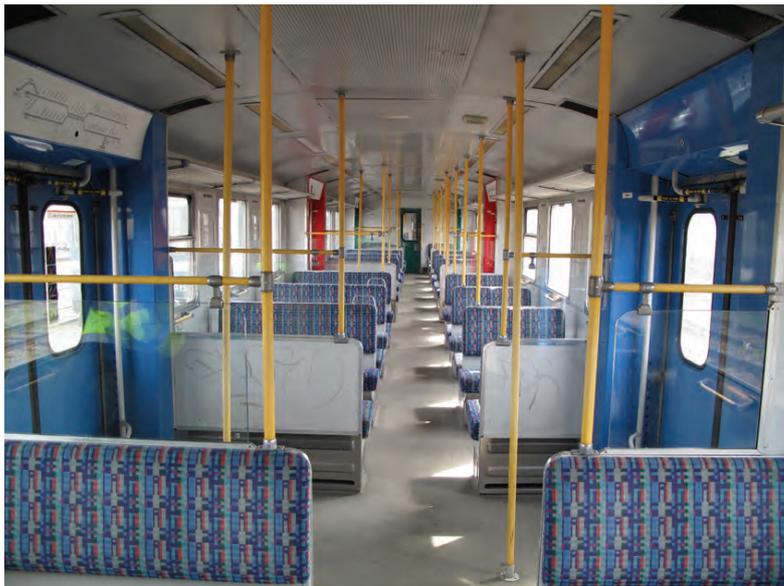
Figure 3.1 Interior design of a X1 train.

The X1 train was manufactured by Asea and owned by Stockholm Public Transport (SL). SL ordered 104 sets of X1 trains from Asea with delivery between 1967-1975 [6]. In 2006 an intensive outsourcing was started and trains were sent to disposal. At the end of 2009 as many as 20 X1 sets were still used as reserve trains. In April 2011 the last X1 trains were taken out of service. X1 3019 can be seen at the railway museum in Gävle. Bombardier still uses one X1 as a test train. The interior design of a X1 is shown in Figure 3.1. The standard X1 train was used in tests 1 and 2.

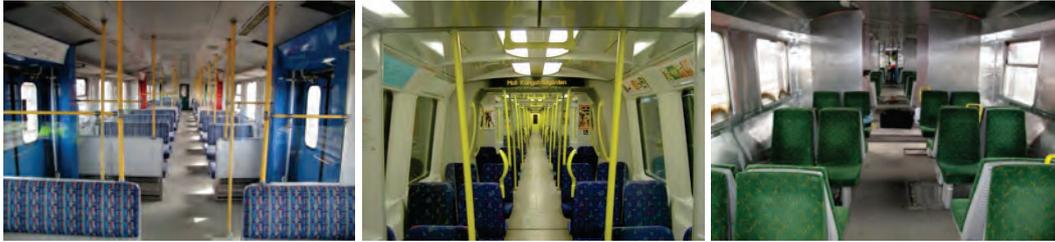
Figure 3.3 Interior X1 (left), C20 (middle) and refurbished X1 (right).

The new tilted walls in the refurbished X1 carriage were made of shielding panels of 1.5 mm thick SS 4007-14 aluminium panels with under-laying insulation of stone wool with a density of 100 kg/m³ similar to the original C20 fitting. The walls between the windows were covered with 0.6 mm thick aluminium metal sheets of the same quality. No under-laying isolation was mounted between the windows. The full interior of the refurbished X1 carriage was covered with incombustible surface material except for the driver's cabin, which was left in its original state. The dividing wall and door was fitted with aluminium metal plates with 50 mm stone wool of above-mentioned density. All joints, pop rivet and interstices were covered with aluminium tape in order to minimize the risk of early smoke and fire spread behind the panels. The refurbished width at the floor was 298.5 cm and the smallest width between the rounded walls below the windows was 283.5 cm.

The seats were changed to seats taken from a later X10 commuter train with the same fire resistance and measures as the seats in a C20 carriage. The set-up of the seats in the refurbished X1 was according to drawings of a C20 mid-section. The C20 carriages are fitted with glass partitions on each side of the doors. The partitions cover the entire floor to ceiling except for the aisle. In C20 the partitions are made of hardened glass, but in the refurbished X1 test carriage the partitions were made of 1.5 mm thick aluminium plates with aluminium taped wall and roof angles to cover the interstices between the pop rivets.

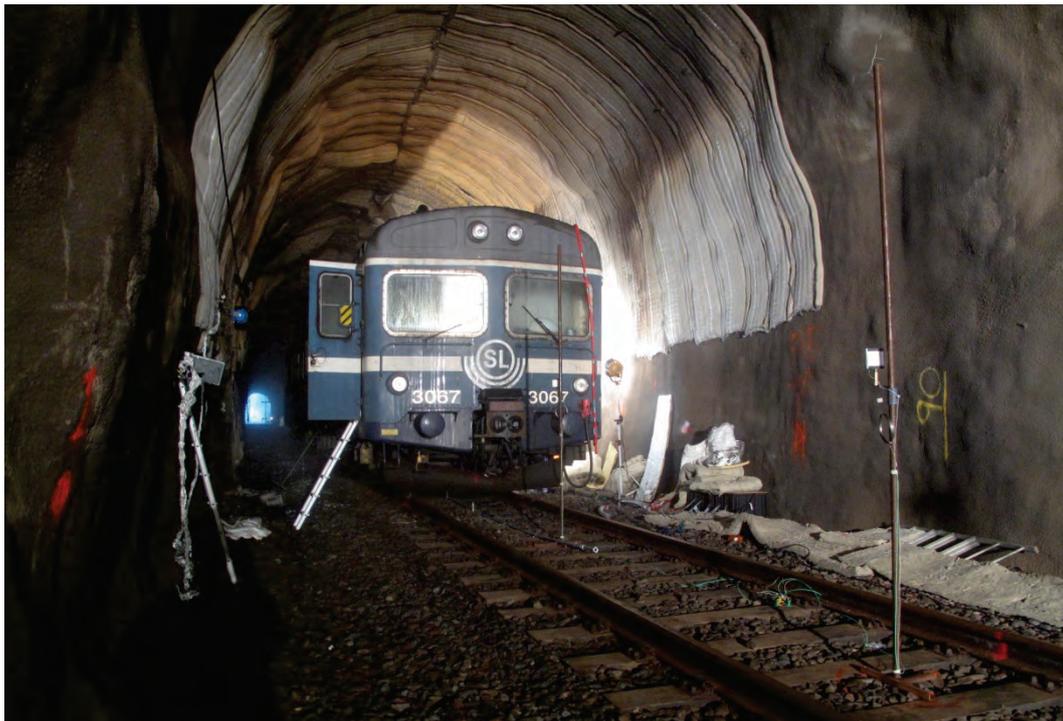
Figure 4.1 The carriage at its position in the tunnel before test 2.

The carriages (see Figure 4.1) used in the fire tests were centred around a position 96 m from the eastern tunnel entrance (180 m from the western entrance). This location is referred to as ‘0 m’ (see Figure 4.2). Negative distance numbering refers to positions upstream of the fire, while positive numbers refer to positions downstream. Since the ventilation flow is coming from the eastern entrance, upstream of the fire means on the eastern side of the carriage and downstream means towards the western entrance of the tunnel. A more detailed description of the measurement positions is included in Chapter 6 and a large version of the drawing is included in Appendix 3. In some cases the “right” side or the “left” side of the carriage are referred to in the text. In these cases the carriage is viewed towards the front of the carriage (from outside) from the eastern entrance (see Figure 4.1), which means that the right side of the carriage faces north.

To protect the concrete lining of the tunnel (approximately 10 cm of reinforced shotcrete), the tunnel ceiling was covered with 630 m² insulation between -15 m and +35 m (see Figure 4.1). The insulation used was 50 mm thick U Protect Wired Mat 2.0 with a density of 55 kg/m³.

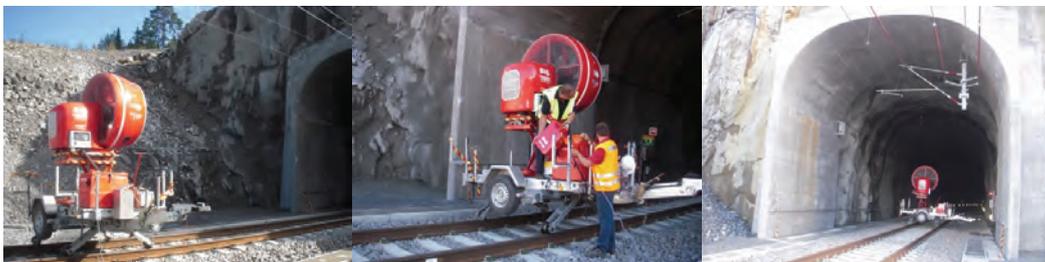
Figure 4.3 The tested locations; outside the tunnel, at the tunnel entrance and inside the tunnel. (Photo: Mia Kumm)

Prior the full scale fire tests, the optimal location of the ventilator, with respect to the tunnel entrance, was investigated at the Ådalen Line tunnels in the north of Sweden [11]. The tunnels used for the ventilation pre-tests were: the Gårdberg Tunnel (820 m), the Murberg Tunnel (1689 m) and the Kroksberg Tunnel (4551 m). The tests were performed with the ventilator placed at the downstream end of the tunnel. During the tests the counteracting wind induced air velocity inside the tunnel varied between 0.1 and 0.5 m/s. For the three tested locations - outside the tunnel, in the tunnel opening and inside the tunnel - the difference in counteracting airflow for the same tunnel varied ≤ 0.09 m/s. The distance outside the tunnel entrance was chosen with respect to the cone angle so the air cone from the ventilator should cover the tunnel opening but meet the rock wall outside the tunnel as little as possible. The same distance from the tunnel entrance was then chosen for the location inside the same tunnel. The variation of the distance between the tunnel opening and the location of the ventilator was ≤ 1.0 m for the three different tunnels.

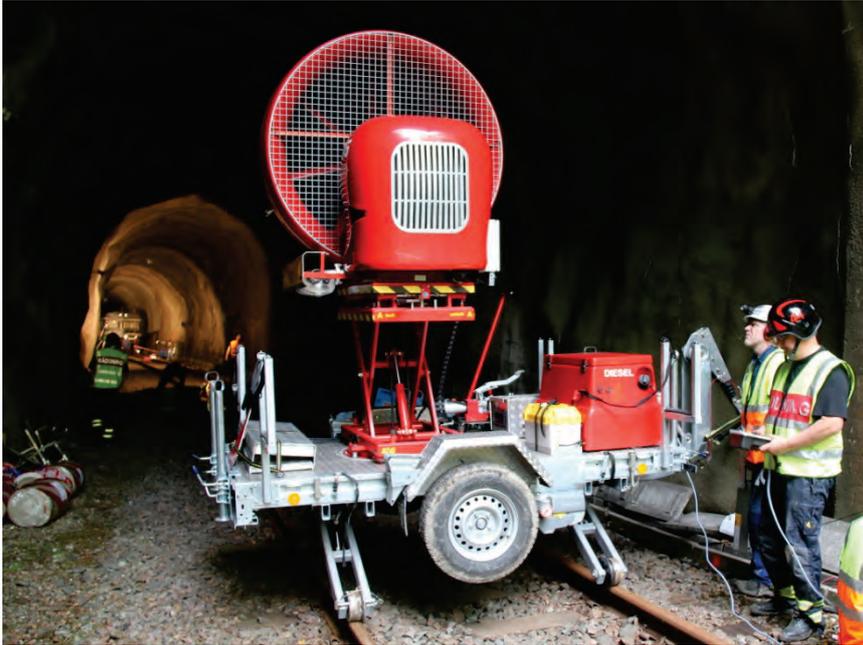
Figure 4.4 The fan was positioned 4 m into the tunnel from the eastern tunnel entrance. (Photo: Per Rohlén)

tunnel from the eastern tunnel entrance. The mean air velocity in the tunnel, before ignition, varied between 2.0 and 3.0 m/s and was somewhat higher for Test 1.

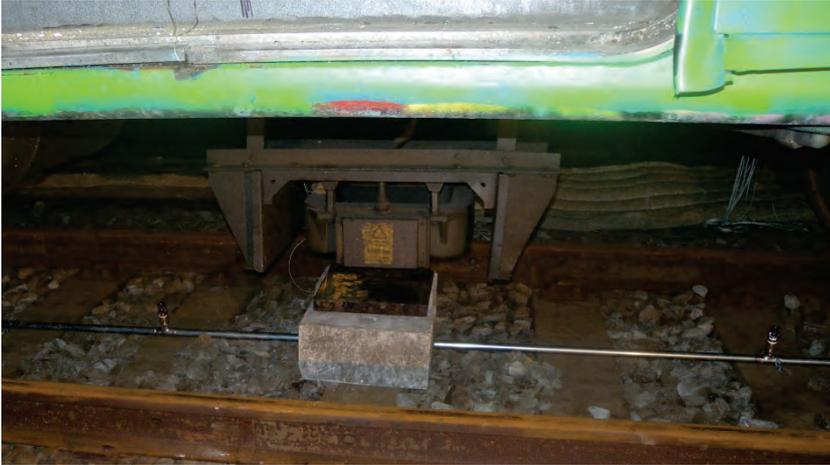
Figure 4.5 Position of the heptane pan in test 1.

The purpose of the fire scenario in test 1 was to evaluate the risk for fire spread underneath the railway carriage in case of a fire in for example the breaks or electrical devices. On the same time it was important that the fire did not spread to the inside of the carriage since it was to be used in a second fire test. Therefore, the temperature in the floor was measured during the test. Furthermore, a manually manoeuvred open sprinkler system with the nozzles pointing upwards was for safety reasons mounted between the rails beneath the carriage. The fire source was a pool of heptane positioned under the ATC receiver (see Figure 4.5). The pool area was 350 mm × 350 mm × 35 mm. The pool contained 3.2 L of heptane. The distance between the top of the pool (edge) and the ATC receiver was 155 mm. The test was performed inside the tunnel and with an air velocity over the pool fire under the carriage of approximately 2-3 m/s. The HRR from such a pool fire was measured in the laboratory (without ventilation) to increase to a plateau at 300 kW after 1 min. After 3 min the HRR increased further to a maximum of

approximately 500 kW after which the HRR decreases until it was self-extinguished after approximately 6 min.

The purpose of test 1 was to evaluate the risk for fire spread underneath the train carriage in case of a fire in for example electrical devices. A pool of heptane was placed approximately 15 cm under the ATC receiver, near the front of the carriage (the first double door). The pool of heptane was lit and temperatures were measured with in particular four thermocouples. These thermocouples were placed above the pool fire, on the door step of the train carriage and in a hole in the floor inside the train carriage, see also Figure 6.10 to Figure 6.13. To study the temperature development inside the carriage floor, also IR-camera was used.

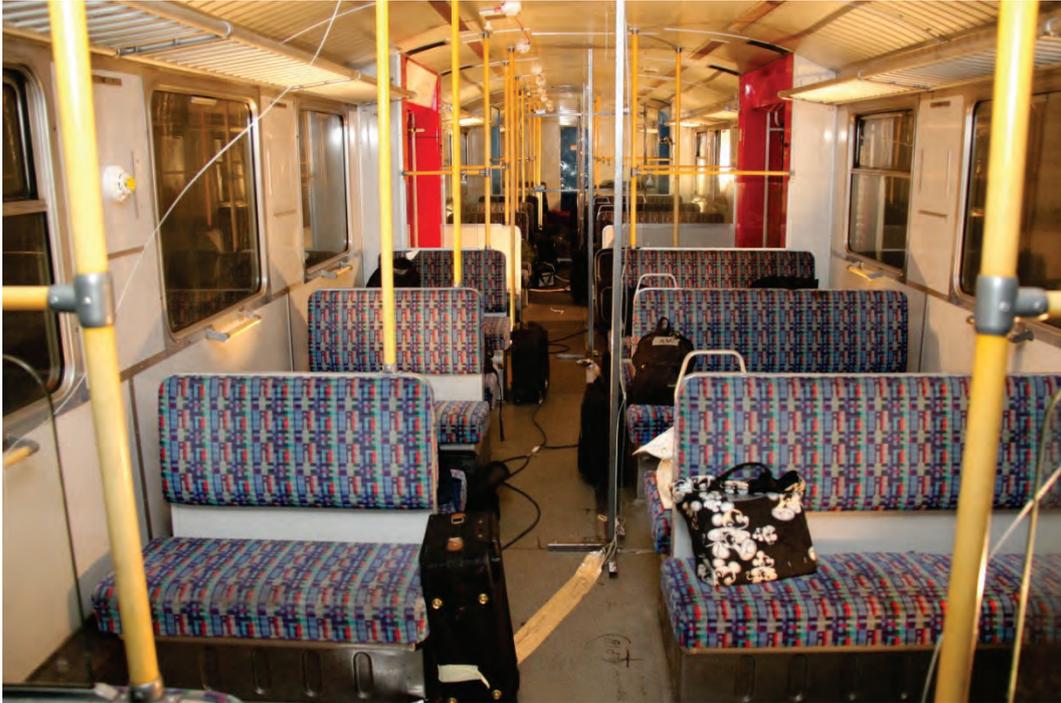
Figure 4.7 Pieces of luggage in, at or under different seats in the X1 carriage before the start of test 2. (Photo: Per Rohlén)

In test 2 an X1 carriage with original interior materials was used. As described in sections 3.2 and 3.3, luggage was added to the carriage to simulated luggage left behind in a burning carriage. Table 4.1 shows the amount and type of each bag that were used in the railway carriage in fire test 2. Figure 4.6 shows how the different types of luggage was placed and distributed inside the carriage. The positions of different pieces of luggage in test 2 are also shown in the schematic in Figure 4.7 and the photo in Figure 4.7.

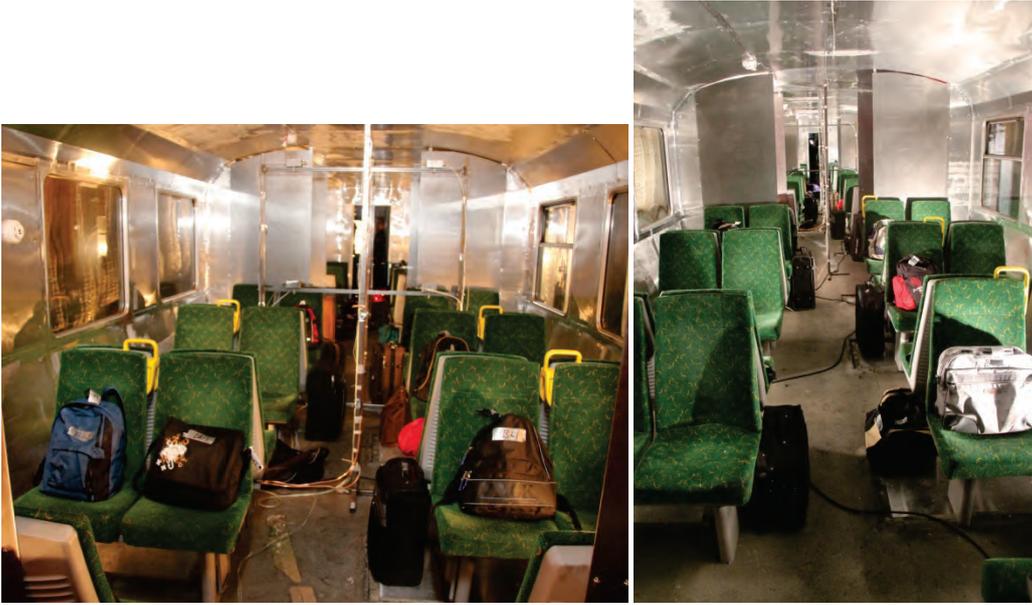
Figure 4.9 Pieces of luggage in, at or under different seats in the refurbished X1 carriage before the start of test 3. (Photo: Per Rohlén)

In test 3, the refurbished X1 carriage (see section 3.1.2) was used. Luggage was added in the same way as in test 3, but the distribution between sports bags/shoulder bags and backpacks was not exactly the same in the two tests (see Table 4.1 and Table 4.2). The weight of these bags were, however, the same. Furthermore, the content was of the same type for all of the bags. This means that that the total weight of the luggage was the same in test 2 and test 3. The distribution of different types of luggage in the carriage were also the same in the two tests. The distribution of the luggage in test 3 can be seen in the schematic in Figure 4.8. The positions of different pieces of luggage in test 3 are also shown in the photo in Figure 4.9

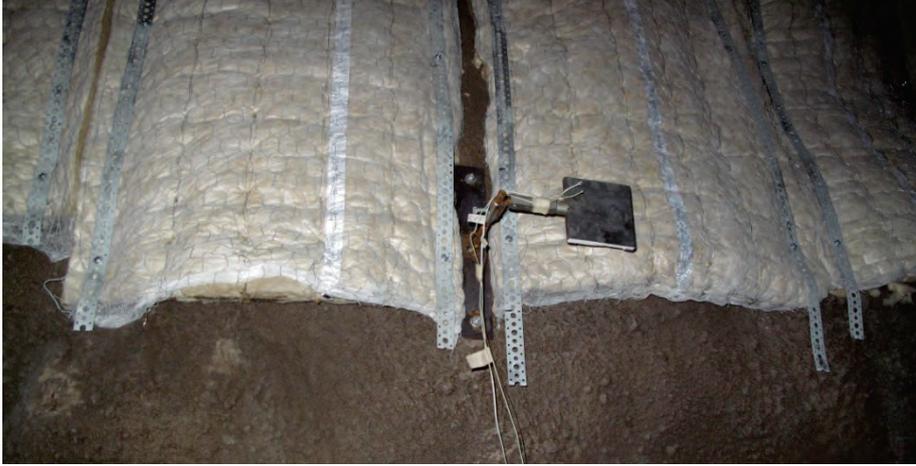
Figure 6.4 Plate thermometer mounted on the wall to measure the radiation from the fire in the carriage.

$$[\dot{q}_{inc}'']^{j+1} = \sigma [T_{PT}^4]^j + \frac{(h_{PT} + K_{cond})([T_{PT}]^j - [T_{\infty}]^j) + C_{PT} \frac{[T_{PT}]^{j+1} - [T_{PT}]^j}{t^{j+1} - t^j}}{\varepsilon_{PT}} \quad (6.1)$$

where the conduction correction factor $K_{cond} = 0.00843 \text{ kW/m}^2/\text{K}$, the lumped heat capacity coefficient $C_{PT} = 4.202 \text{ kJ/m}^2/\text{K}$, and the surface emissivity of the plate thermometer $\varepsilon_{PT} = 0.8$.

The convective heat transfer coefficient (h_{PT}) is dependent on the airflow in the tunnel and how the PTC is placed in the airflow. Because of the complex geometry in the tunnel, the shifting forced airflow and the flow induced by the fire, it is very likely that h_{PT} has varied during the fire. Because of the complexity, h_{PT} is estimated to be $0.010 \text{ kW/m}^2/\text{K}$ (equals natural convection) for all PTC:s placed perpendicular to the airflow. For the PTC:s placed on the wall facing the carriage, P6-P8, forced convection is assumed and h_{PT} is calculated below, see equation (2-4) [21].

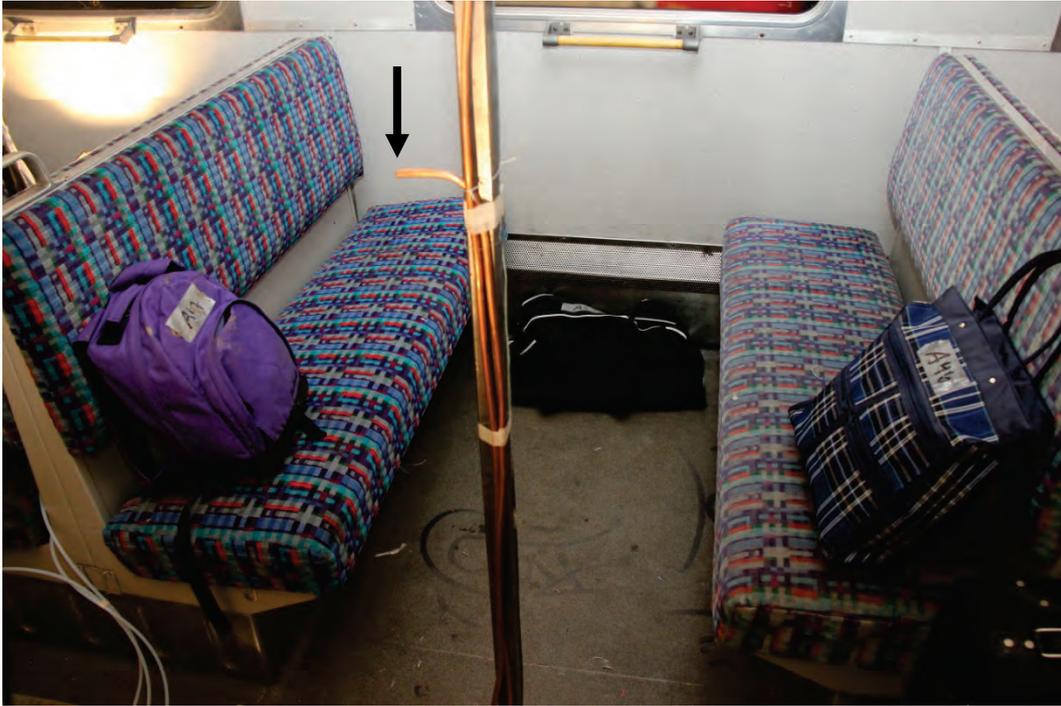
Figure 6.5 Inlet pipe for the gas sampling inside the railway carriage.

Figure 6.5 shows one of the inlet pipes for gas analysis in the railway car. The gas samples were taken at three different heights, 28.8 cm, 120 cm and 211.2 cm from the ceiling. Figure 6.6 shows the placement of the gas analyse at the measuring station downstream the fire. Shown in Figure 6.6 is inlet pipe at 0.83 m and 3.45 m over the railway sleepers, the inlet pipe at 6.07 m is not visible at the picture.

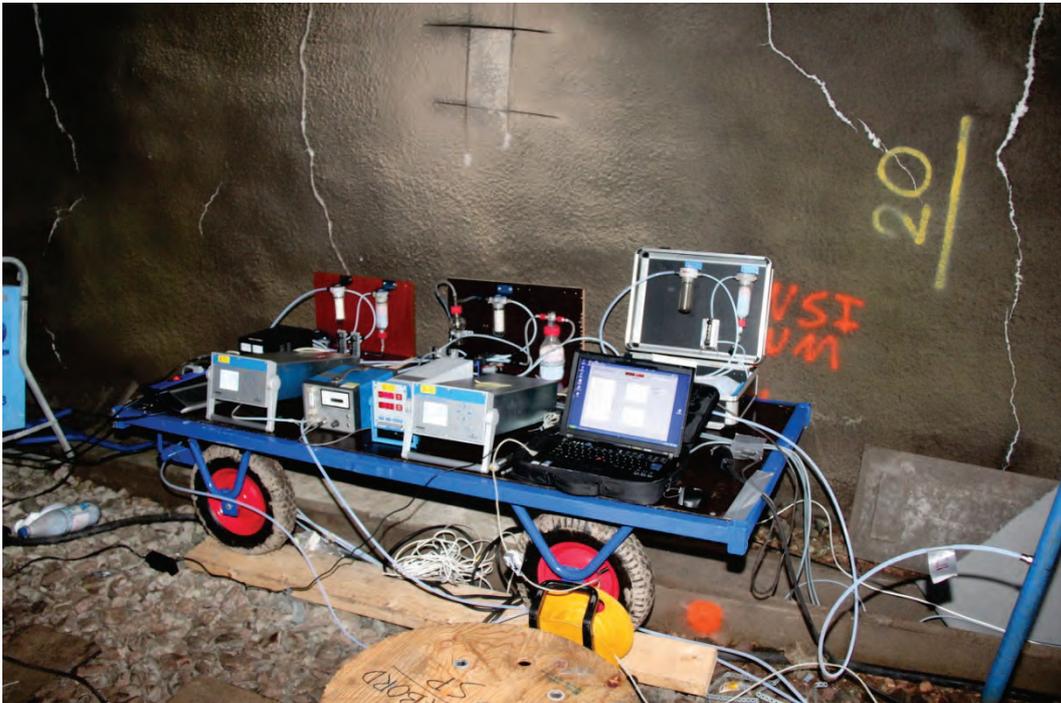
Figure 6.7 One of the stations where the gas analysis instruments were placed.

- Rosemount Analytical inv. No. 900863 (Ch131,Ch134,Ch137; P38; 3.45m), and No. 900865 (Ch130,Ch133,Ch136; P38; 6.07m), with a calibrated measuring range of 0-20.95 vol% O₂, 0-10 vol% CO₂ and 0-1 vol% CO. Inv. No. 900864 (Ch62,Ch65,Ch68;P19;211.2cm) and No. 900866 (Ch60,Ch63,Ch66; P19;28.8cm) with a calibrated measuring range of 0-20.95 vol% O₂, 0-30 vol% CO₂ and 0-10 vol% CO.
- M&C O₂ Analyser PMA10 inv. No. 201625 (Ch132;Pos38;0.83m), and No. 700173 (Ch61,Pos19;120cm) with a calibrated measuring interval of 0-30 vol%.
- Rosemount BINOS 100 CO and CO₂, inv. No. 701133 (Ch64,Ch67;Pos19;120cm) with a calibrated measuring interval of 0-10vol% for CO and 0-30vol% for CO₂.
- Rosemount 100 2M, inv. No. 700394(Ch135,Ch138;Pos38;0.83m) with a calibrated measuring interval of 0-1vol% for CO and 0-10vol% for CO₂.

The response time of the analysers inside the carriage was 30 s and the response time for the analysers at the measurement station was 23 s. This has not been corrected for in the graphs in this report.

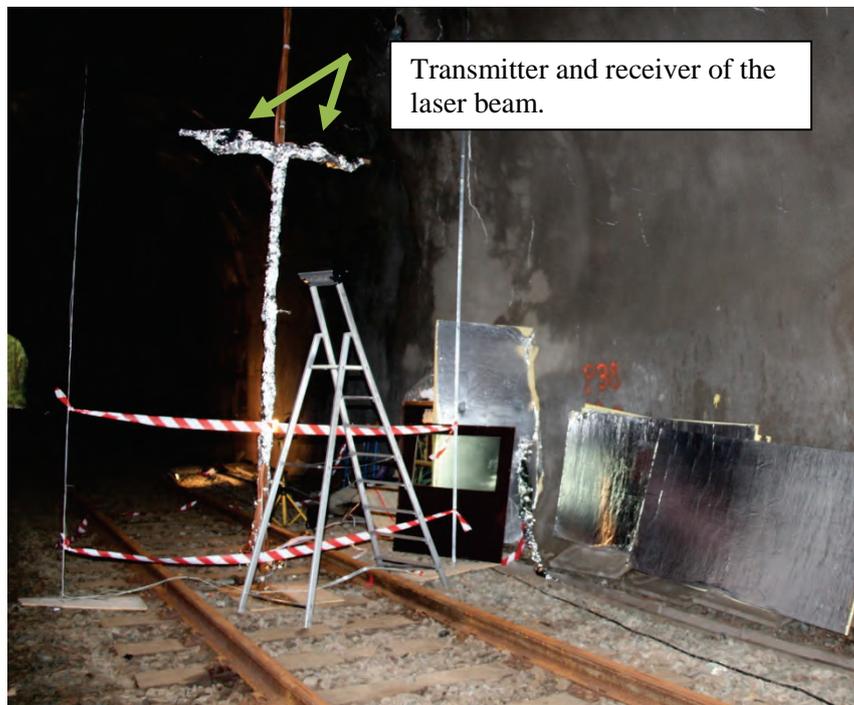
Figure 6.9 Position of the laser equipment in the measurement station.

Figure 6.9 shows the arrangement for the laser transmitter and receiver at the measuring station, position P38. The distance between the transmitter and receiver at this position was 40 cm. The smoke density was measured with the transmitter/receiver system at 3.45 m over the railway sleepers.

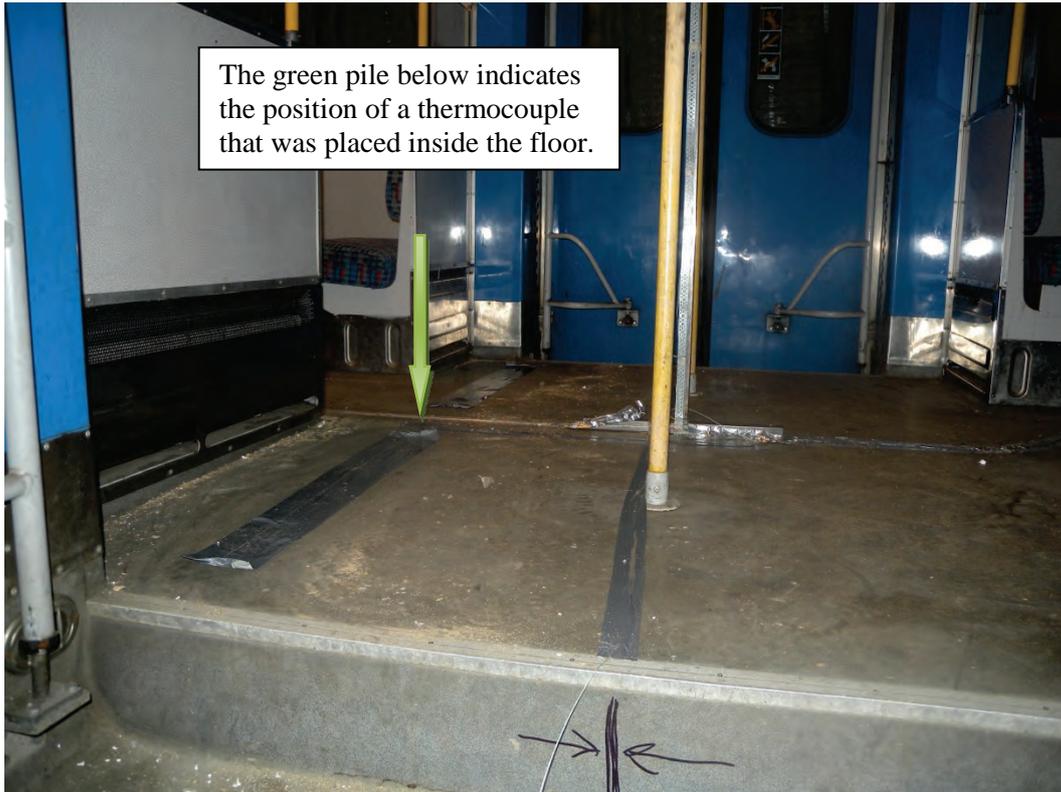
Figure 6.10 Position of the thermocouple that was placed inside the floor (Ch 89).

Not included in the drawing shown in Figure 6.3 are four thermocouples shown in Figure 6.10 - Figure 6.13 for fire test 1. These measurements were connected to Ch89 – Ch92. These extra temperature measurement were positioned: 1) in a drilled hole in the carriage floor (Ch89; Figure 6.10), 2) at the lower edge of the door near the fire (Ch90; Figure 6.11), 3) at the steel frame above the Automatic Train Control (ATC) unit (Ch91; Figure 6.12), and 4) at the top of the ATC unit (Ch92 Figure 6.13).

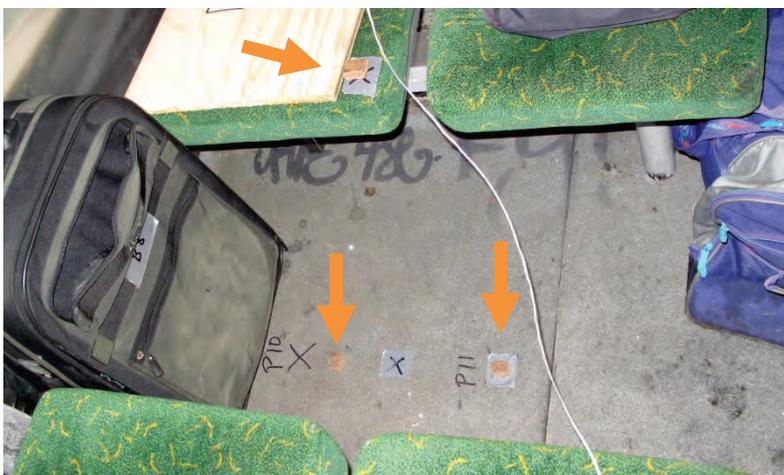
Figure 7.1 Positions of the fibre board pieces used to ignite the petrol.

Three small ignition sources (fibre board with added paraffin) were used. One was placed on the seat just outside the plywood board and two on the floor (see Figure 7.1). One of the ignition sources on the floor was placed in position P11 and one between P10 and P11, in test 2 18.5 cm from P11 and in test 3 somewhat closer to P10. The small ignition sources were 23 mm × 30 mm × 15 mm in size. When pulling a string, the milk container tumbled over and the petrol flowed out on the seat and floor and was ignited by the burning fibre board ignition source.

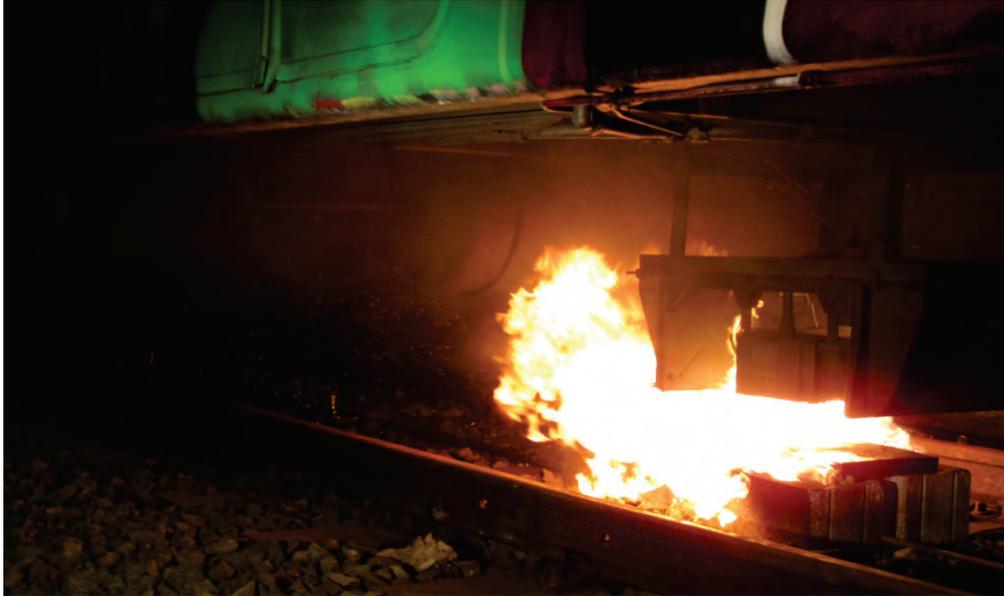
Figure 7.2 The flames a few minutes into test 1.

The heptane pool fire in test 1 did locally ignite train dirt/paint at the surface (the protection plates are engulfed in the flames in Figure 7.2) of the ATC unit located above the fire, but the fire did not spread further and self-extinguished approximately 13.5 minutes after the pool fire burnt out.

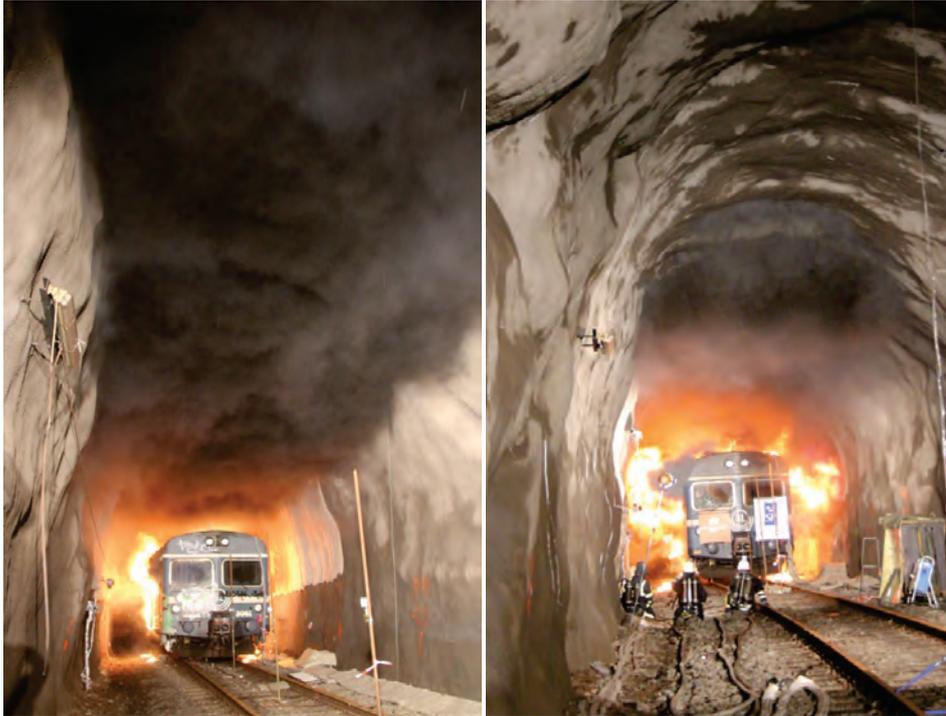
Figure 8.3 Developed backlayering in test 2 (left) and large flames and progressing backlayering in test 3 (right). (Photo: Per Rohlén)

are flows in the opposite direction, out of the tunnel. These flows occur about the same time as back-layering, see test 3 in Appendix 1. The back-layering is shown in Figure 8.3.

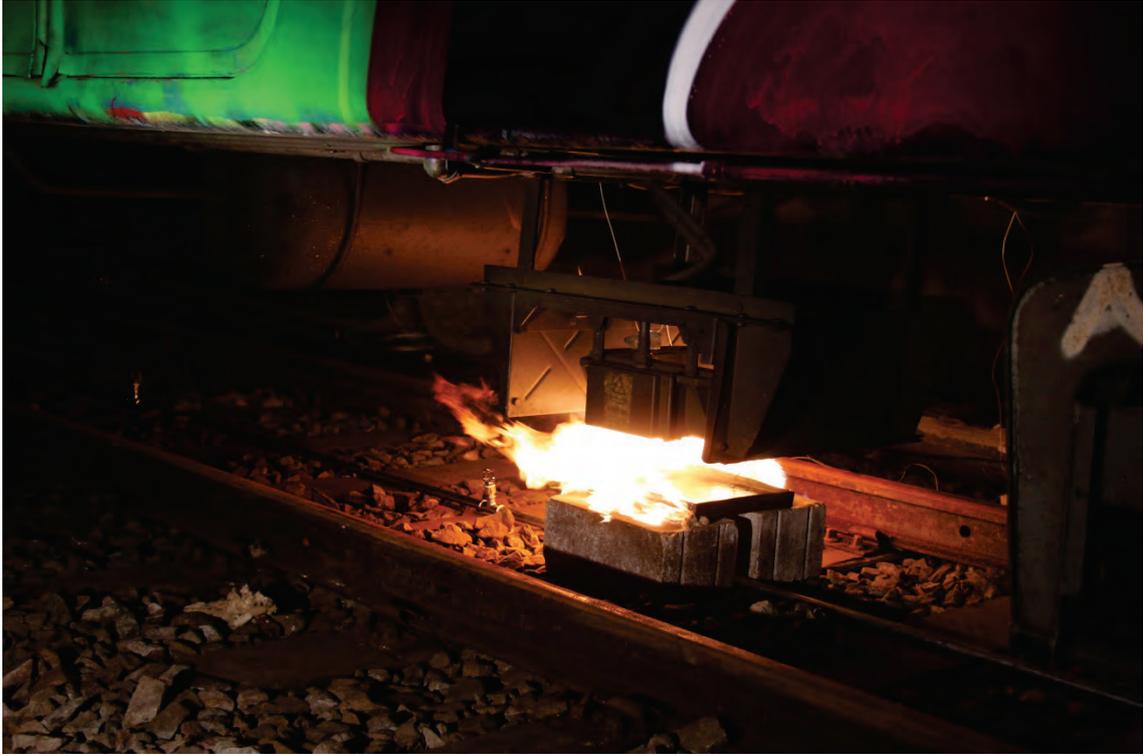
Figure A4.1 Flames from the heptane pool shortly after ignition in test 1.(Photo: Per Rohlén)

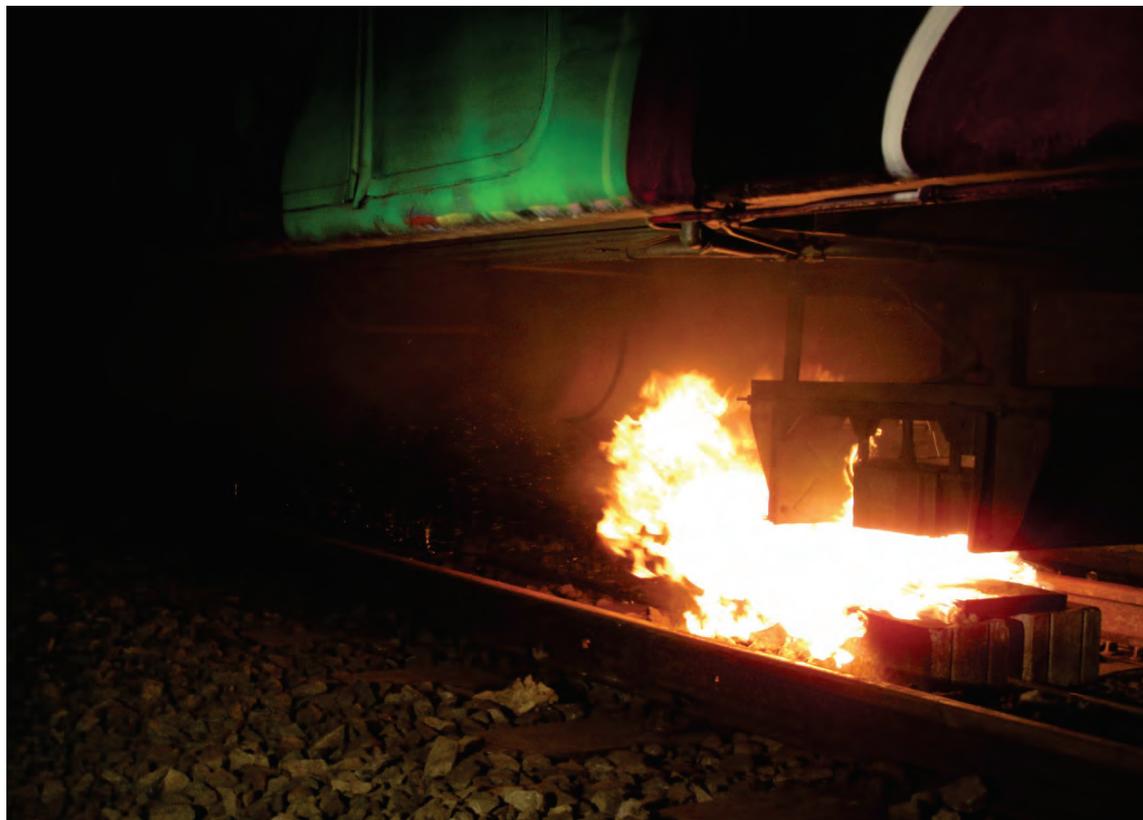
Figure A4.2 Flames from the heptane pool a few minutes after ignition in test 1.(Photo: Anders Lönnermark)

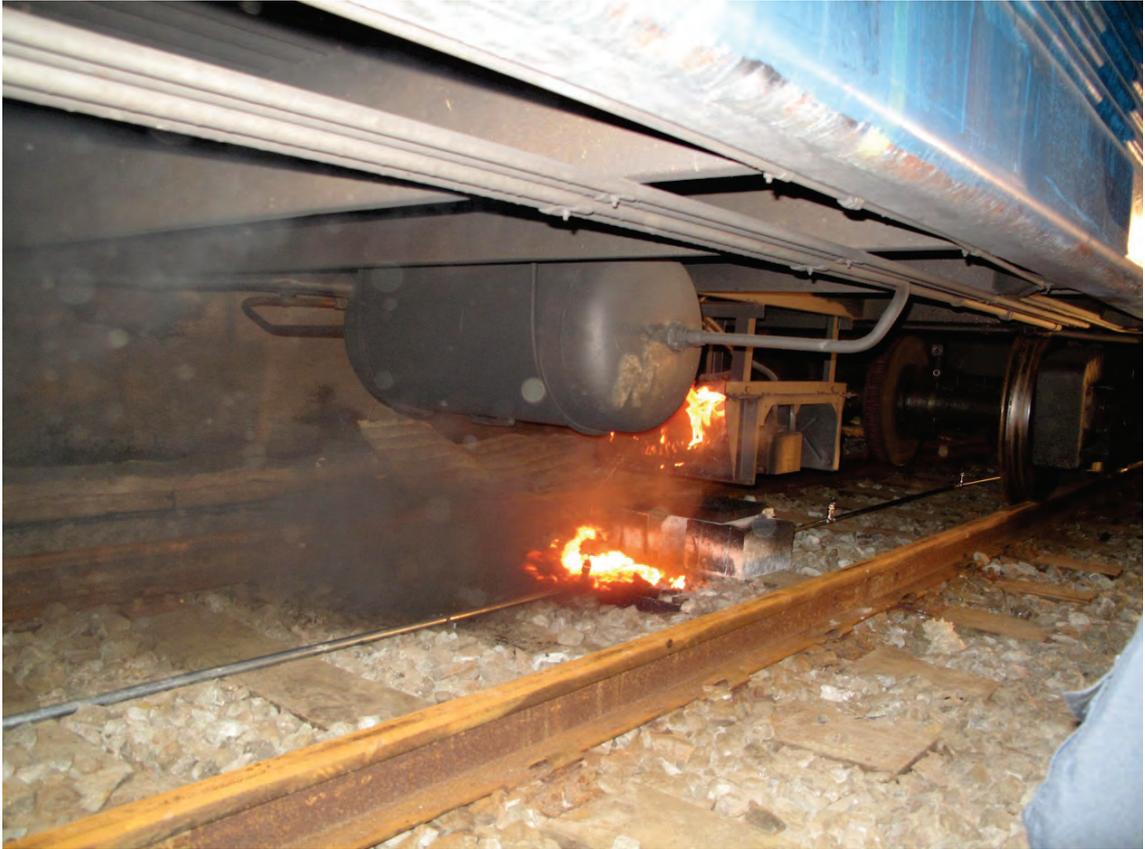
FigureA4.3 Flames from the ATC receiver and after the heptane was burnt in test 1
(Photo: Anders Lönnermark)

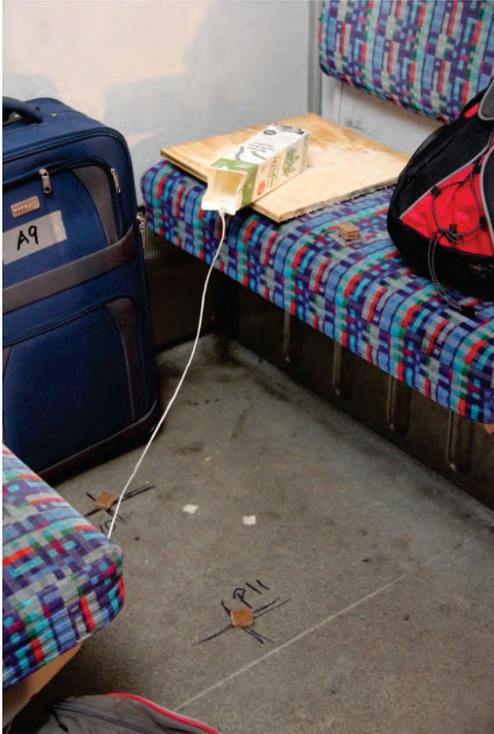
Figure A4.4 The ignition set up in test 2. The milk cartridge was filled with one liter of petrol and the three small fiber board pieces was lit. The petrol was ignited by pulling the string (Photo: Per Rohlén)

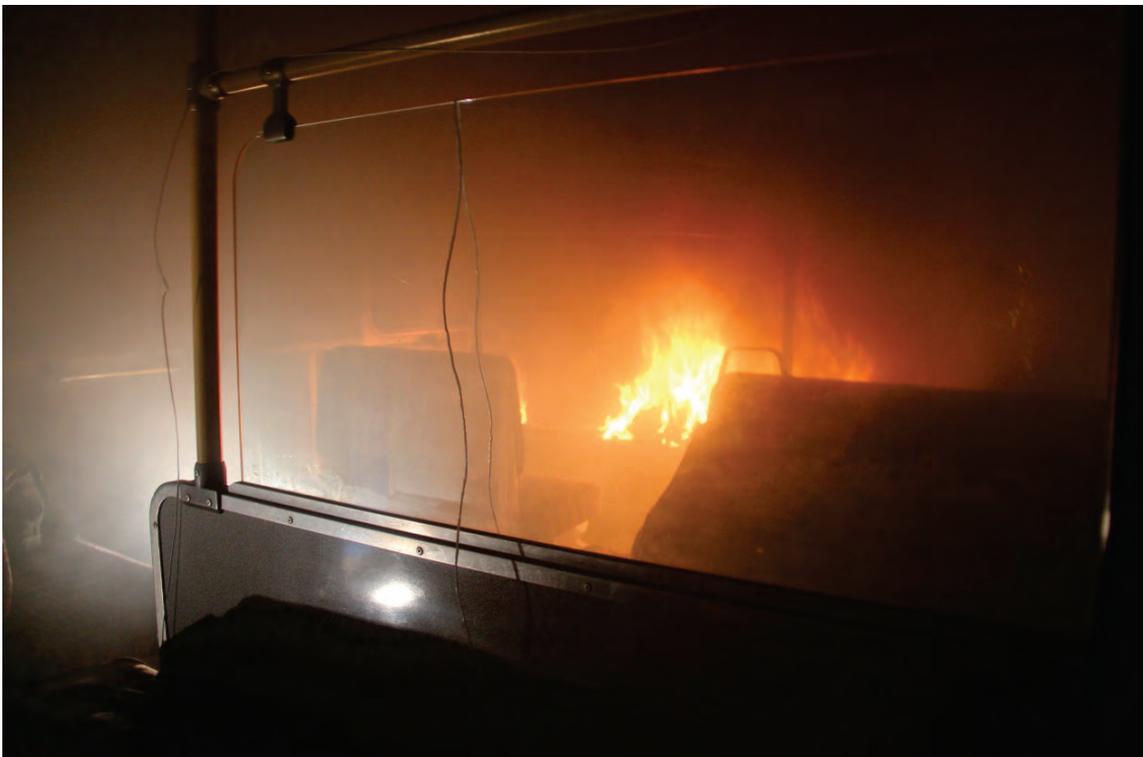
Figure A4.5 Flames shortly after ignition in test 2. (Photo: Per Rohlén)

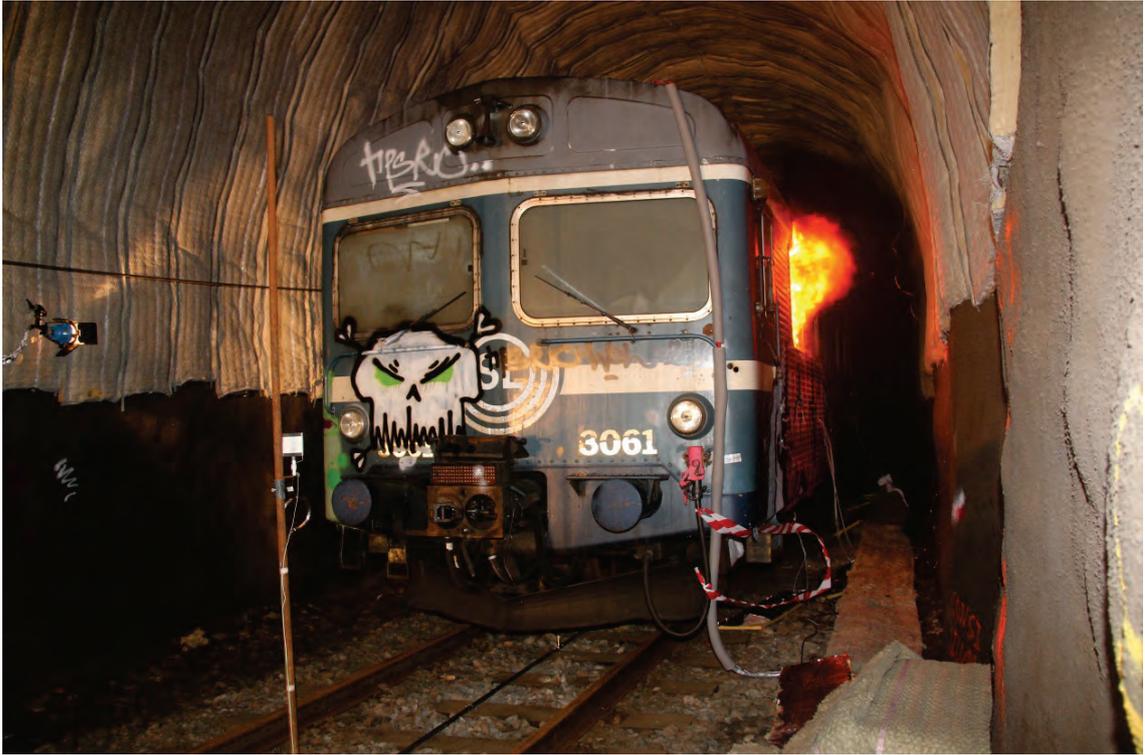
Figure A4.6 Flames from the windows on the right side of the carriage approx. 4 min after ignition.
(Photo: Per Rohlén)

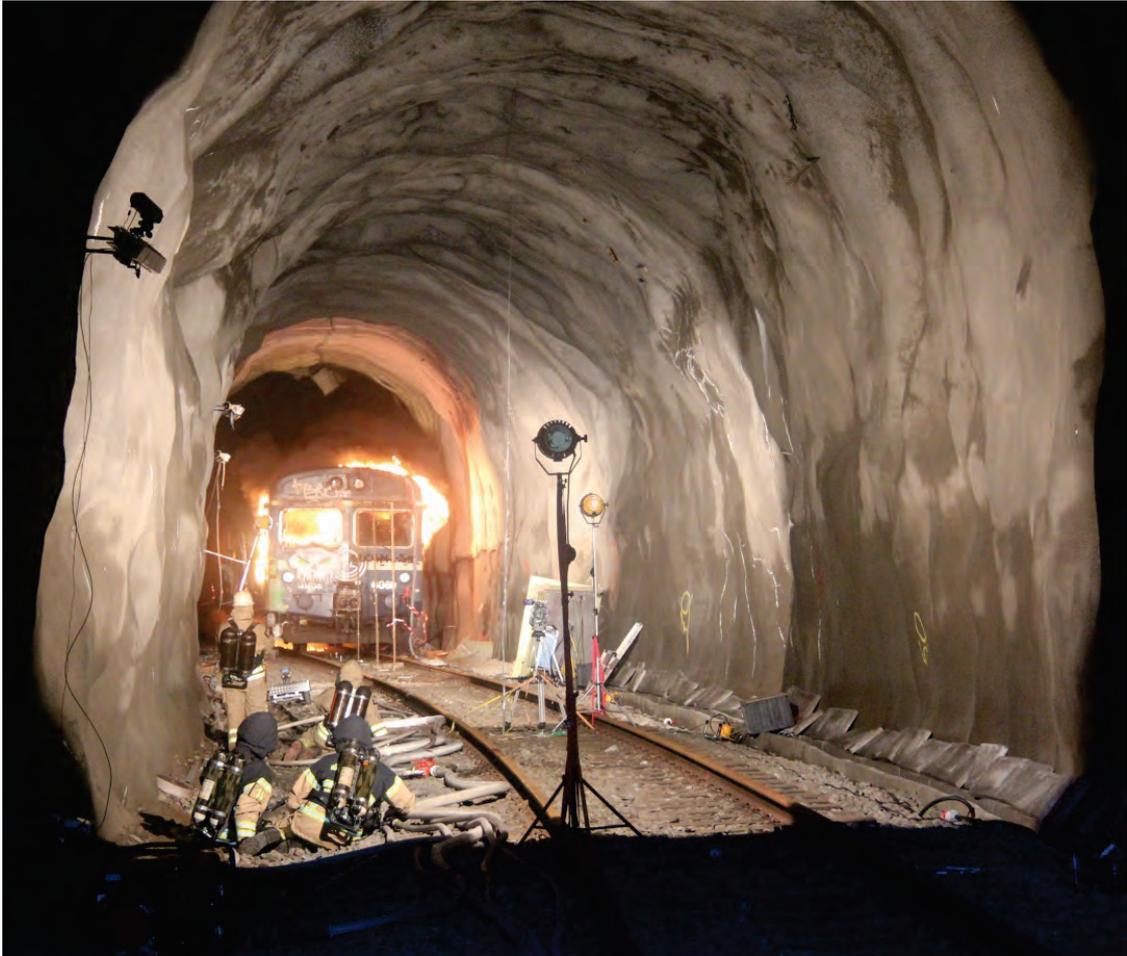
Figure A4.9 Flames from the carriage approx. 45 min after ignition, the driver compartment is now on fire and the right window is broken. (Photo: Per Rohlén)

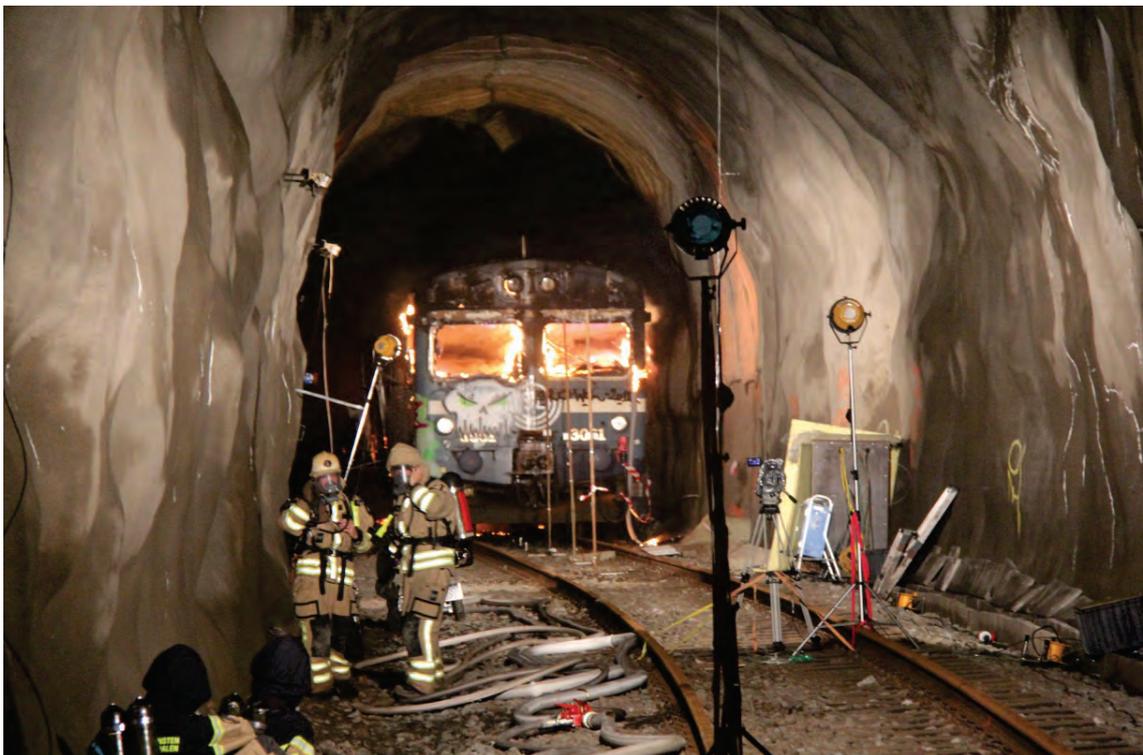
Figure A4.10 The flames from the carriage in the beginning of the decay period. The picture is taken approx. 50 min after ignition. (Photo: Per Rohlén)

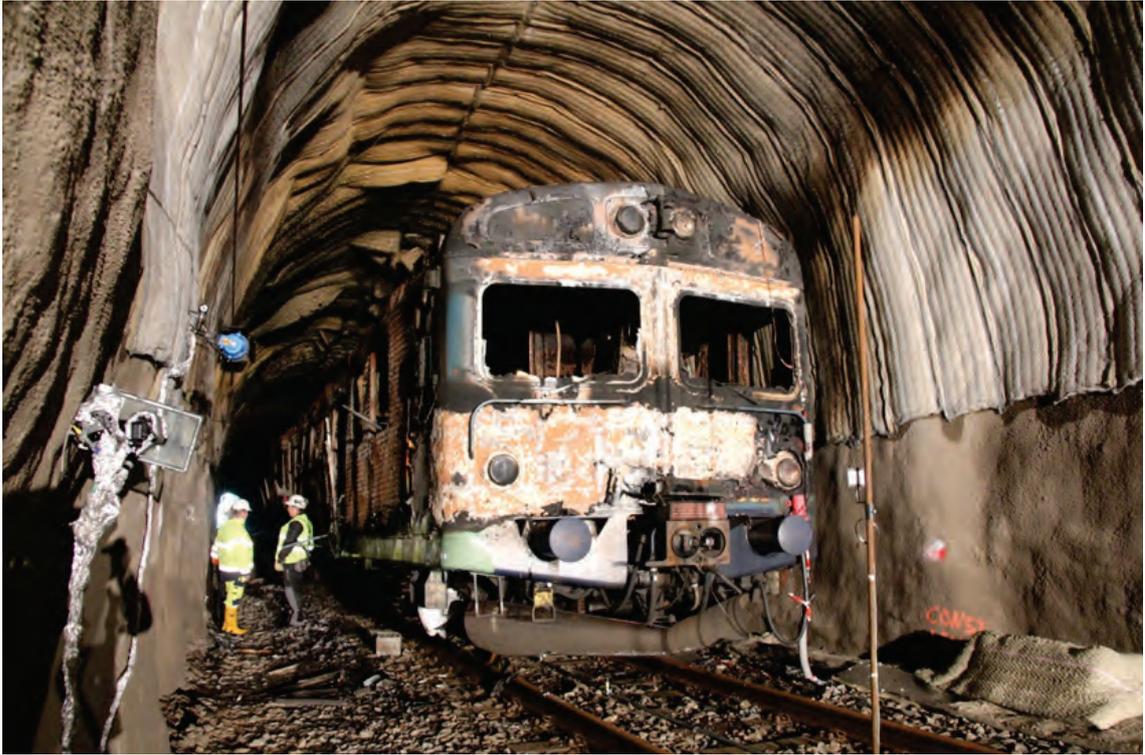
Figure A4.11 The remains of the carriage after test 2. (Photo: Per Rohlén)

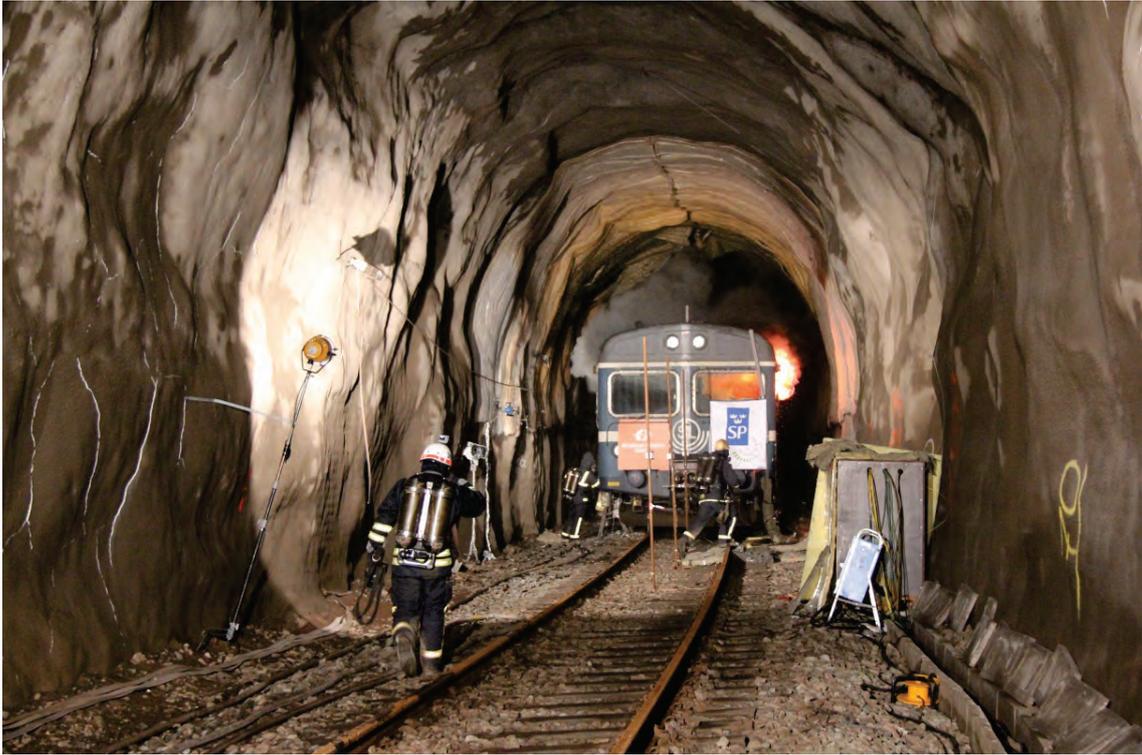
Figure A4.15 This picture shows the first flames outside of the carriage, the picture is taken approx. 1 h 50 min after ignition. In contrast to test 2 the first flames exit from the driver compartment. (Photo: Per Rohlén)
