Full-scale fire tests with a commuter train in a tunnel

Anders Lönnermark, Alexander Claesson, Johan Lindström, Ying Zhen Li, Mia Kumm, Haukur Ingason

SP Technical Research Institute of Sweden

SP Report 2012:05
ISBN 978-91-87017-22-3
ISSN 0284-5172
Borås

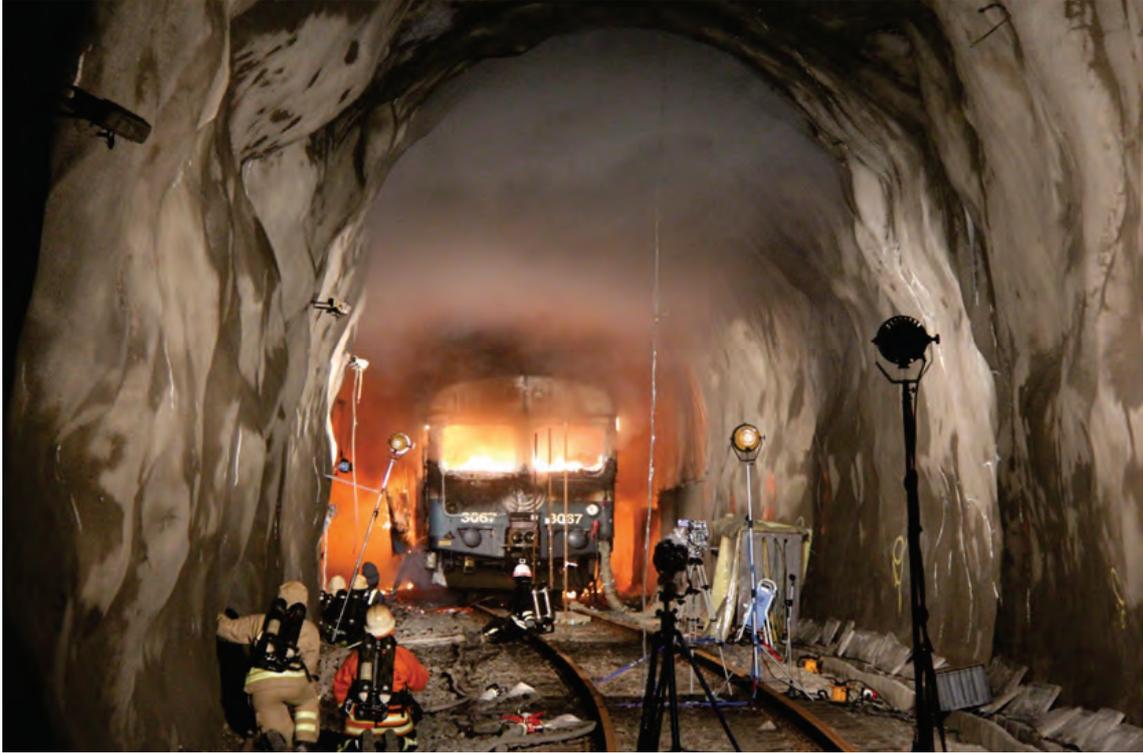
Figure A4.19 This picture is from the beginning of the decay period approx. 2 h 5 min after ignition. (Photo: Per Rohlén)

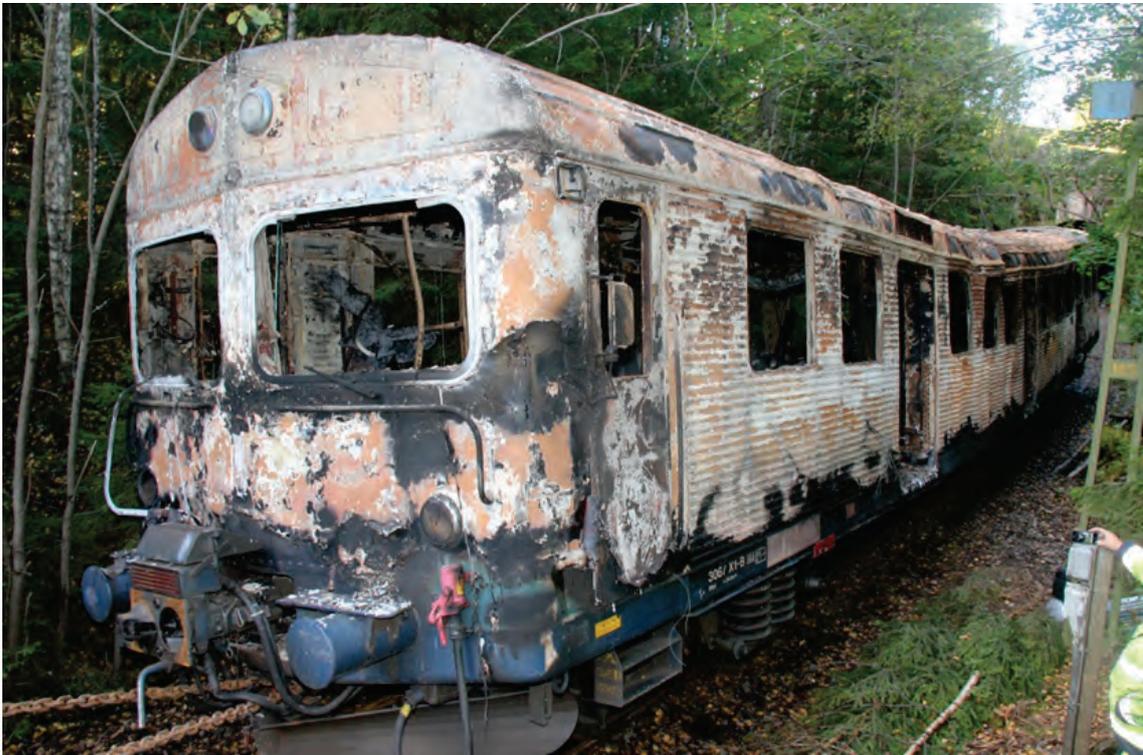
Figure A4.20 The remains of the carriage after test 3. (Photo: Per Rohlén)

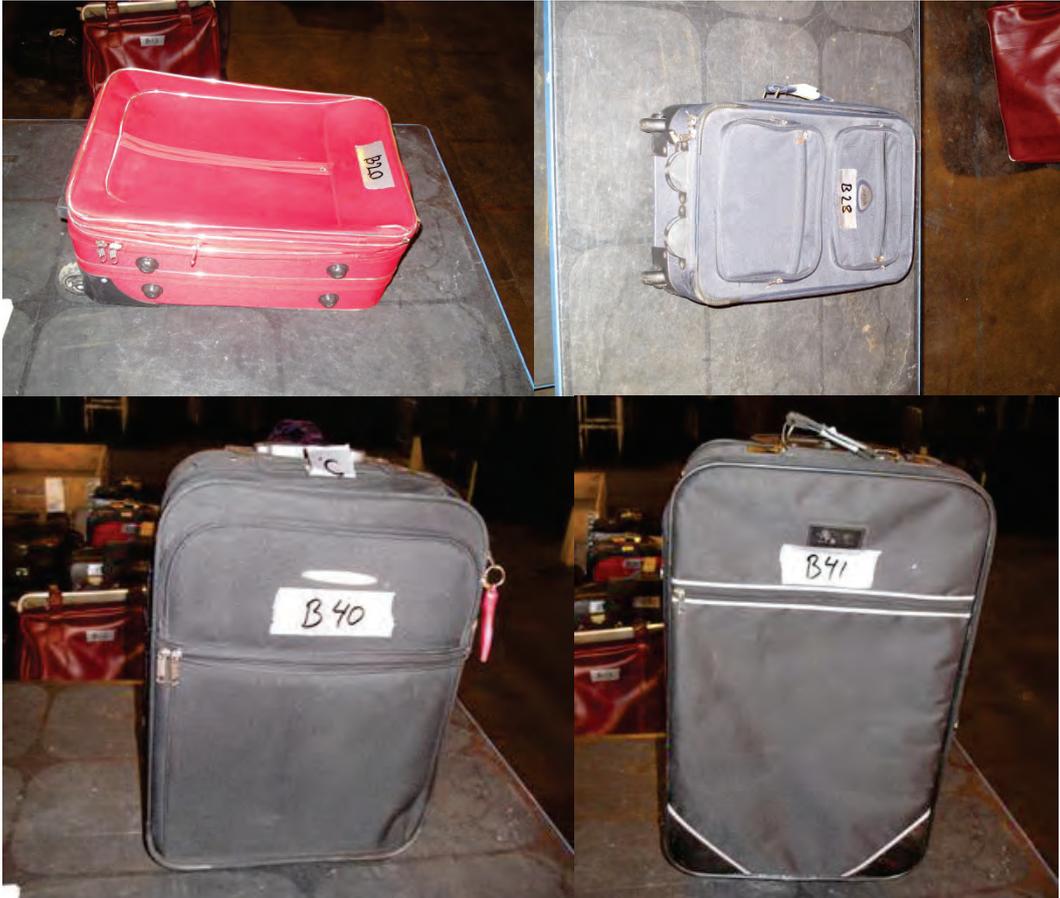
Figure A4.28 Examples cabin bags used in test 3, each with a total mass of 5.3 kg.

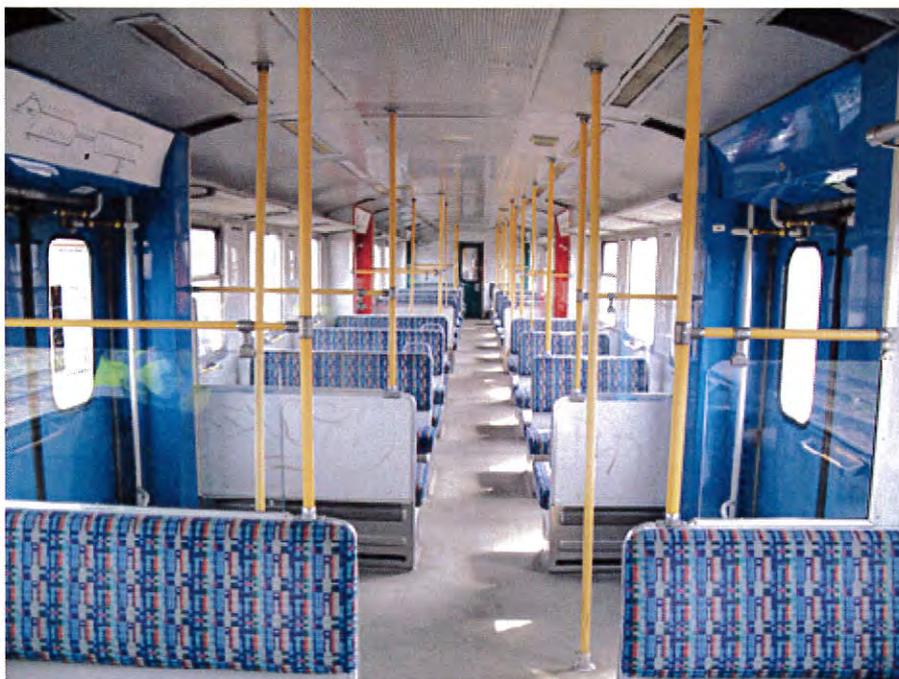
Photo 1 - Interior of "X1"

Two types of trains were involved in the METRO-project, train type "X1" and a combination of train types "C20" and "X10", in this report referred to as "C20/X10". The "C20/X10" corresponds to interior material, except for the floor, from train type "C20" with ceiling and walls covered with an aluminium layer, passenger seats are from train type "X10". Materials tested in this study were wall linings, floor from "X1" and passenger seats from both train types. Ceiling lining was not tested because of lack of material.

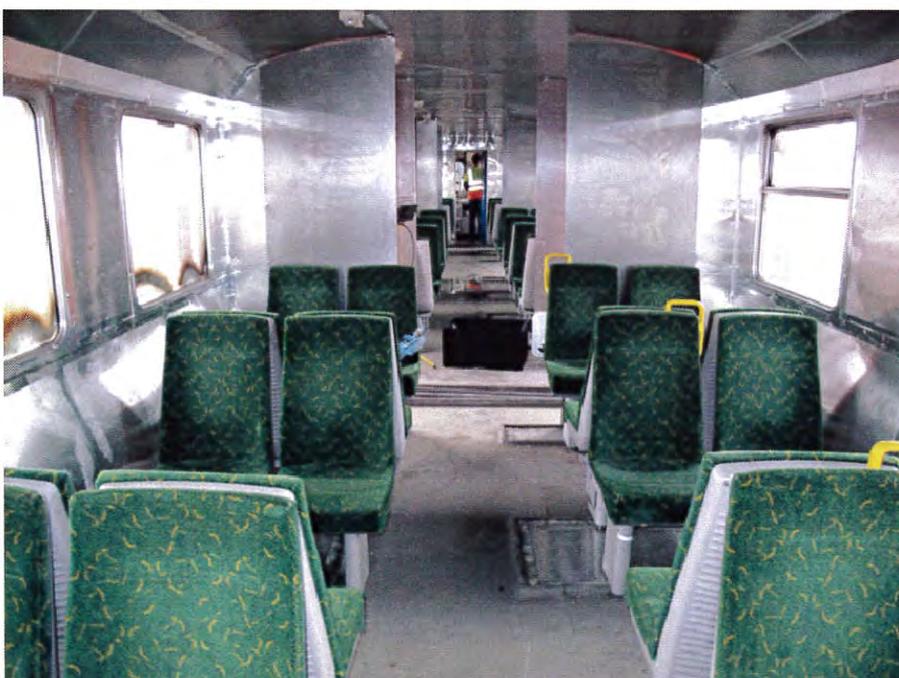
Photo 2 - Interior of "C20/X10"

Test results regarding the furniture and interior of the train called “C20/X10” indicates Hazard Level HL3 for wall lining and Hazard Level HL3/HL1 for passenger seats.

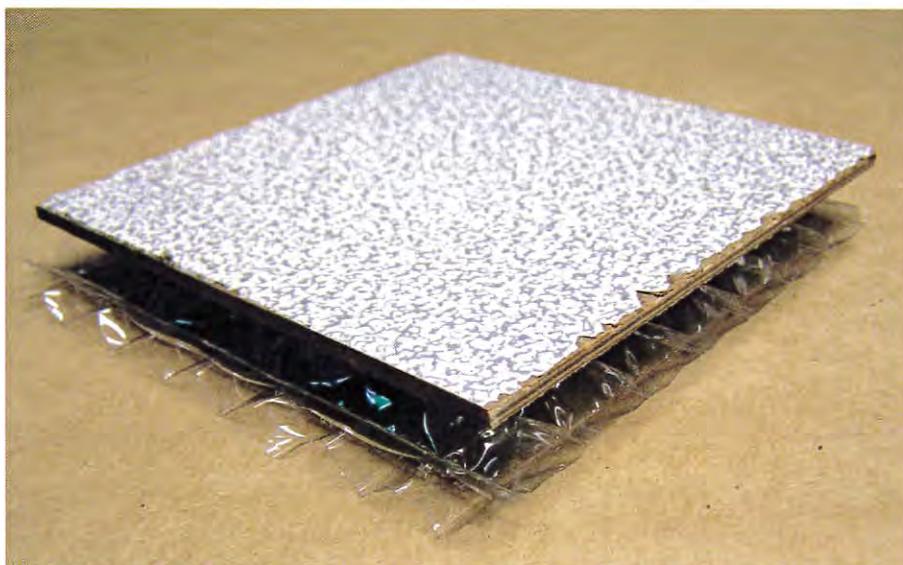
Photo 3 - "X1", wall lining

Wall lining consisting of, nearest to the cabin, 3 mm laminate with 36 mm insulation layer behind.

Conducted tests indicate that classification according to CEN/TS 45545-2:2009 would be HL2.

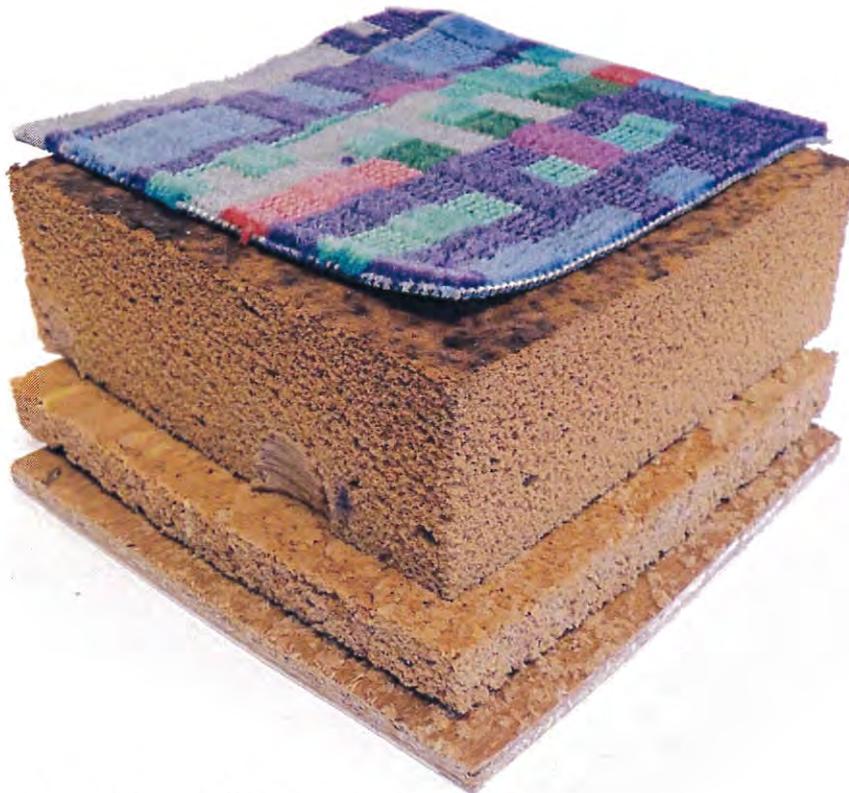
Photo 5 - "X1", material composition of passenger seat

The seat consisted of, from the top; fabric 3 mm, foam for seat 60 mm, foam for backrest 12-25 mm, cork wood 9 mm and painted wooden board 4 mm. Downwards facing surfaces and also vertical surfaces where covered with steel sheet why only the upwards facing surface need to be tested.

Conducted tests indicate that classification according to CEN/TS 45545-2:2009 would be HL1.

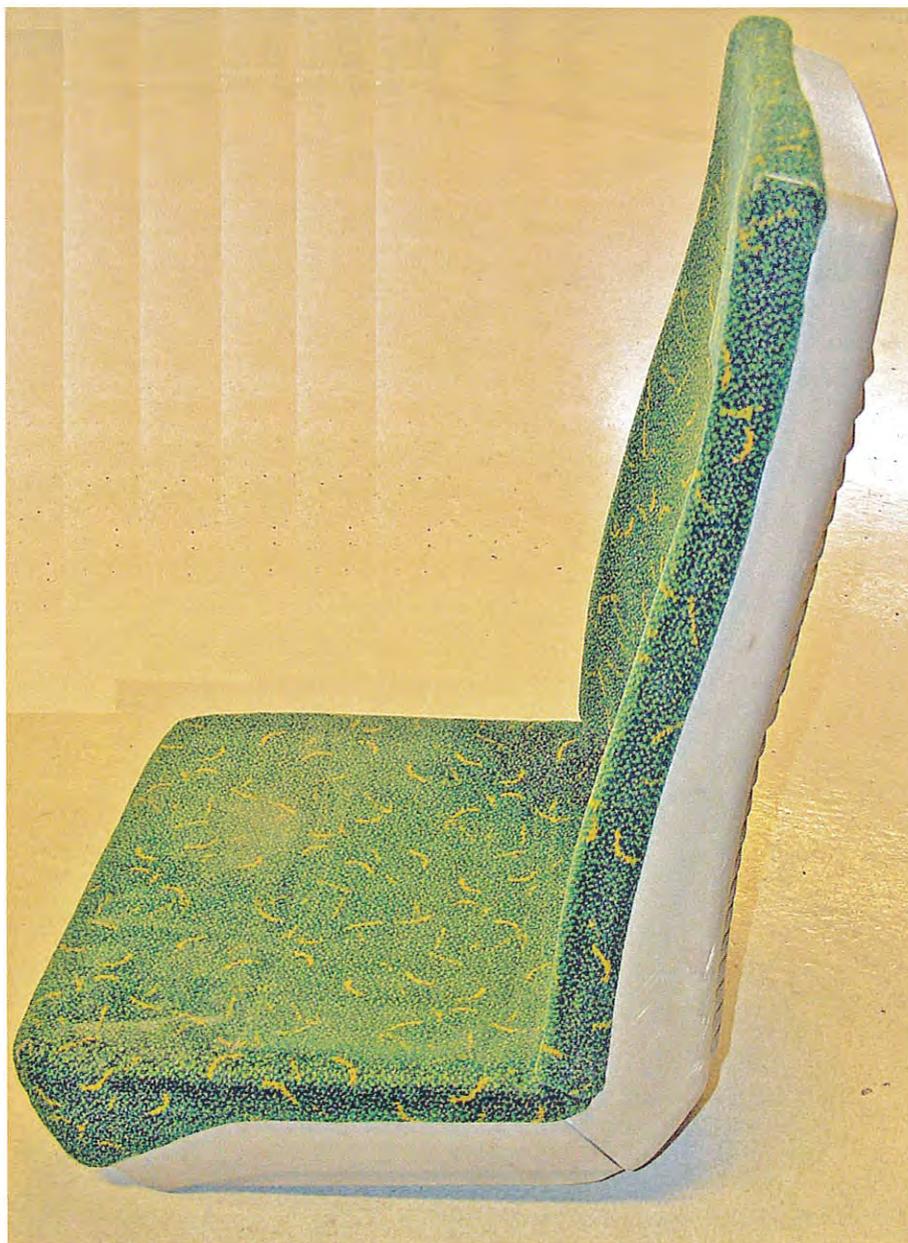
Photo 7 - "C20/X10", passenger seat

The material composition of the seat consisted of, from the top; fabric 4 mm, foam for seat 75-120 mm, foam for backrest 30-40 mm and corrugated plastic board 3 mm.

Conducted tests indicate that classification according to CEN/TS 45545-2:2009 would be HL1.

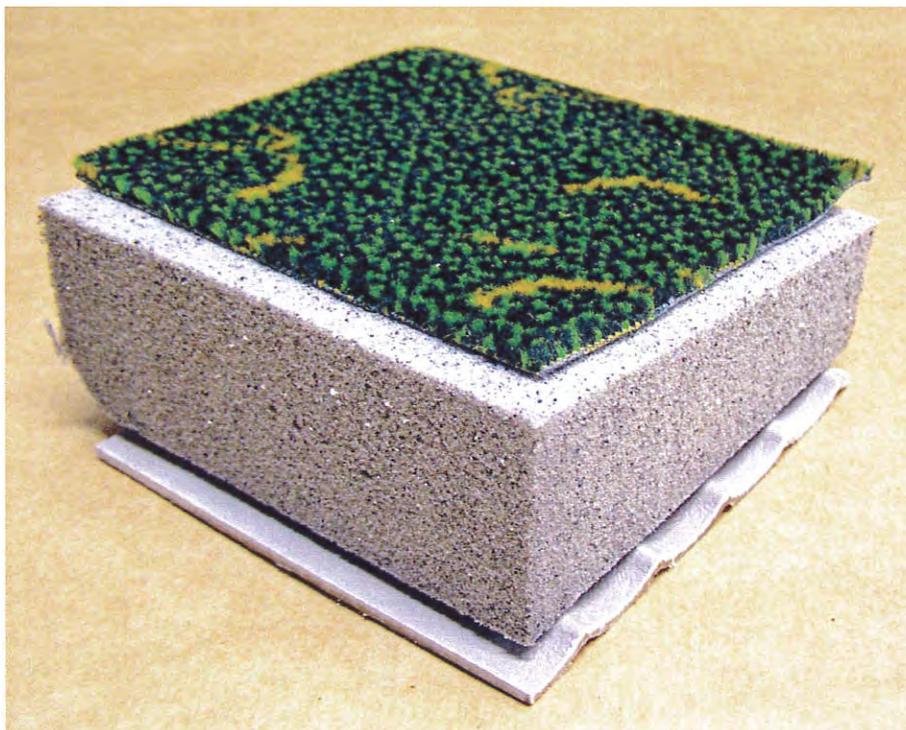
Photo 8 – “C20/X10”, Upholstery, material composition of passenger seat*

* Picture showing principle of specimen, the foam in the specimens tested had overall the same thickness.

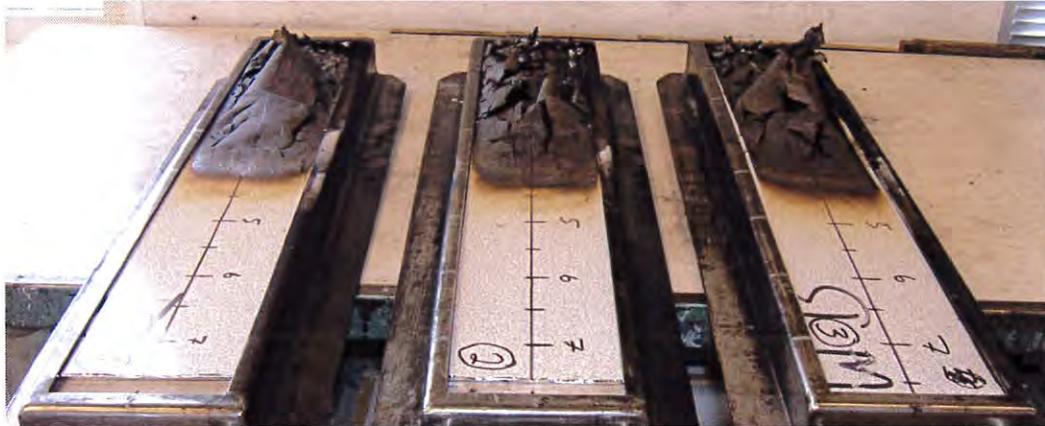
Photo 12 - All three of the tested specimens, no difference detected between specimens with or without insulation layer behind the laminate layer.

For all three specimens the surface cracked during the test, see photo no 12.

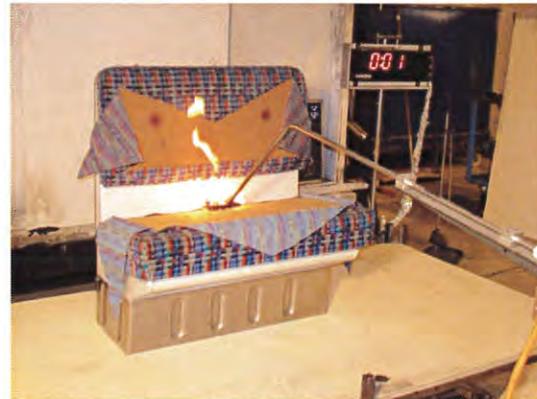
Photo 2 - Time 00:01. The burner has been applied.

Time min:s	
-02:00	The gas burner was ignited.
00:00	The ignited gas burner was placed on top of the seat. See photo 2.
00:54	The fabric on the back of the seating part is igniting but is unable to support a constant combustion.
03:00	The gas burner was removed from the seat. See photo 4.
03:02	The flames cease but progressive smouldering is visible. See photo 5.
05:03	The smoke production has decreased. See photo 6.
08:56	The progressive smouldering has died out and no smoke is visible. See photo 7.
23:00	The measurements and test is terminated. See photo 8.

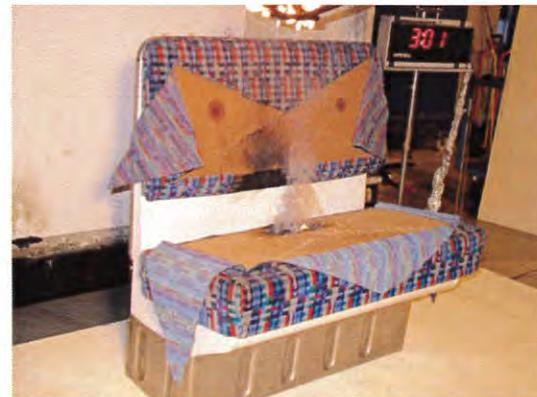
Photo 4 - Time 03:01. Burner just removed.

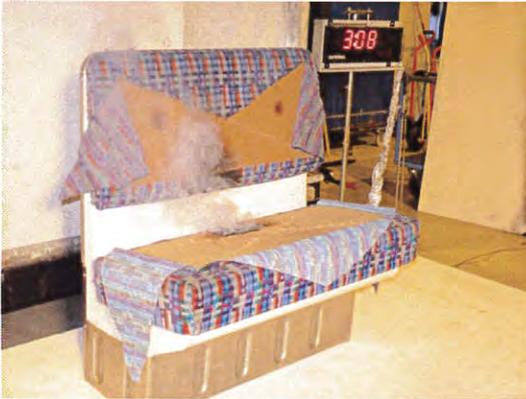
Photo 5 - Time 03:08. The flames cease but progressive smouldering is visible.

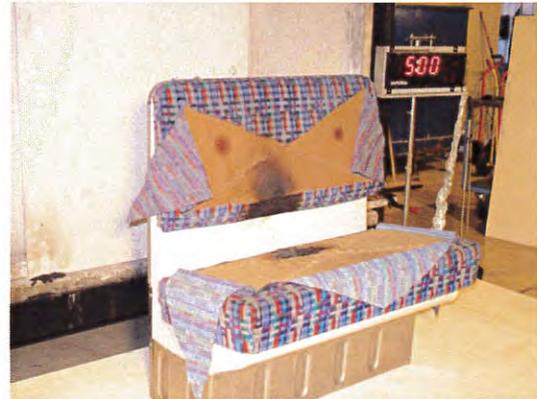
Photo 6 - Time 05:00. The smoke production has decreased.

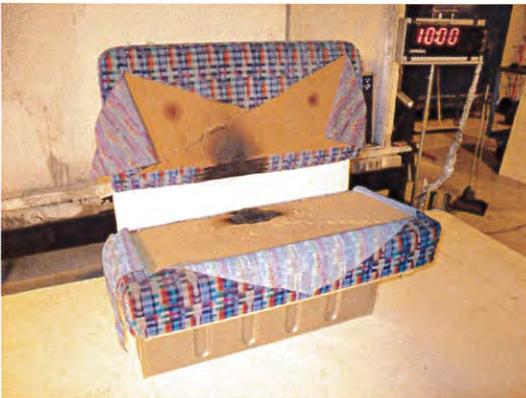
Photo 7 - Time 10:00. Smoke is no longer visible.

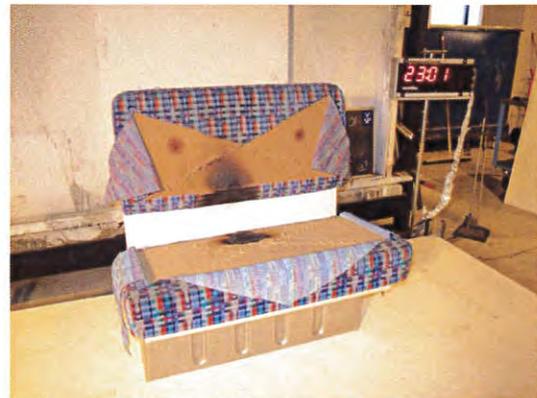
Photo 8 - Time 23:01. The test is terminated.

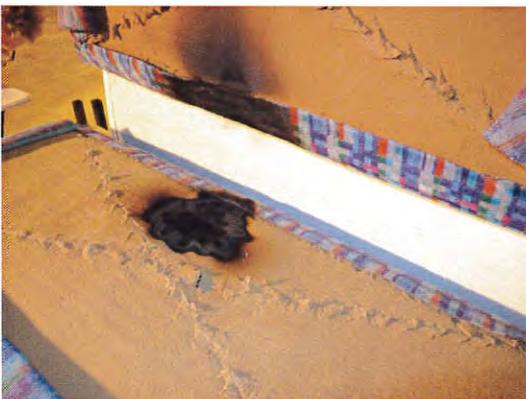
Photo 9 - After test. Some charring is visible around the area where the burner was applied as well as on the lower part of the back.

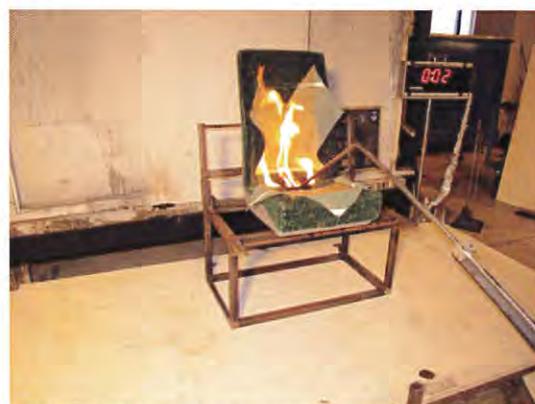
Photo 2 - Time 00:02. The burner has been applied.

Time min:s	
-02:00	The gas burner was ignited.
00:00	The ignited gas burner was placed on top of the seat. See photo 2.
00:33	The foam on the backrest and parts of the seat is burning and small areas of the fabric have ignited. The flames are high and reaches over the top of the backrest. See photo 3.

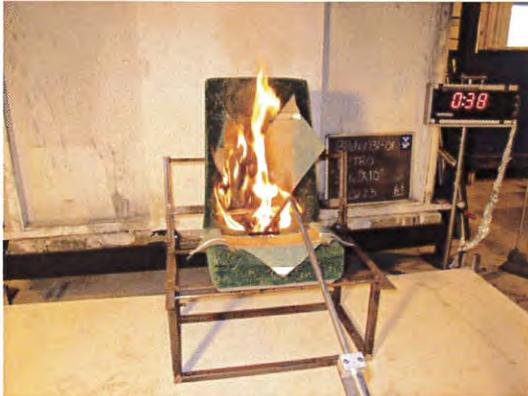
Photo 3 – Time 00:38. The foam on the backrest and parts of the seat is burning and small areas of the fabric have ignited. The flames are high and reaches over the top of the backrest.

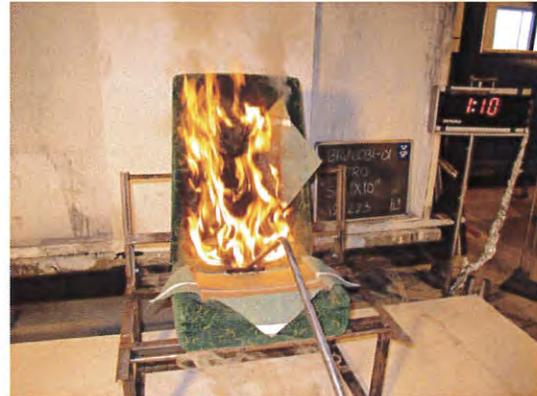
Photo 4 - Time 01:10. All of the exposed foam is burning with large flames and thick, green smoke is coming out from under the seat.

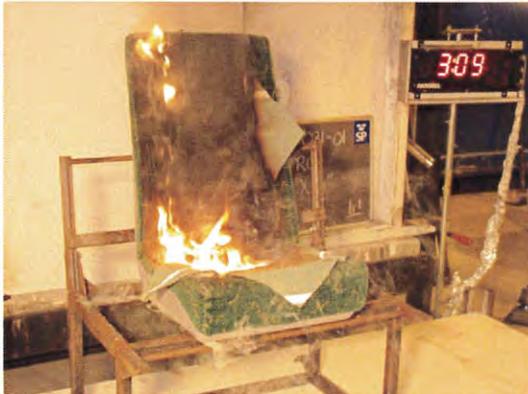
Photo 5 - Time 03:09. The burner has just been removed.

01:05	All of the exposed foam is burning with large flames and thick, green smoke is coming out from under the seat. See photo 4.
03:00	The gas burner was removed from the seat. See photo 5.

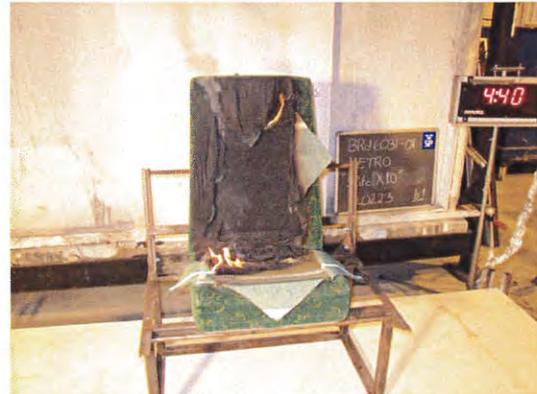
Photo 6 – Time 04:40. The fire has lost in intensity and only parts of the Velcro is burning as well as the foam around it.

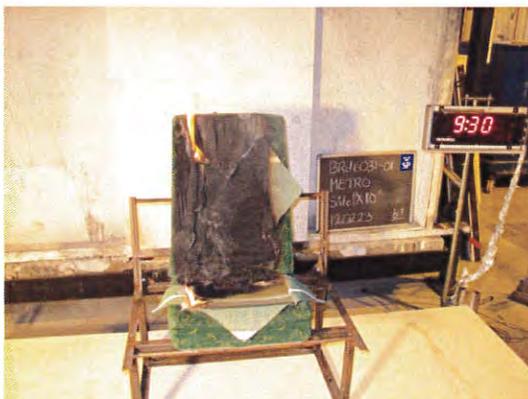
Photo 7 - Time 09:30. The Velcro is burning on the back underneath the pendant piece of fabric.

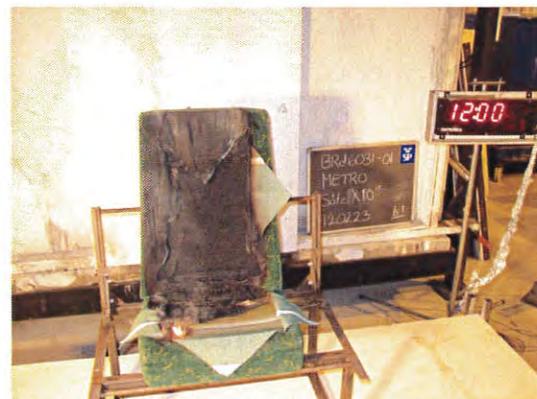
Photo 8 - Time 12:00. The flames on the backrest cease.

09:29	The Velcro is burning on the back underneath the pendant piece of fabric. See photo 7.
11:57	The flames on the backrest cease. See photo 8.
12:41	The flames on the seat cease. See photo 10.

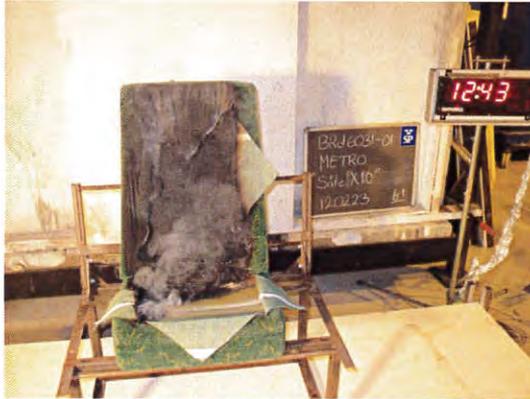
Photo 9 - Time 12:43. The flames on the seat cease.

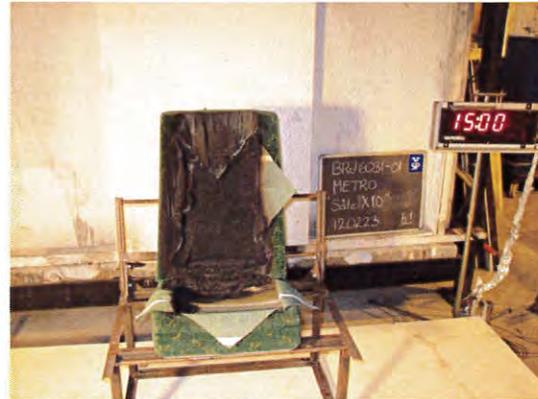
Photo 10 - Time 15:00. The smoke production has stopped.

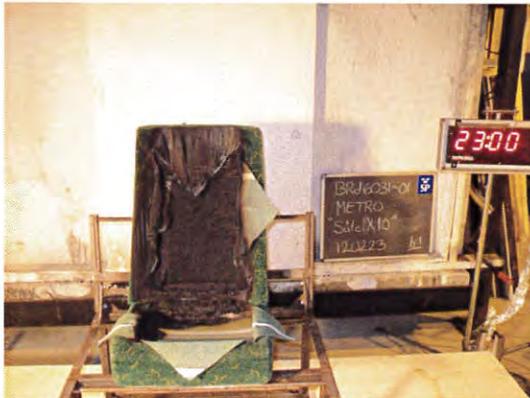
Photo 11 - Time 23:00. The test is terminated.

23:00	The measurements and test is terminated. See photo 11.
