BRANDFORSK  
2017:1

## Fire Stops in Buildings

Alar Just och Daniel Brandon

Fire stops, cavity barriers, model scale fire tests

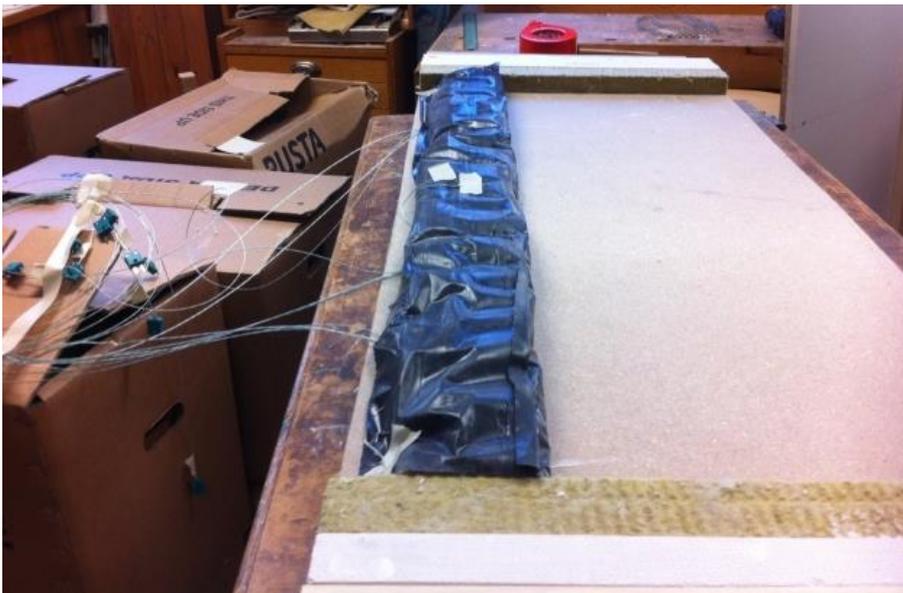
*Figure 1 - Single-barrier specimen of test series 1*

A first test series was performed in order to make a first assessment of a method that includes combustible materials in the cavity. In the test series called test series 1, cavity barriers were placed between two particle boards. The cavity barriers were glued on one of the cavity walls before the second cavity walls were placed (see Figure 1). Specimens were placed on top of a furnace (Figure 2) and then they were exposed to a standard fire in accordance with EN1363 for one hour.

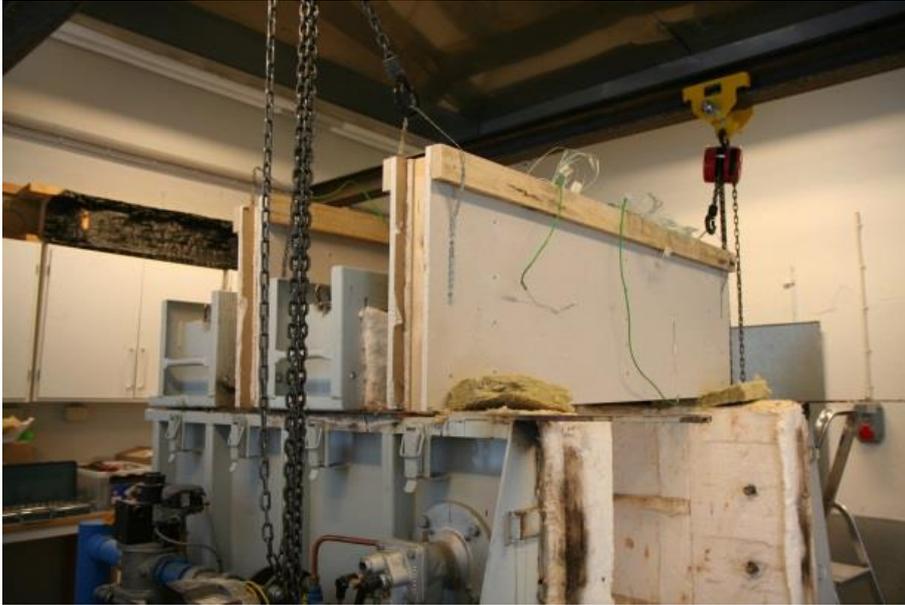
*Figure 2 - Positioning of 2 specimens on top of a furnace.*

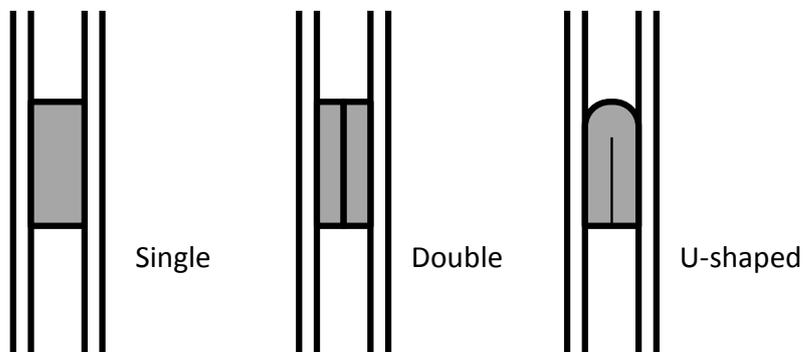
*Figure 3 - Single, Double and U-shaped positioning between two cavity walls*

Test series 1 included four different cavity barriers, of which an overview is given in Table 1. The brands of the cavity barriers are kept anonymous as this is an ad hoc procedure, but a description of the different barriers is given in Table 1 and Table 2. Common methods to install cavity barriers are illustrated in Figure 3. The aim of this first test series was to identify weaknesses of an initial test method. Therefore, it was chosen to install the cavity barriers differently, using the most practical way considering the dimensions and compressibility.

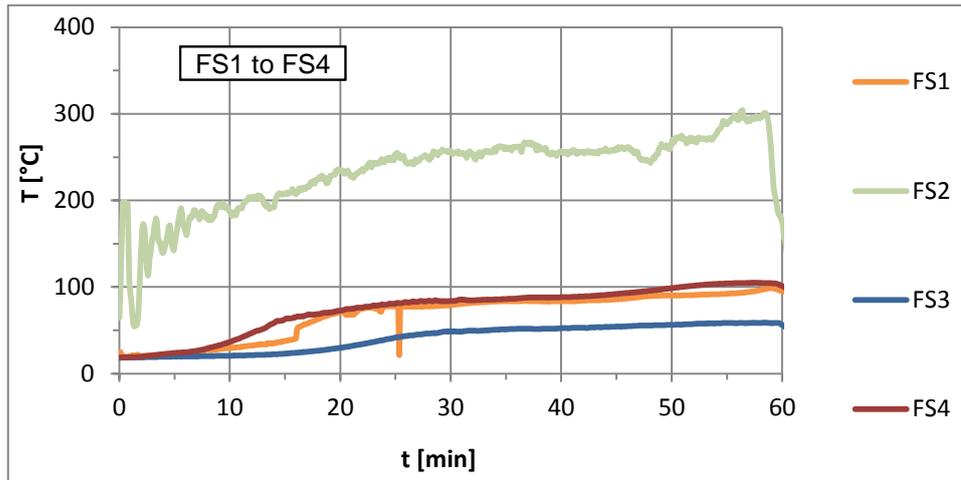
Figure 4 shows temperatures measured on the unexposed side of cavity barriers. It can be seen that the best performance was achieved with plastic covered glass wool of 50 x 160mm, which also had the largest volume. The stone wool did reach the failure criterion as the temperatures on the unexposed side were over 300°C. The method seems to be able to differentiate between performances of different materials. However, it can be questioned whether the specimens are exposed to conditions that are severe enough, so that the fire stops can be used to avoid high damage cavity fires. For an assessment of weaknesses of the preliminary test method a review of real cavity fires is performed. This is discussed in the next chapter.

Figure 4: temperatures on the unexposed side of the cavity barriers

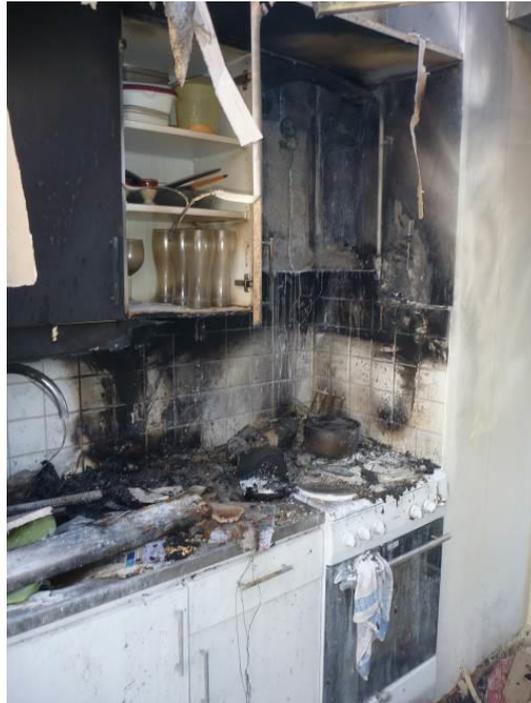
*Figure 4 - Fire damage after extinguishment of the fire in the ignited compartment<sup>2</sup>*

The fire originated in a kitchen due to ignited oil in a saucepan. The fire brigade arrived quickly at the fire and managed to extinguish the fire in the original compartment (see Figure 5). However, the fire spread through the ventilation shaft and ignited combustible material in the attic. The attic burned out after approximately 1.5 hours, at which the visible fire stopped. However, within the cavities the fire spread downward (see Figure 6) and caused re-ignition of the fire in lower floors. The fire brigade struggled to extinguish the fire and had to demolish building elements in order to find and reach the fire. After the fire, the building had to be demolished as the fire damage was too severe for recovery.

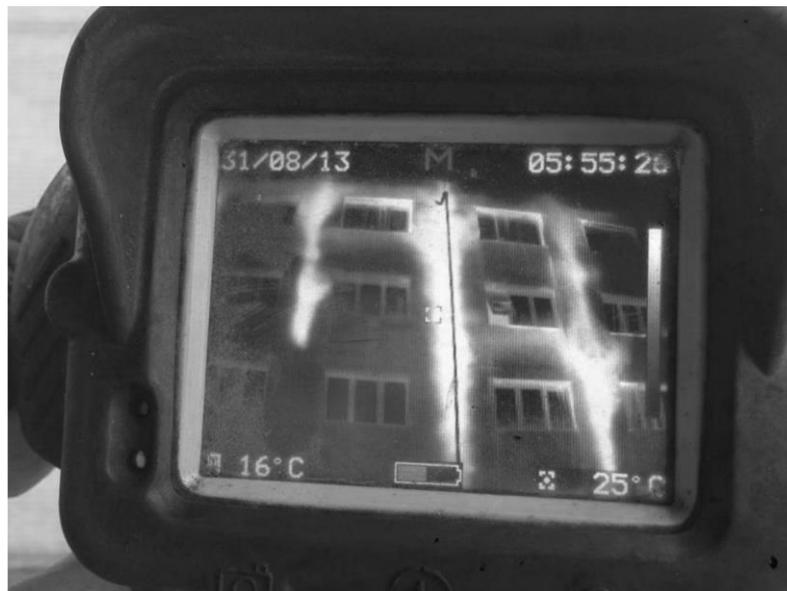
*Figure 5 -Infrared camera picture indicating a downwards fire spread through cavities<sup>2</sup>*

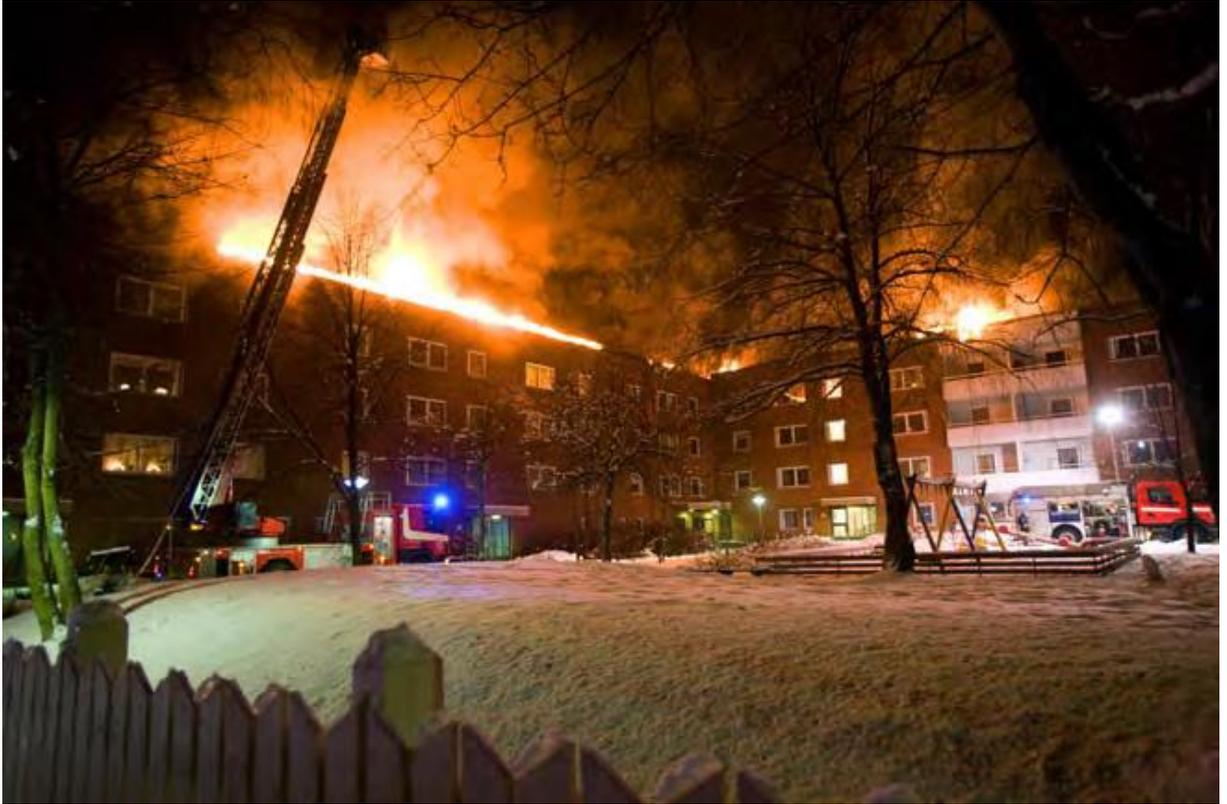
Figure 6 - Building fire in Umeå, Ålidhem (Umeå Kommun Brandförsvaret och Säkerhet, 2009).

The building consisted of three buildings parts adjacent to each other (see Figure 6), each part consisted of four floors and an attic. The building had a concrete structure and a masonry façade. The attic ranged over the whole building without fire walls (Umeå Kommun Brandförsvaret och Säkerhet, 2009). The building in Umeå had a non-combustible structure, but had combustible material in the cavities.

The fire ignited in a pan with oil in the kitchen and spread to the cupboard above the kitchen range. The fire was extinguished quickly by the fire brigade, after which the situation was assessed to be safe. However, after a few hours the fire re-ignited in the attic and the fire spread down to several apartments. Investigation of the fire showed that the fire spread through the cavity in the external wall, where any cavity barrier was absent.

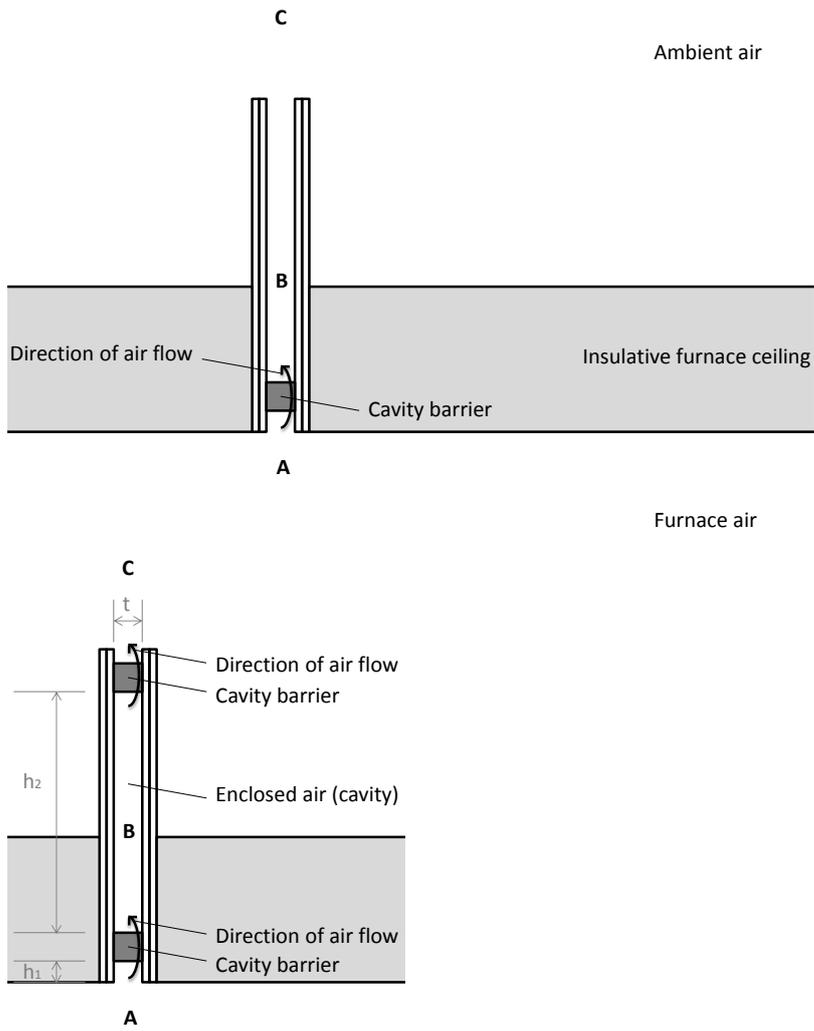
Figure 7 - Single-barrier (left) and double-barrier specimens (right), schematic

In test series 2, an enclosed cavity is tested by using two fire barriers in a single specimen (Figure 7, right). These specimens are here simply referred to as double-barrier specimens. In contrast with the single-barrier specimen (Figure 7, left), which is in accordance with the draft of EN 1364-6 (2016), the double-barrier specimen contains an enclosed cavity. Both specimens contain a fire barrier between the cavity (B) and the furnace (A, Figure 7), which limits the temperature rise and air flow in the cavity during the heating phase of a fire. However, the temperatures in the cavity of the double-barrier (B, Figure 7) specimen can be significantly higher than those in the single-barrier specimen, as there is a barrier between the cavity and the ambient air (C, Figure 7, right). As buildings generally have multiple fire barriers and enclosed cavities, it is, as a worst case scenario, important to consider double-barrier specimens instead of single-barrier specimens.

where  $t$  is the cavity width as denoted in Figure 7

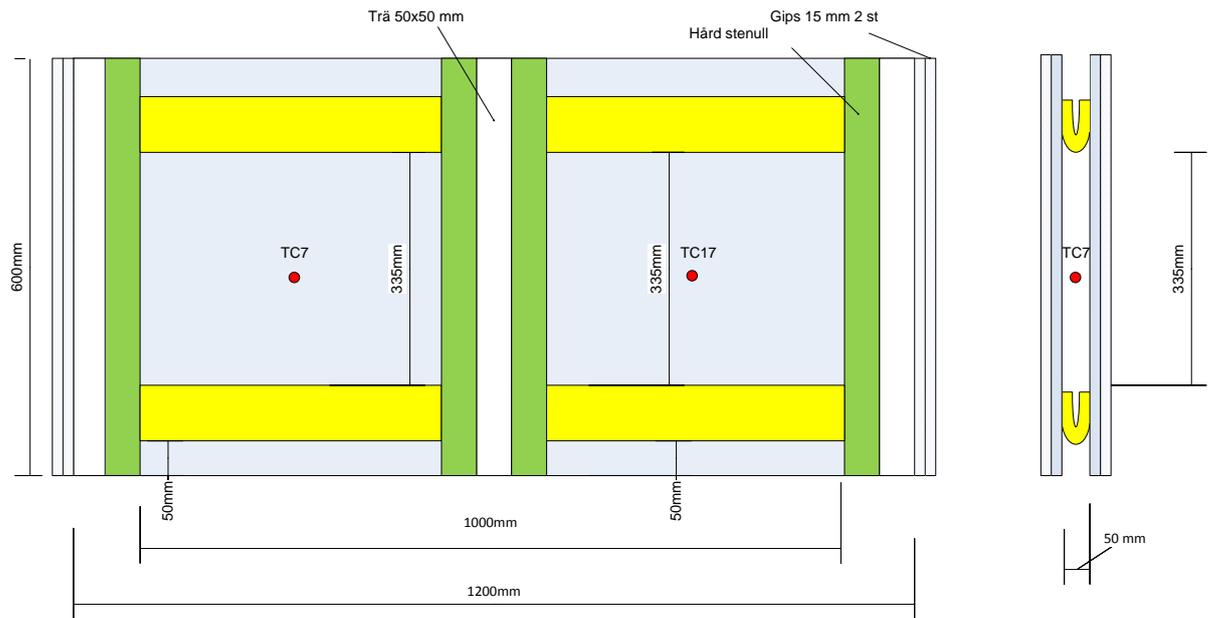
Figure 8 - Cross-sections of specimens of test series 2, exposed from the bottom

The cavity walls comprised of 10mm thick particle board with 15mm gypsum board screwed on the unexposed sides. The density of the particle board was  $812 \text{ kg/m}^3$ . The cross-section of the specimens is shown in Figure 8. Seven different cavity barriers were tested, in order to evaluate the testing method. An overview of these cavity barriers is given in Table 2 and Table 3.

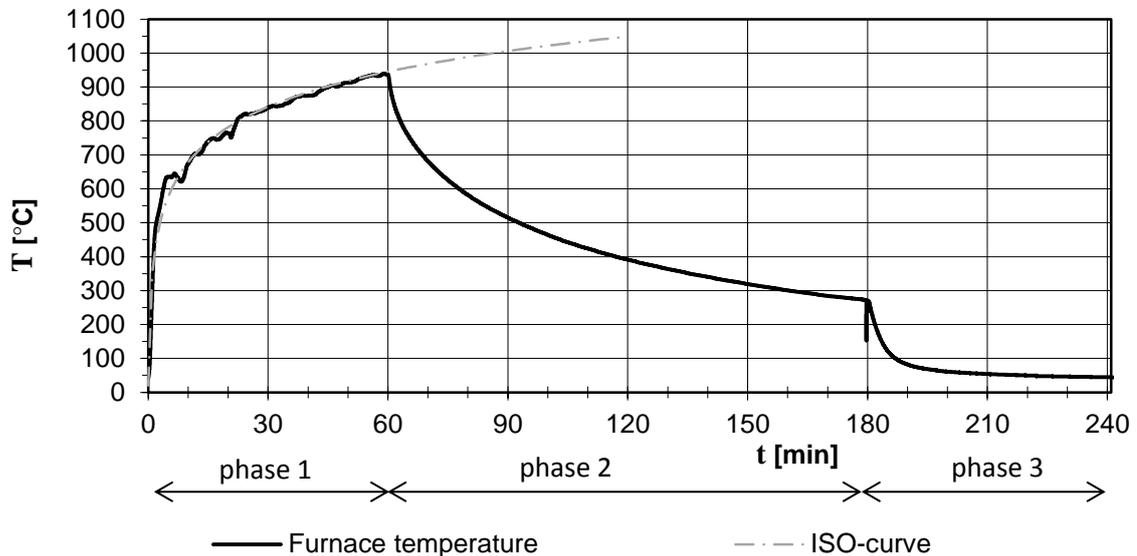
Figure 9 - Average heat exposure measured using two plate thermometers (test 1)

For this study, the heating phase (Phase 1) was performed in accordance with the standard fire curve defined in EN 1363-1 (see Figure 9). The pressure in the furnace was controlled and was 19 Pa +/- 4 Pa, 100 mm from the top of the furnace. Phase 1 was maintained for 1 hour. Subsequently, Phase 2 considered the cooling phase as shown in Figure 10, while the furnace remained closed. A cause of re-ignition was stimulated

during Phase 3 by removing 1 wall of the furnace, which resulted in rapid cooling and an increase of air flow driven by buoyancy through the specimens. This phase was used to assess the presence of combustion within the enclosed cavity, as discussed in the next section. Phase 2 and Phase 3 lasted for two and one hours, respectively.

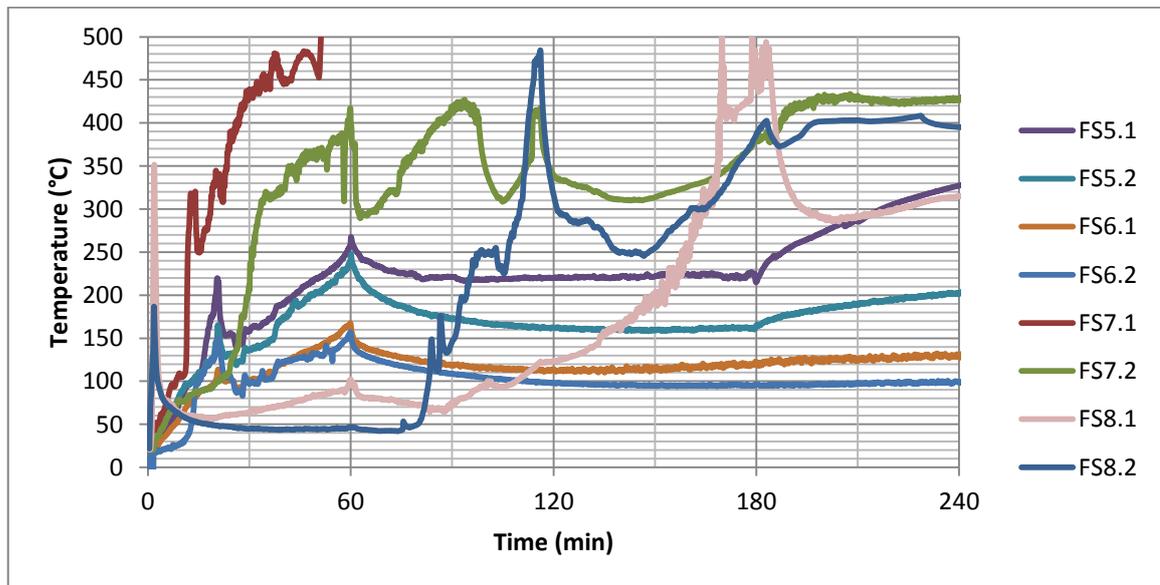
The temperatures measured in the centre of the enclosed cavities are shown in Figure 10. The curves corresponding to, at room temperature closed cavities, (all curves except for FS8.1 & FS8.2) showed a large variation. The temperature in specimen FS7.1 increased rapidly during the heating phase. After approximately 80 minutes visible flames started leaving the top of specimen FS7.1, after which the cavity was filled with stone wool to stop the fire. According to the two failure criteria mentioned before, the cavity barriers corresponding to specimens FS5.1, FS7.1, FS7.2, FS8.1 and FS8.2 fail the test, as the temperatures remained higher than 300°C. The barriers of specimen FS5.2 and FS6.1 fail the test as well, because they show a significant temperature increase during Phase 3. It should be noted that the specimens FS5.1 and FS6.1 are identical, but show significantly different temperatures. Whether this is caused by, (i) variations in the product, (ii) variation in the mounting or (iii) something related to the chosen test method we do not know, further investigations will show that. This indicates that more than one model scale

Figure 10 - Temperatures measured in the centre of the cavities

The two curves in Figure 10 that correspond to ventilated cavities (FS8.1 and FS8.2) show a peak at the very beginning of the test which is logical as this is cavity barriers that are open at room temperature. However, the temperature decreased rapidly afterwards, which indicates that the lower intumescent cavity barrier expanded. The temperature in the center of the cavity did not significantly increase for the first 80 minutes, indicating that the upper barrier was not fully activated during this period. During this period the test could, thus, be considered as a single-barrier test (see Figure 7A). Therefore, the applied method should be questioned for ventilated cavities. The increase of the temperature observed after 80 minutes could be caused by potential expansion of the upper barrier or possible degrading of the lower barrier.

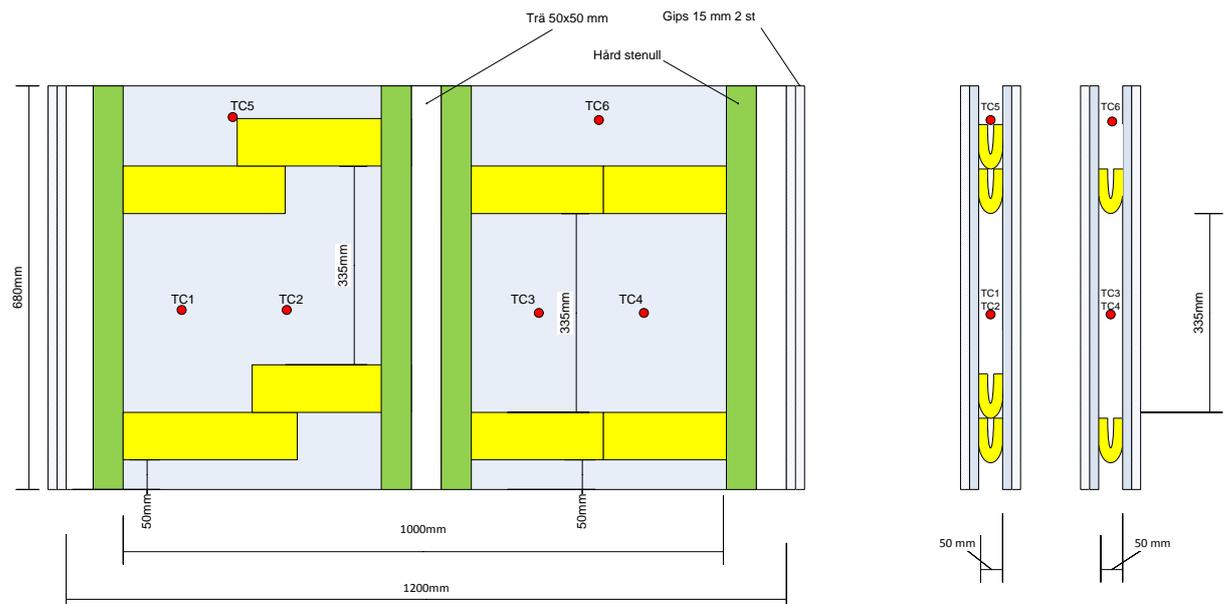
Figure 11 - Cross-sections of specimens with overlapping joints (left) and butt joints (right), exposed from the bottom

Table 5 gives an overview of the performed tests of test series 3. The performance of overlapping joints and butt joints between cavity barriers, as shown in Figure 11 was studied. Test FSJ1.1 and FSJ1.2 comprised of plastic covered cavity barriers which were positioned in a cavity with walls made of particle board. The unexposed sides of the particle board were covered by gypsum plaster boards similar to the specimens of the previous test series. Tests FSJ1.1 and FSJ1.2 functioned as reference tests for the other tests. Tests FSJ2.1 and FSJ2.2 were similar tests, without plastic covering of the cavity barriers. The difference between FSJ3.1 and FSJ3.2 compared with FSJ 1.1 and FSJ 1.2 was the combustible wall material of the cavity, as FSJ3.1 and FSJ3.2 were made using plywood with a density of 680kg/m<sup>3</sup> instead of particle board.

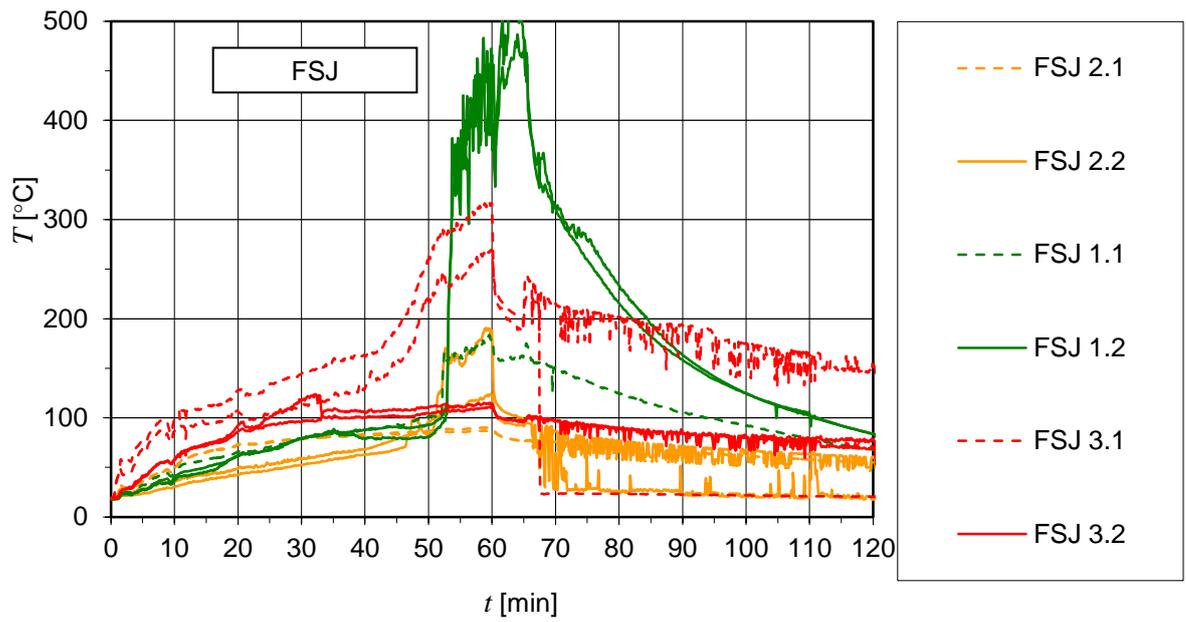
Temperatures measured in the centre of the cavities are shown in Figure 12. Test FSJ 1.2 showed the highest temperatures in the cavity after one of the cavity barriers fell into the furnace. It can be seen that FSJ2.1 and FSJ2.2 showed the best performance. These correspond to tests of cavity barriers without plastic. Observations of the test specimens after the tests, indicated that there was a significant air flow across the cavity barriers (Figure 13). Air channels are indicated by dark lines in the wooden surface at the position of the barriers. In contrast, the specimens of FSJ 2.1 and FSJ 2.2 (Figure 14), which correspond to cavity barriers without plastic, did not show these lines. The temperatures measured in the cavity were also significantly lower during the test. This indicates that cavity barriers without plastic covering are more suitable to limit the air flow into the cavity.

Figure 12 - Temperature measured in the center of the cavities

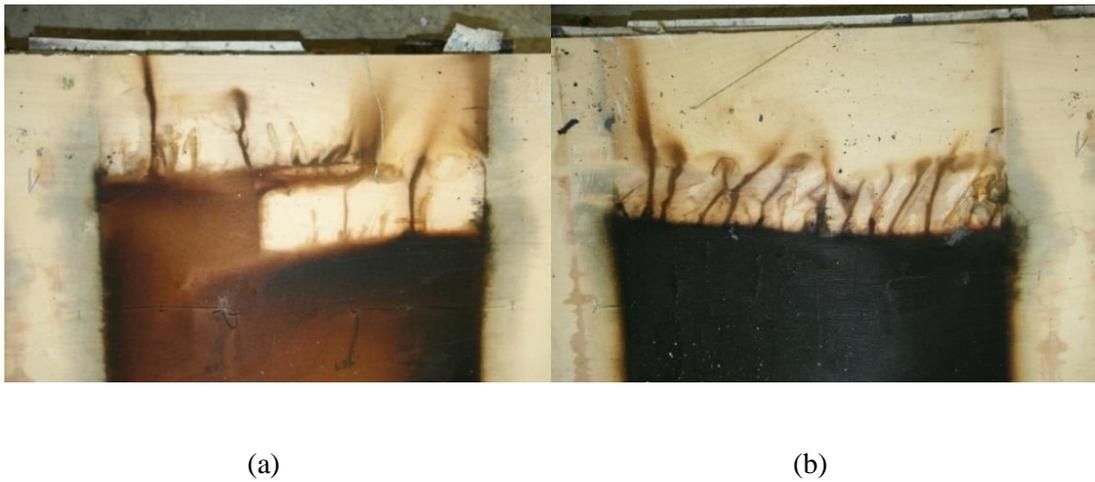
Figure 13 - Cavity walls of FSJ1.1 (a) and FSJ1.2 (b) after the test

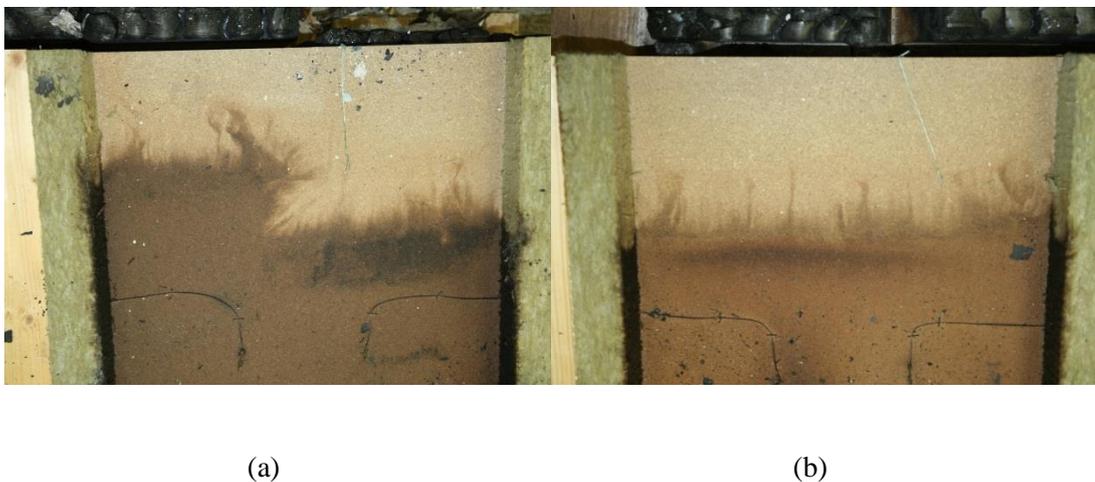
Figure 14 - Cavity walls of FSJ2.1 (a) and FSJ2.2 (b) after the test

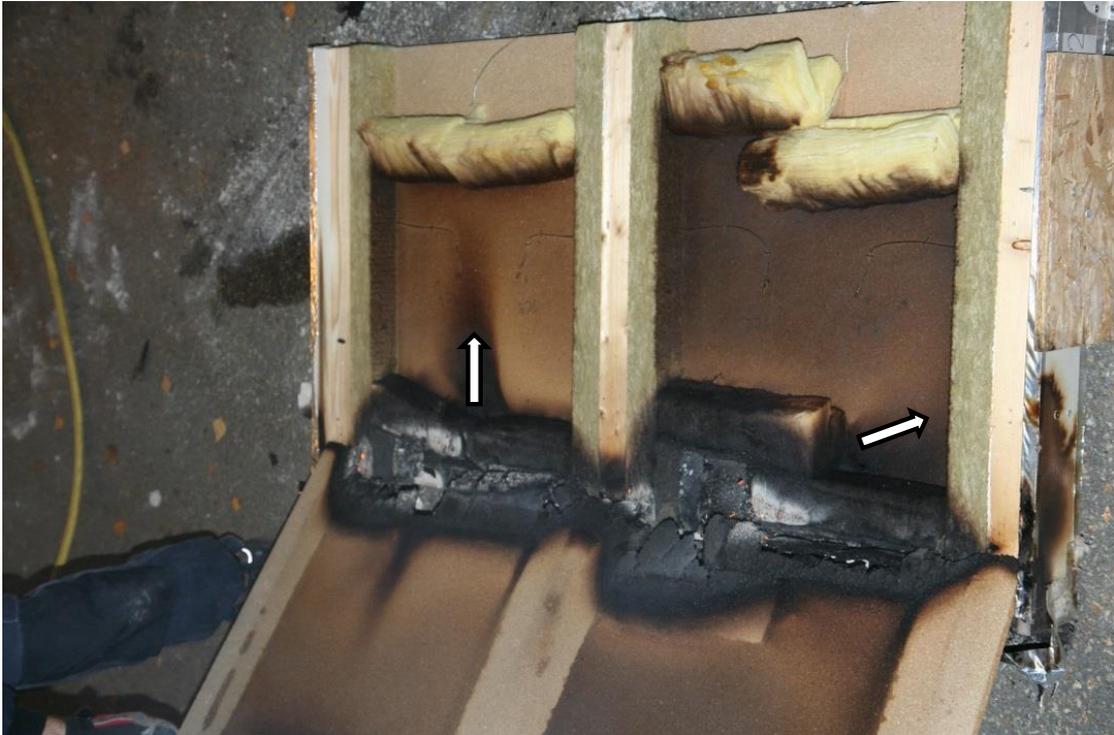
Figure 15 shows the specimen of FSJ2. The arrows indicate the direction of most significant air flow in the joints. Both cavities did not have to be extinguished after the fire test.

Figure 15 - Inside of the cavities FSJ2.1 (right) and FSJ2.2 (left) after the test

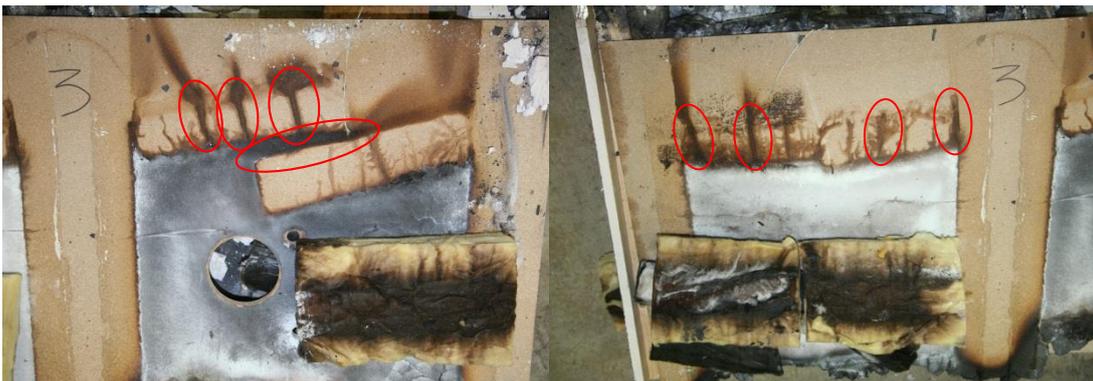
The second highest temperatures were measured in FSJ3.1. Observation of the specimen after the test (Figure 16 a) showed that the overlap joint was not entirely tight as the cavity barriers were inclined with different angles. This created an undesirable air channel. The test specimen of FSJ3.2 did not show an air channel at the location of the joint. During the installation it was considered easier to make the butt-joint tight.

Figure 16 - Cavity walls of FSJ3.1 (a) and FSJ3.2 (b) after the test

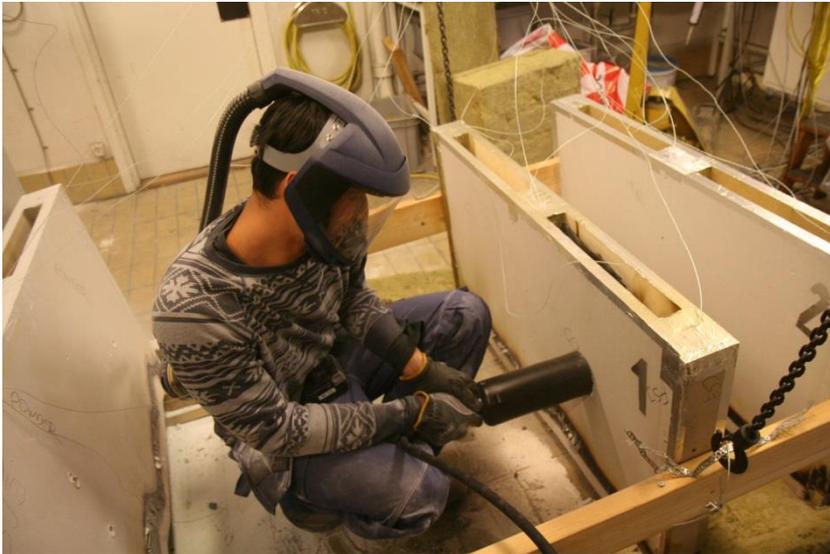
Figure 17 - Extinguishing of specimen FSJ1.

After the test of series 3 there was still combustion in the cavities of specimen FSJ1 and FSJ3. For the extinguishments a hole was drilled through the cavity wall and CO<sub>2</sub> and/or powder extinguishers were used (see Figure 17). The consumed weight of the substance used for extinguishments is reported in Table 6.

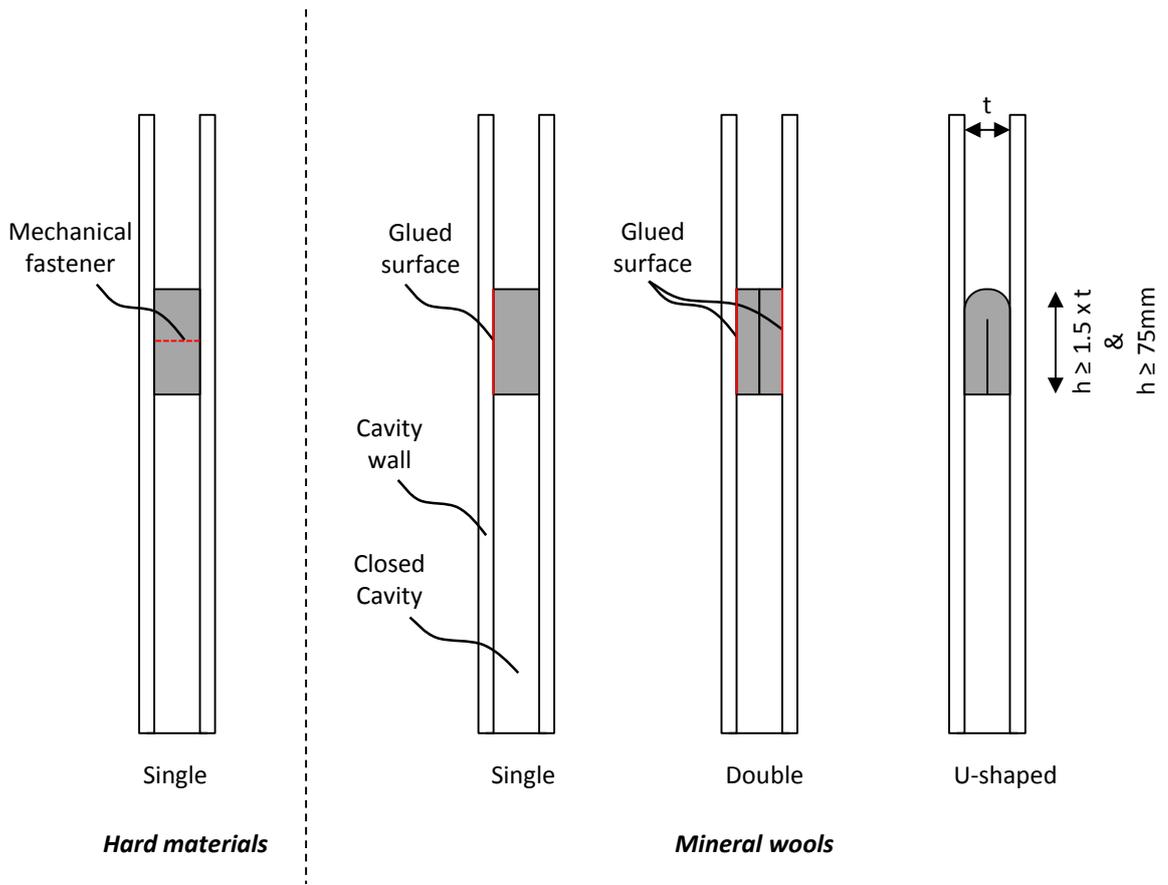
Figure 18 – Cross-sections of single double and U-shaped cavity barriers

There are several methods of installation recommended for cavity barriers. As shown in Figure 18 potential placement of the cavity barriers could be single double or U-shaped. In case mineral wools are used as cavity barriers, the minimum dimension is recommended to be chosen, so that its compressed density after installation is  $50 \text{ kg/m}^3$  or higher. Additionally, its height after installation,  $h$ , should be at least equal or larger than the maximum of 75mm and  $1.5t$ , where  $t$  is the cavity width. For a U-shape placement of the cavity barrier the cross-section should be at least  $t \times 3t$ . Additionally, the minimum density of the uncompressed material should be  $25 \text{ kg/m}^3$ .

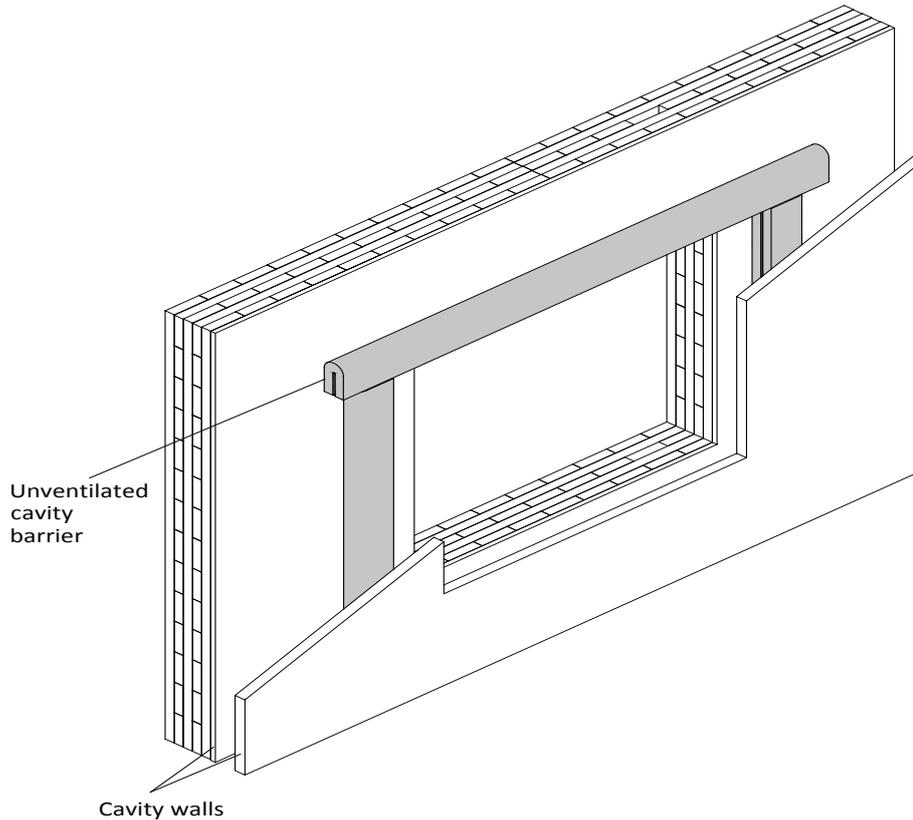
*A fire leaving a compartment through an opening will expose the upper side of the opening significantly more severely, than the lower side of the opening. Therefore, there is an increased risk that the cavity barrier above the opening falls, which would allow the fire to easily access the cavity. By letting highly exposed, horizontally positioned, cavity barriers within walls rest on the vertically positioned elements (Figure 19), the risk of falling becomes small.*

*Figure 19 - Prevention from falling of cavity barrier by robust design*

The design of cavity barriers should aim to (1) avoid falling of the cavity and (2) avoid air channels across and along the cavity barriers. Falling of the specimens can be avoided by appropriate fixation methods and, if possible, by robust design. Using robust design, falling of the barrier can be avoided, even if the primary fixation method (using glue, fasteners or by clamping) fails. An example of a robust solution that prevents falling of highly exposed cavity barriers is shown in *Figure 19*.

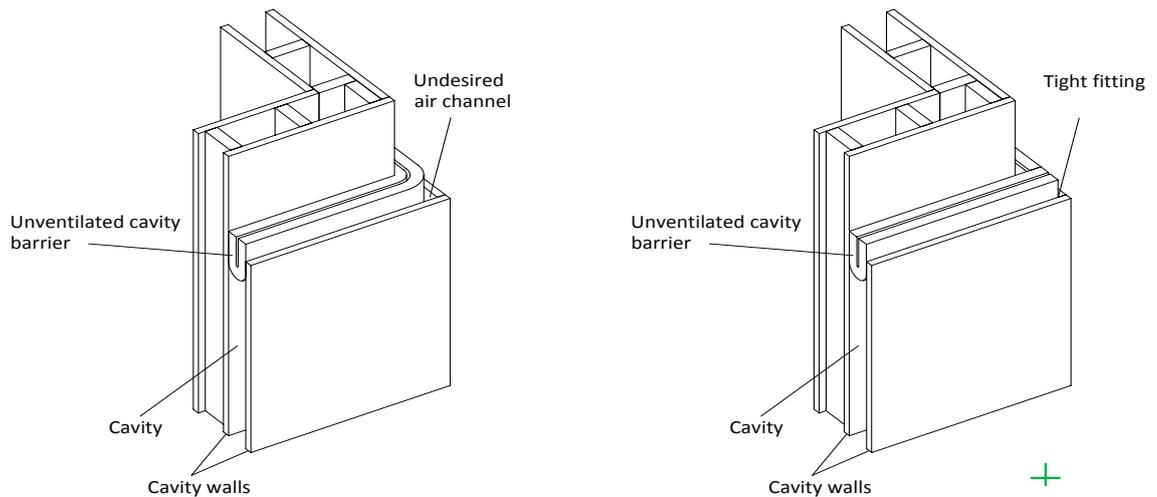
Undesired air channels can be avoided by design. Such undesired air channels could occur in corners and bends of the cavity barrier material, as shown in Figure 20. Solutions can be obtained by designing separate cavity barriers which are connected, instead of using bended cavity barrier in corners.

Figure 20 - Possible risk for undesired air channel in the outer corner

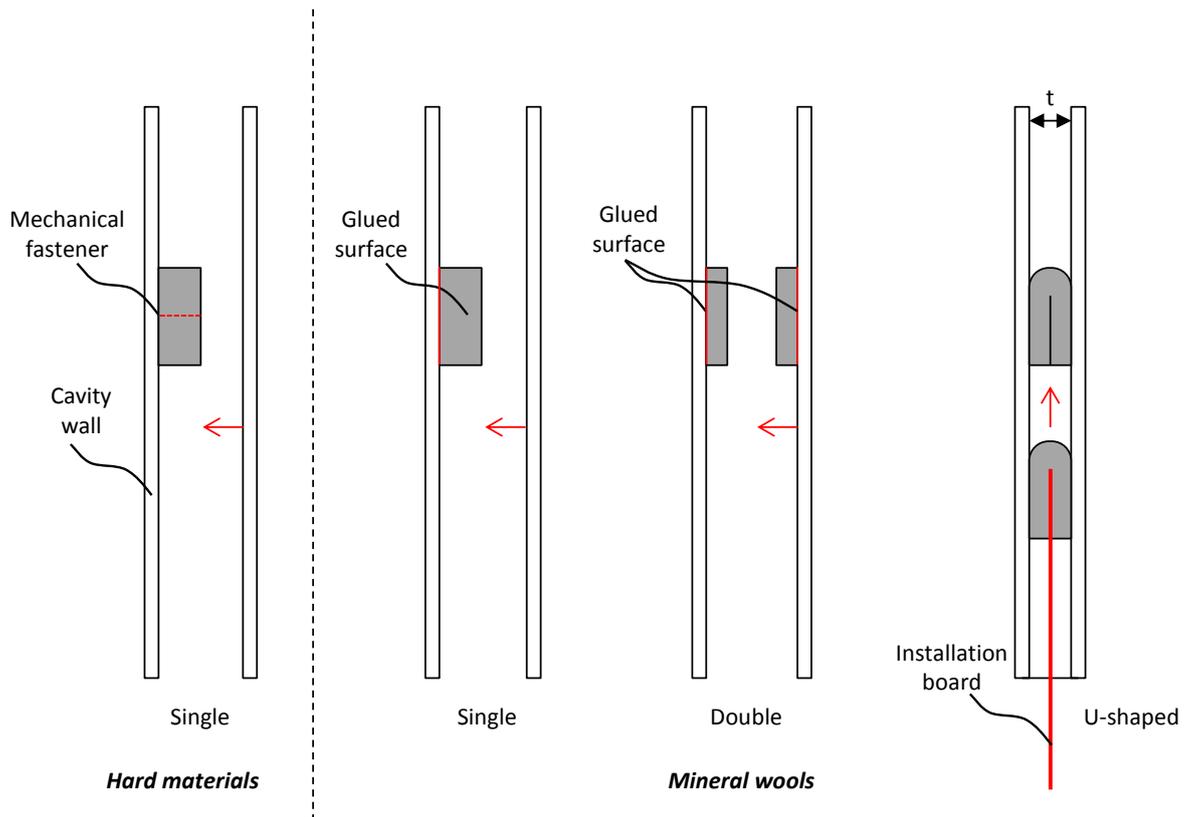
A schematic drawing concerning the installation of single, double or U-shaped placed cavity barriers is shown in Figure 21. The single and double placement of cavity barriers is especially applicable for cavities between modules of modular buildings. In this case the cavity barriers should be fixed to the cavity wall before the cavity is closed. Gluing of the cavity with high temperature resistant adhesives is recommended. For cavity barriers with a double placement, misalignment is allowed as long as the height of the contact area between the cavity barriers is equal or higher than the maximum of 75mm and  $1.5 \times t$  (see Figure 22).

Figure 21 – Schematic drawing of installation

The U-shape placement should be done using an installation board, as shown in Figure 21 and Figure 23. The intended position should be ensured using this installation board, which is especially relevant at the locations of joints. The resistance of the board should be used to indicate whether the cavity barrier is installed firmly.

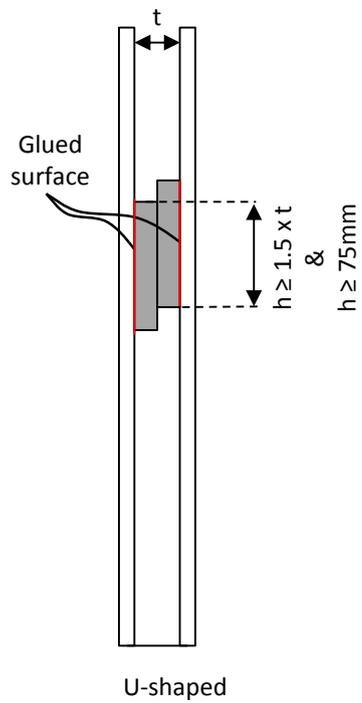
Figure 22 – Allowable geometrical misalignment

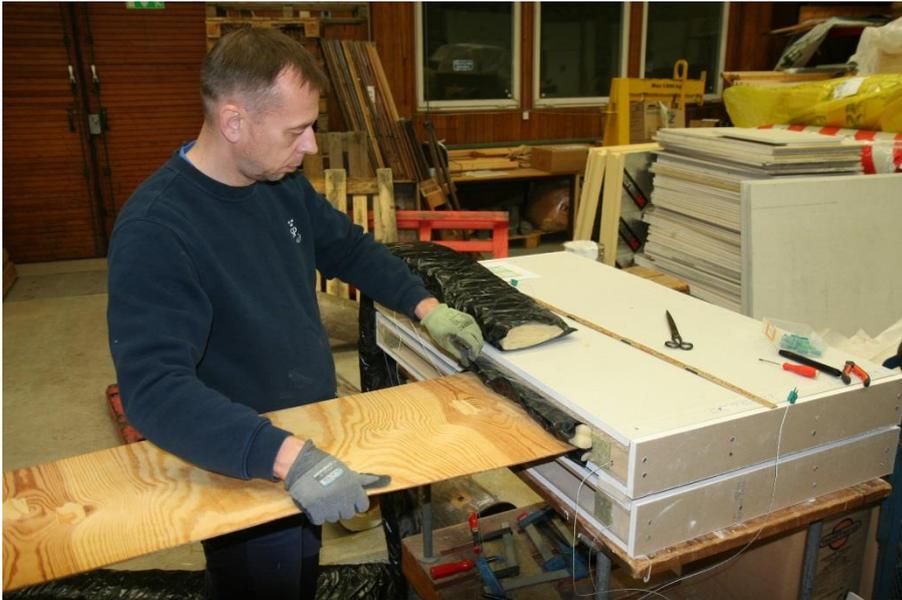
*Figure 23 - Sliding cavity barrier into the cavity for a U-shaped placement*

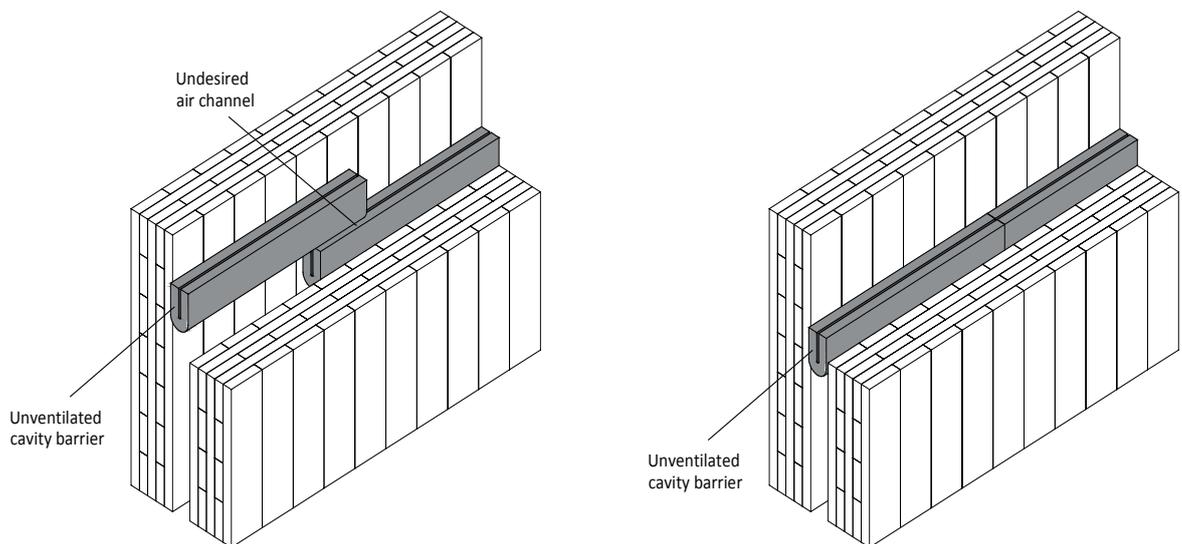
Joints between cavity barriers should be made, so that air channels in the joint are avoided. Using cavity barriers with a U-shaped placement could lead to undesired air channels in joints, as shown in Figure 24. Therefore, in-line and butt-joints are recommended for cavity barriers with a U-shaped placement. However, an overlapped joint, as shown on the left hand side of Figure 24, can be applied if (1) the length of the overlap is at least equal the height,  $h$ , of the cavity barrier and (2) the cavity is made of mineral wool without plastic covering. It must be ensured that both cavity barriers in one joint are placed tightly against each other.

*Figure 24 - Possible risk for undesired air channel with overlapped joint*
